Seismic Performances of Different Strengthening Techniques in Masonry Residential Buildings

Abstract: This study evaluates the seismic performance and retrofitting strategies for a masonry residential building in Malatya, Türkiye, that collapsed during the February 6, 2023, Kahramanmaraş earthquake owing to an illegally added story. Nonlinear static (pushover) and dynamic (time history) analyses were performed using a finite-element macro-model. The unretrofitted structure collapsed at approximately 0.45 g in the longitudinal direction. Two retrofitting techniques, namely stainless steel strip jacketing and carbon fiber-reinforced polymer (CFRP) laminates, were investigated. The strengthened models demonstrated significantly improved seismic performance: the stainless steel strip retrofit increased the base shear capacity to 0.69 g, whereas the CFRP retrofitting further enhanced it to 0.79 g. Both methods also reduced the maximum inter storey drift ratios (from 0.50% to 0.34% for CFRP) and limited the crack widths (from 17.8 mm to less than 8 mm). CFRP retrofitting provided the most effective improvement. These results highlight the urgent need to retrofit unauthorized story addit

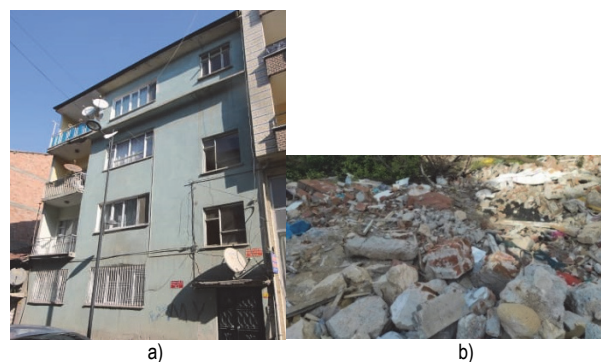
Figure 2 State of the building a) Before earthquake; b) Post-earthquake

The case study structure is located in Malatya, Türkiye. The location of the building is shown in Fig. 1. When the researchers reached the location of the building after the 2023 Kahramanmaraş earthquake, the building had completely collapsed (Fig. 2).

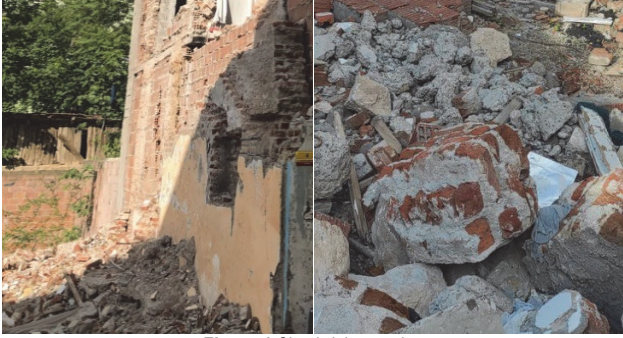
Figure 4 Clay brick samples

The clay bricks used in the construction of the masonry walls were found to have dimensions of $190 \times 90 \times 60$ mm, with material properties detailed in Tab. 1 [12]. The sample was taken from the debris following the earthquake to analyze its composition and strength. The debris and clay brick samples taken from the building can be seen in Fig. 4.

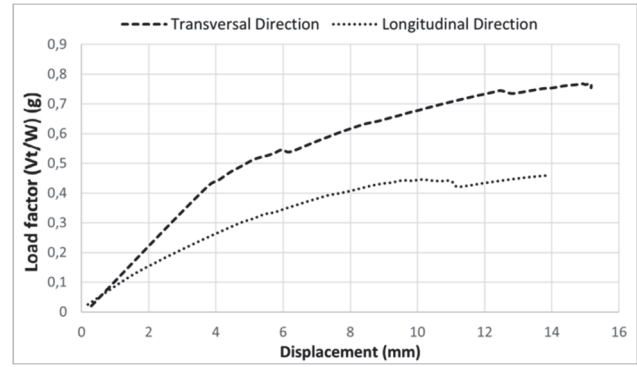
the control node (Fig. 7) in the transverse and longitudinal directions, as shown in Fig. 9.

Pushover analysis graphs are shown in Fig. 9 for the transverse and longitudinal directions. According to the results of the nonlinear static analysis, a building with an added story resists a maximum of 0.76 g in the transverse direction. In the longitudinal direction, the building resisted a maximum of 0.45 g. After the nonlinear static analyses, the crack propagations are shown in Fig. 10. Furthermore, the damage patterns of the building were evaluated using the maximum crack widths, which are considered reliable damage indicators [37]. Cracks were visible on all floors of the building. We observed that these cracks were concentrated on the edges of the window openings and the 10 cm-thick interior walls. The concentration of cracks along the edges of the window openings and interior walls indicates potential weak points in the structure that may be susceptible to further damage or collapse.

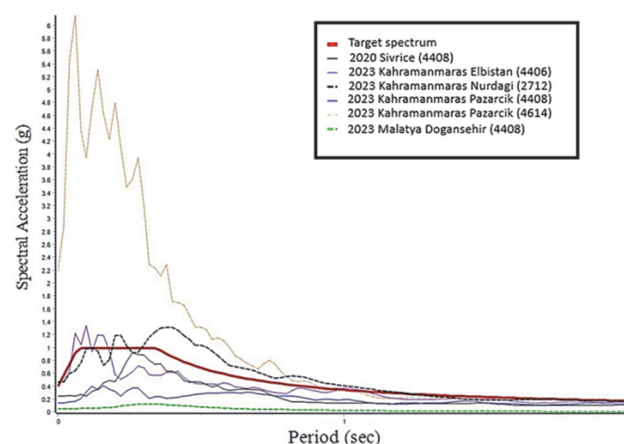
Figure 12 Target design spectrum and spectral accelerations

The spectral acceleration plots in Fig. 12 show the comparison between the target elastic design spectrum and the acceleration spectrum of the selected earthquake records. It is evident that three of the seismic responses in all records exceeded the design spectrum with a return period of 475 years. Specifically, the 2023 Kahramanmaraş Pazarcık record (Station code 4614), the 2023 Kahramanmaraş Elbistan record (Station code 4406), and the 2023 Kahramanmaraş Nurdağı record (Station code 2712) all surpassed the specified design criteria.

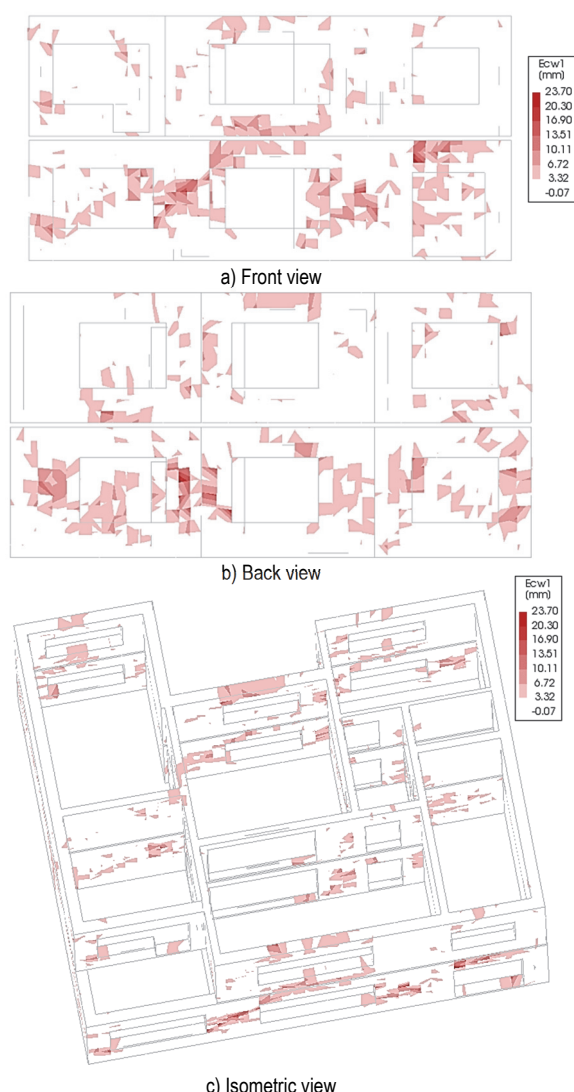
Figure 14 The crack widths of story added building under 2023 Doganşehir earthquake (3.96 s)

The crack widths of the building were given in Fig. 14. The crack widths were obtained under 2023 Doğuşehir earthquake (3.96 s). In the figure, the cracks range between 10-23 mm occurred under the earthquake. The crack widths observed during the 2023 Doğuşehir earthquake highlighted the potential vulnerabilities of the building

under seismic activity. It was clear that immediate action needed to be taken to ensure the safety and stability of the structure in the event of future earthquakes. Fig. 15 highlights walls with significant cracks, which in this study are defined as those wider than 10 mm. These cracks, recorded during the 2023 Doğuşehir earthquake, measured between 10 and 23 mm. The walls with these cracks were identified as critical weak points and were chosen for retrofitting.

According to the nonlinear time history analyses results obtained in Section 4, locations of crack propagation were given in Fig. 14. It is seen that tensile damages occurred in the walls marked in Fig. 15. For this reason, the retrofitting methods described in detail in the section 5.1 and 5.2 were applied to these walls. In this section, the retrofit methods discussed in this study are numerically applied to the building and the change in the seismic performance of the structure is observed.

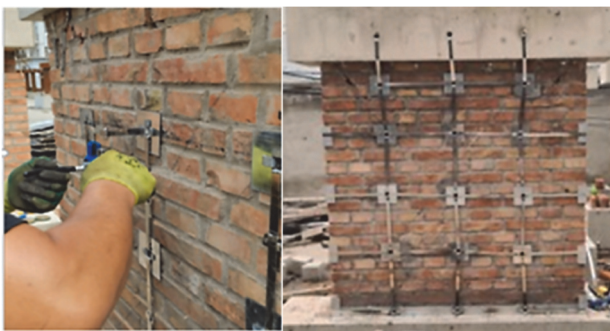
Figure 16 Visual representation of retrofitting technique adopted from [49]

The investigation of [49] focused on the reinforcing technique of connecting stainless steel strips to unreinforced masonry walls. This method has been found to greatly improve both the ability of the masonry wall to withstand deformation and its load-bearing capacity. This technology successfully combines the durability of stainless steel with the structural characteristics of masonry, resulting in enhanced resistance to mechanical pressures. The retrofitting procedure is illustrated in Fig. 16.

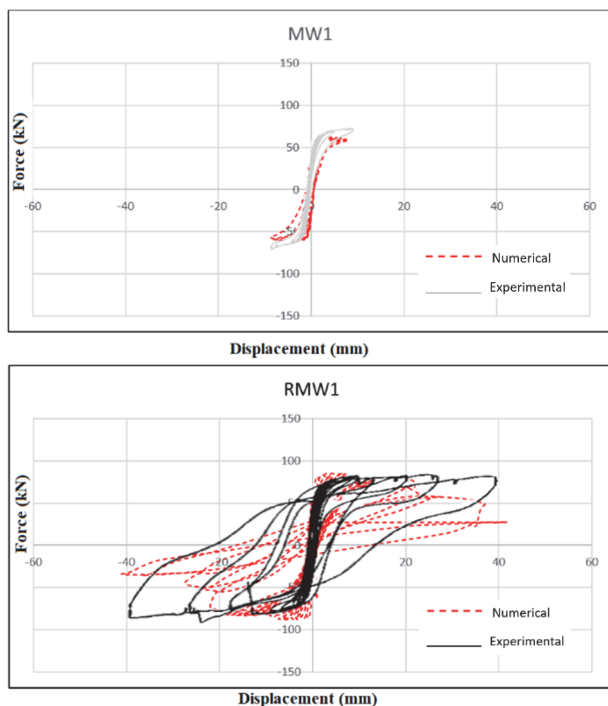
Figure 19 Force- displacement curves for unreinforced and reinforced walls

Tab. 7 displays the maximum displacement and maximum force of both the experimental wall and the computational findings. Furthermore, Fig. 19 provided displacement-load curves for both the MW1 and RMW1. Based on the findings, there is a disparity of 23.1% and 17.1% between MW1 and the numerical values for displacement and force, respectively. In addition, the disparity between RMW1 and the enhanced numerical outcomes is 7% and 3% for displacement and force, correspondingly.

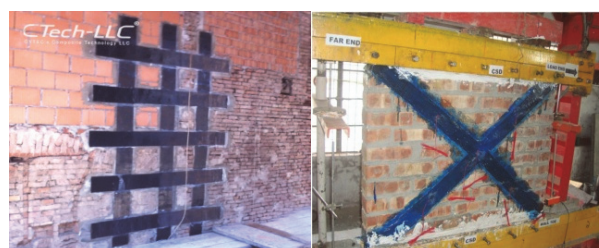
Figure 20 Some examples of CFRP applications [50, 51]

While FRP retrofitting offers the greatest enhancement in strength and reduction of drift, it comes with significant limitations. The process demands meticulous surface preparation and skilled labor, as inadequate bonding can lead to early failures. The high costs associated with materials and installation might restrict its use in low-income housing projects. Additionally, FRP offers limited defense against out-of-plane failures unless anchors are used and requires protective coatings due to its vulnerability to fire. These considerations suggest that the application of FRP should be assessed within the context of economic and safety limitations.

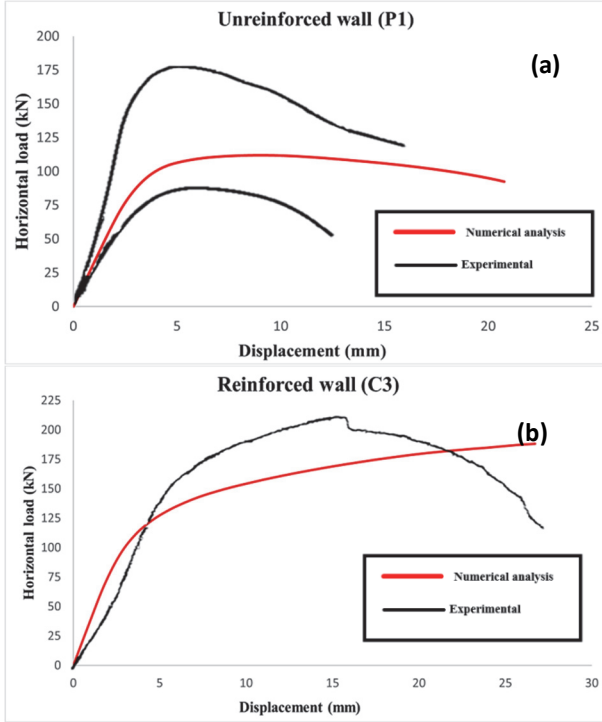
Figure 23 The force-displacement capacity curves of experimental and numerical analysis

The calculated force-displacement capacity curve in Fig. 23a is accurately positioned inside the experimental

envelope, indicating a high level of representativeness. Specifically, the beginning gradient of the numerical curves closely matches the experimental data, indicating that the numerical elastic stiffness is similar to the actual stiffness. The global force-displacement curves derived for the FRP-reinforced panels (C3) were found to closely match the experimental ones, similar to the unreinforced case (Fig. 23b).

Fig. 23 highlights the differences between numerical and experimental outcomes in response curves. Although the overall trend and ultimate capacity align, the model falls short in estimating initial stiffness and slightly overestimates residual strength post-cracking. These variations arise from several factors: Material properties: The strength of the mortar and bond behavior were not field-measured; instead, literature-based values were used, which might not accurately reflect the actual wall properties. Link elements: The macro-model assumed a rigid connection between masonry and CFRP/steel strips, whereas, in reality, local slip and imperfect adhesion could reduce efficiency. End boundary conditions: Experimental supports introduce partial rotations and out-of-plane effects that are simplified in the numerical model. Despite these differences being within 12-18% of benchmark values, better calibration could be achieved by incorporating measured mortar properties, adjusting interface elements for partial slip, and refining boundary condition modeling to enhance the correlation between experimental and numerical behavior.

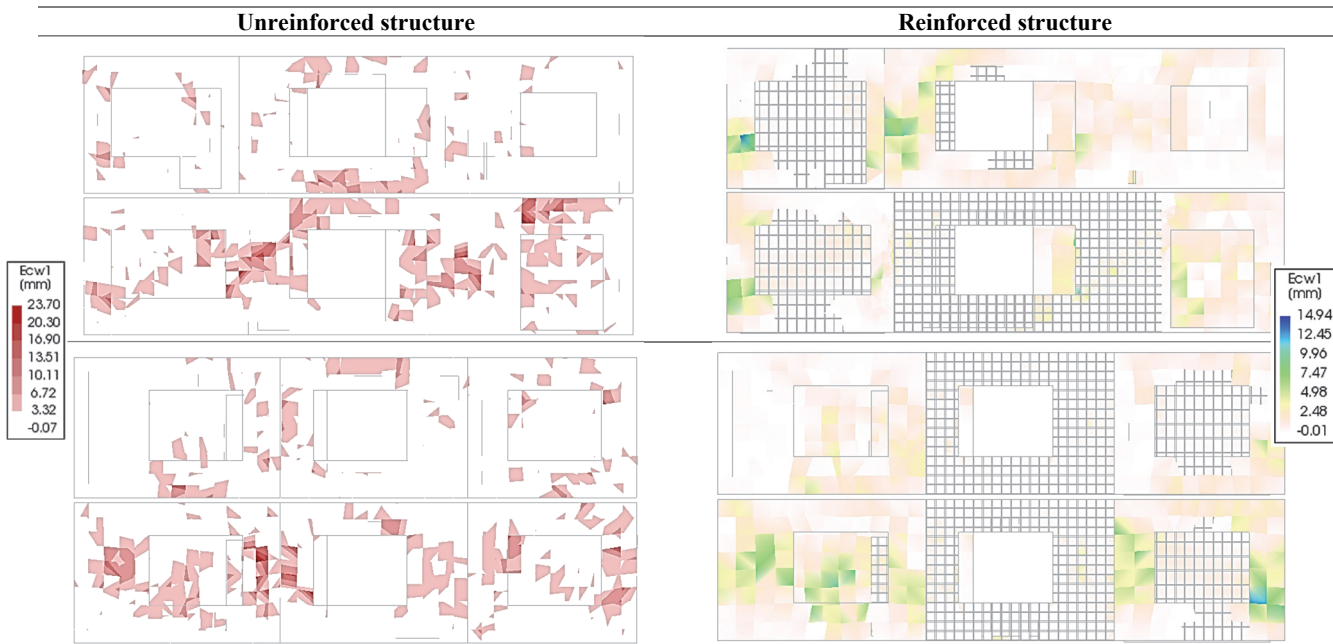
Figure 27 Distribution of the crack widths

comparing the results between unreinforced and reinforced structures. The results indicated a slight reduction in parameters such as normalized displacement and inter-story drift ratio, while a substantial reduction in crack width was observed in the reinforced structure. The outcome is attributed to the fact that the strengthening methods used, such as stainless-steel strips and CFRP laminates, primarily function at a local level by confining masonry units and bridging cracks, rather than significantly enhancing the overall stiffness of the structure. Consequently, reductions in inter-storey drift and displacement are minimal, but crack propagation is effectively managed, resulting in much narrower crack widths. This suggests that the retrofitting techniques mainly improve damage control and reparability rather than significantly boosting the structure's overall deformation capacity.

This suggests that the reinforcement measures implemented were effective in reducing the structural vulnerability to seismic events. The responses of the story added building (unreinforced) remained above the Collapse prevention (CP) performance level according to FEMA 356. The performance level of the retrofitted structure was between Life Safety (LS) and Collapse Prevention (CP) (significant but restorable damage).

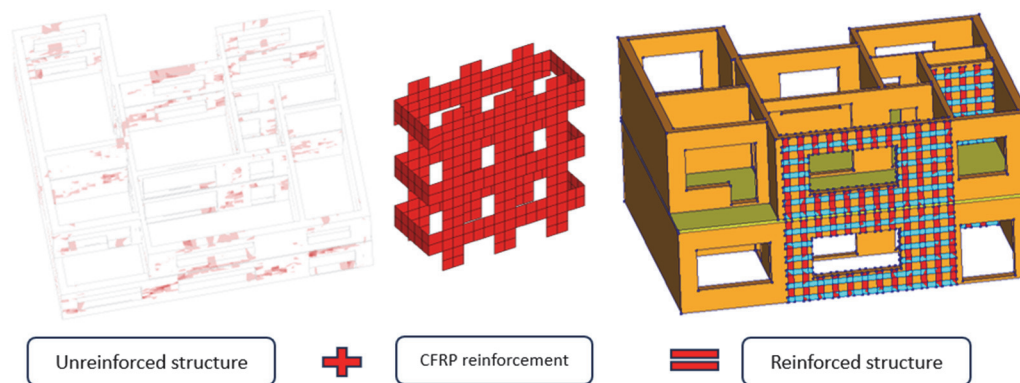
Figure 28 FEM of CFRP reinforced structure

The 3D numerical representation of the CFRP retrofitted model is seen in Fig. 28. The retrofitted structure's 3D finite element model has 431952 elements and 166839 nodes. The retrofit method was applied to the ground floor and first floor as critical cracks had developed

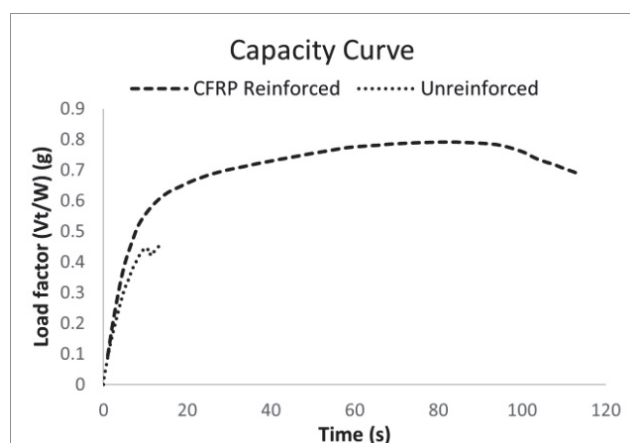
Figure 29 Comparison of capacity curves

direction has increased from 0.45 g to 0.79 g. Furthermore, the displacement capabilities were enhanced. The addition of CFRP reinforcement has significantly improved the structural performance of the building, increasing both load capacity and displacement capabilities in the longitudinal direction. This demonstrates the effectiveness of using CFRP reinforcement in enhancing the seismic resilience of structures.

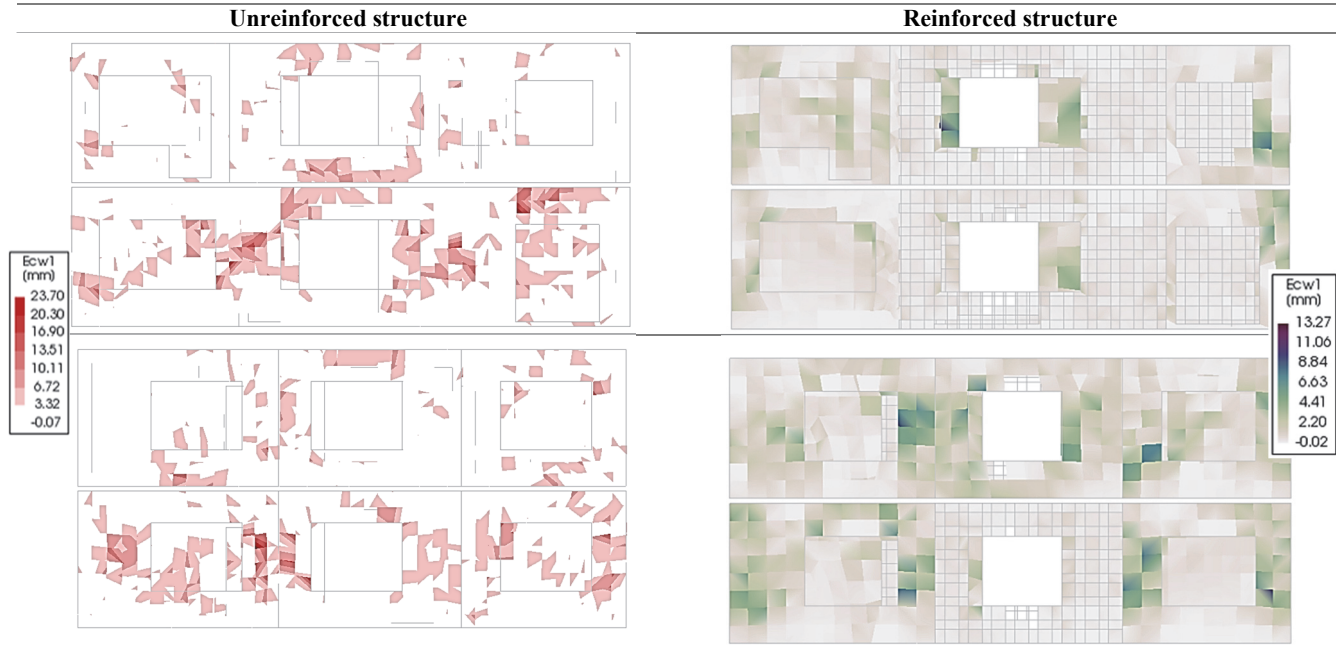
Figure 30 Distribution of and crack width

According to the results of the nonlinear time history analyses, the maximum normalized displacement, maximum crack width, and maximum inter-story drift ratio values decreased in the CFRP reinforced structure. The responses of the building (unreinforced) remained above the Collapse prevention (CP) performance level according to FEMA 356. The performance level of the retrofitted

While the selected retrofitting method has not changed the dynamic response of the structure, it decreased the amplitudes related to the seismic vulnerability of the structure. In addition, this method has not increased the mass of the structure. Therefore, this method is easily applicable and effective in improving seismic resistance of the structure. After retrofitting, crack widths decreased and crack accumulation occurred in the *x*-direction walls that were not retrofitted. The occurrence of cracks in the reinforced walls is quite low. When both retrofitting methods were compared, the load bearing capacity and displacement limits of the structure increased more in the retrofitting with CFRP application. Overall, retrofitting with CFRP application proved to be more effective in improving the seismic resistance of the structure compared to steel stirrup methods. The decrease in crack widths and low occurrence of cracks in reinforced walls further support the success of this method.
