THE INFLUENCE OF THE BASE MATERIAL SURFACE PREPARATION ON THE PROPERTIES OF THERMALLY SPRAYED COATINGS

Preliminary Note – Prethodno priopćenje

V. Marušić, S. Aračić, I. Samardžić, Faculty of Mechanical Engineering, University of Osijek, Slavonski Brod, Croatia

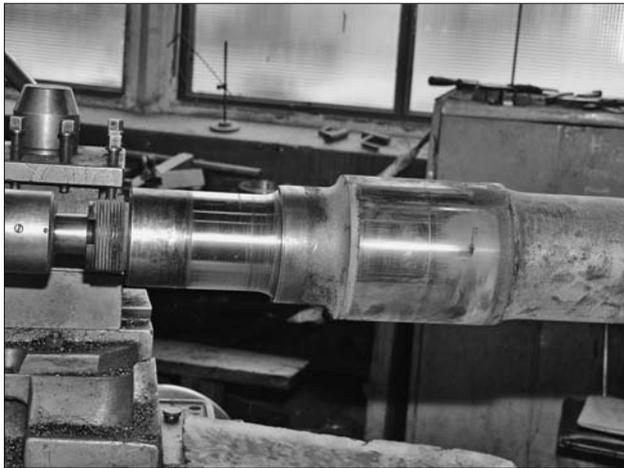
Figure 1. shows an example of damage on the axle of a rail wagon as caused by torsion of the inner ring of the roller bearing. Such damages appear as cracks (surface mechanical damage) of 0,8 mm in depth and 40 to 50 mm in length radially to the wheel axis [1]. The trunnion is 180 mm long, ϕ 120.

Figure 1. Damaged trunnion of a wagon axle

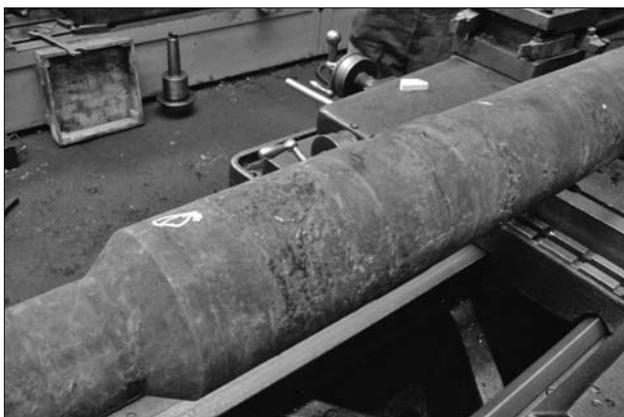
The photo in Figure 2. shows the screw press shaft which was damaged after only 2 years in operation. A screw press is basically an endless screw provided with a conical shaft that compresses the pulp as it moves from an inlet to an outlet. The endless screw is enclosed in a body that is provided with a screened surface allowing the excess fluid to be expelled from the pulp. The shaft length is \approx 4500 mm and it has a cascade diameter of ϕ 152 / ϕ

Figure 2. Damaged shaft of the screw press

153,8 / ϕ 155 / ϕ 158 / ϕ 160. The damage occurred on the segment ϕ 152 to ϕ 155 and had a length of \approx 1600 mm. Using a comparator, the depth of local damages was measured as reaching up to 2 mm. It must be pointed out that the shaft surface was found greasy due to oil and seed residue particles protruding between the facings of adjacent screw press segments. The hardness of the screw press was measured with a mobile measurement unit and found to be in the range of 200 to 220 HB.

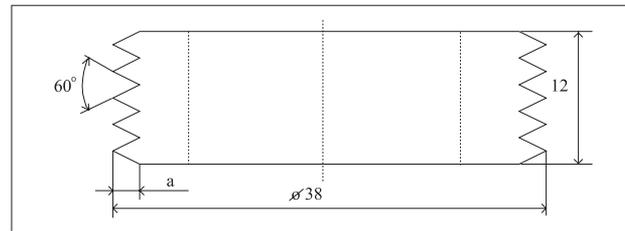
$a = 0,25$ mm; $a = 0,50$ mm; $a = 1,00$ mm; $a = 1,25$ mm
Figure 3. The appearance and dimensions of specimens 1 – 4, as prepared for spraying by surface cutting

According to the experiment plan, the respective specimen surfaces (dimensions given in Figure 3 and 4) were prepared as follows:

- I – using cutting methods (specimens No. 1; 2; 3 and 4)
- II – by means of mechanical knurling (specimen No. 5).

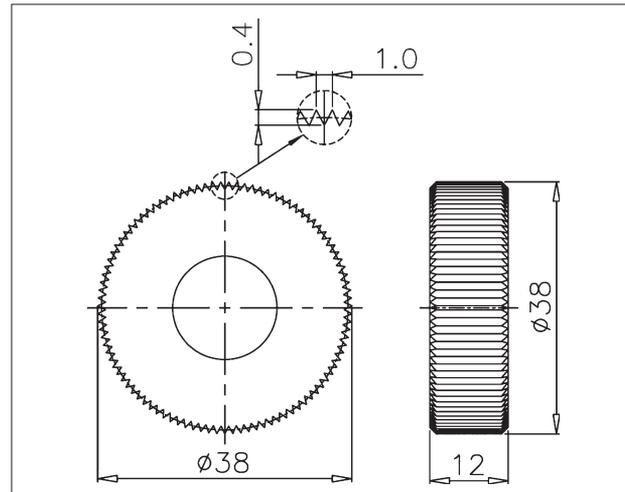
Figure 4. The appearance and dimensions of the specimen No.5, as prepared for spraying by surface knurling

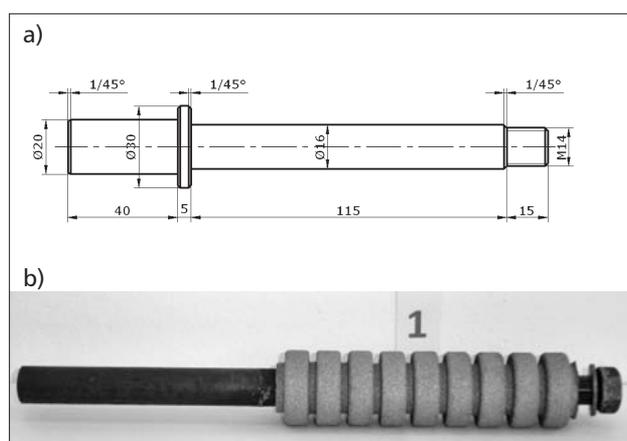
Before spraying, the specimens had been mounted onto a “thorn” bearing (the dimensions are given in Figure 5.a). A set of already sprayed specimens is given in Figure 5.b.

Figure 5. Specimen bearing (a) and a set of sprayed specimens (b)

To perform spraying of the additional material, the thorn bearing was fixed into a lathe chuck. It was supported with a rotating pike to ensure its rigidity. The

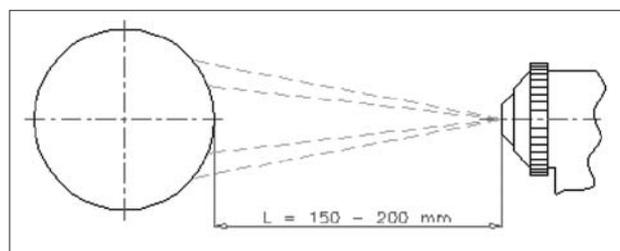
feed rate of the spray gun mounted onto the lathe was set at 3 mm per specimen revolution. The distance between the specimens and the air outlet of the gun was $L = 150 - 200$ mm (Figure 6). During interlayer spraying, the tip of the wire was fixed to 1,5 mm inside the gun outlet. During final spraying, it protruded 12 to 15 mm. This setting was fixed altering the length of wire protrusion up to constant melting without splatter.

Figure 6. The position of the spray gun during thermal spraying

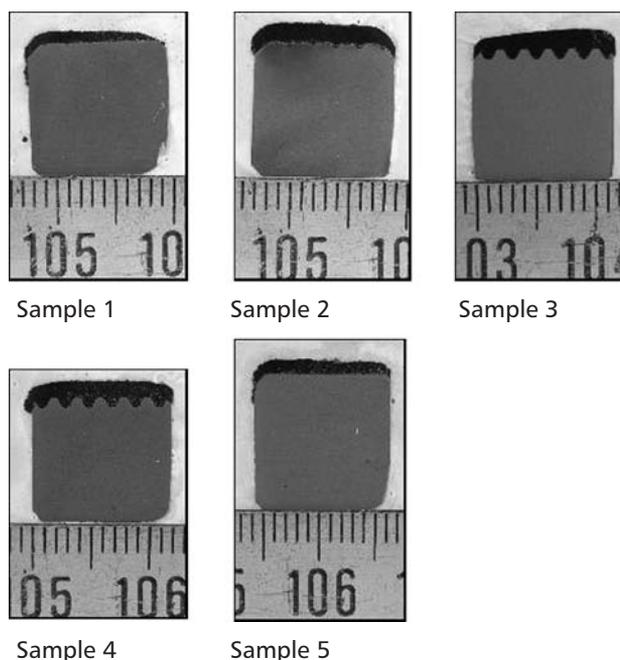
The samples were cut from the sprayed specimens in order to examine the surface and in-depth structure and hardness. Figure 7 illustrates the cross-sections of the sprayed specimens. Figure 8 shows the microstructure of the interlayer and the final coating. The thickness of the sprayed coatings was measured, as well as their cross-sectional HV 0,1. These results are given in Table 3 and 4.

Figure 7. The photographs of the cross-sections of sprayed coatings with a different surface preparation

The results of cross-sectional hardness measurement of coatings and along referential HV 0,1 – lines both indicate a difference in the layer thickness. The maximal layer thickness of ≈ 2 mm was measured on the specimens 2; 3

and 4. For the specimen No. 5, the layer thickness was established with $\approx 1,5$ mm. The specimen No. 1 had the lowest thickness of $\approx 0,4$ mm. The specimens 2; 3 and 4 showed the lowest scattering of measured hardness values across the layer. A comparison of HV 0,1 values illustrates the influence of base material surface preparation prior to thermal spraying. The cross-sectional hardness distribution is further confirmed by means of a metallographic

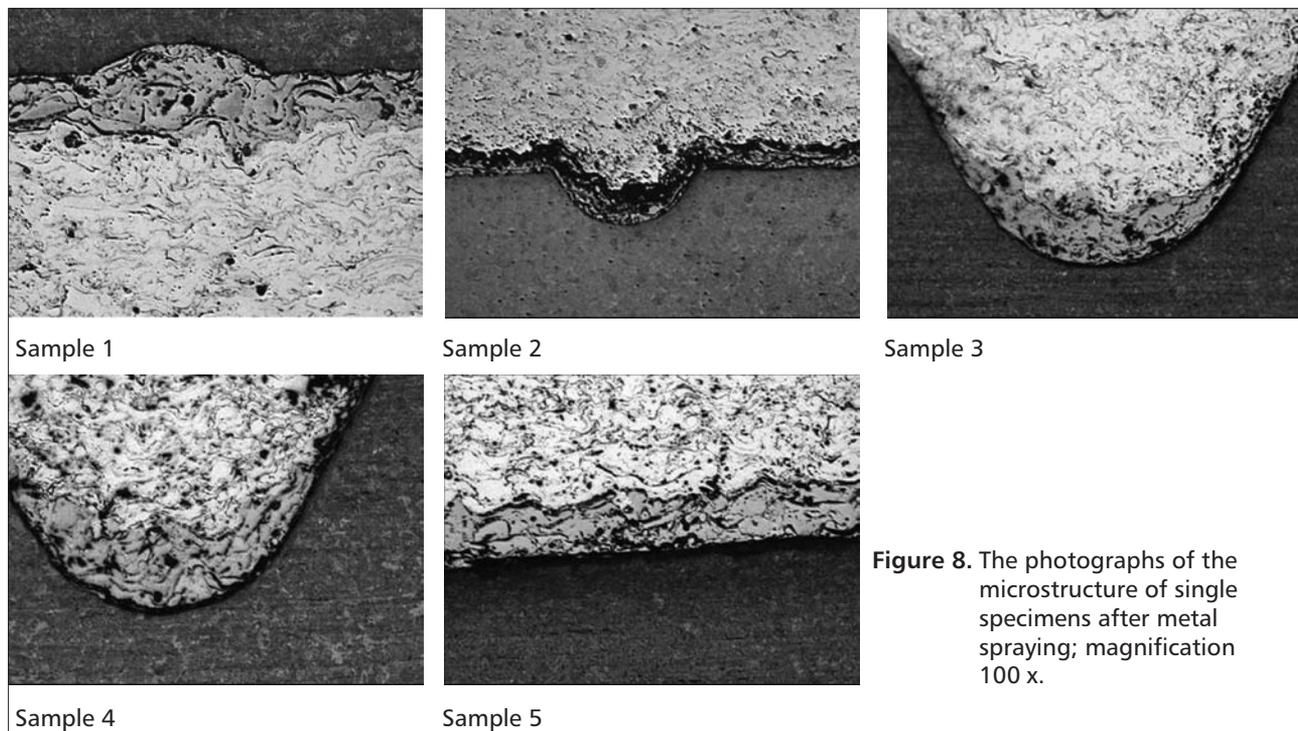
Figure 8. The photographs of the microstructure of single specimens after metal spraying; magnification 100 x.

structure analysis. The final layer is found to be of varying thickness and with clearly visible porosity. The specimens with a dented base surface exhibit a distinctive interlayer and a homogeneous, fine-grained microstructure. Further testing with the adequate examination methods should offer an insight into the characteristics and the types of microstructure constituents within respective layers and their effect on the bond quality between the base material, the interlayer and the final coating. Therefore, it can be concluded that both the hardness and the layer thickness depend on the quality of base material surface preparation. The dented surfaces, i.e. maximized bonding surfaces between the roughened base material and the sprayed coating, exhibit the thickest sprayed coating. This experiment has identified a method and a type of surface preparation that secures the acceptable spraying thickness and the desired hardness. Some further experiments should serve to test shear behaviour and offer a detailed comparison of coatings with respect to the base material surface preparation and the related bond quality.
