# RECONSTRUCTION OF THE RAILWAY LINE VINKOVCI – OSIJEK

Waldemar Alduk

Professional paper

After 17 years, railway line Vinkovci – Osijek has been finally restored and opened to traffic. Reconstruction of the railway line Vinkovci – Osijek is important for wider community of the two neighbouring counties. With this railway line, the Osijek – Baranja County and the Vukovar – Srijem County have got better connectivity and convenient alternative to road transport, offering the shortest and cost effective connection between the regional centres Osijek and Vinkovci. Complete replacement of the track on the line was made in a total length of 11,530 km, which includes extending from the trunk line, laying the buffer protection and geosynthetic layer. The track was made with used materials: concrete sleepers HŽ-70, rails type 49E1, rail fastening type K and new ballast bed. The line is capable of speeds of 80 km/h and traffic trains with weight of 225 kN per axle and 80 kN/m, in a total length of 33,339 m.

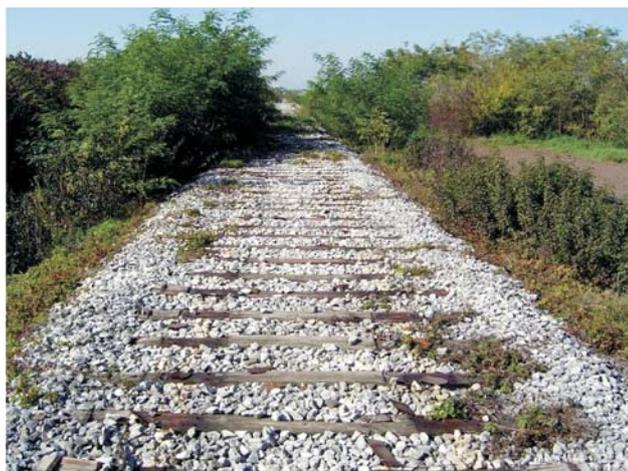
During the war the railway line suffered significant devastation. The greatest damages were at the locations of the war demarcation line, where the ballast bed and wooden sleepers were used for establishing military positions (Fig. 2). After the reintegration the demining of the line started gradually, during 2001. Subsequently, further demining of the wider belt line route was needed, which was done in 2004. During the first demining, the tour was conducted and detailed insight into the state of the line was obtained by employees of HŽ-Infrastruktura, Sekcija ZOP Osijek.

*Figure 2 Part of track between Ernestinovo and Laslovo without estranged rails and rail fastening  
Slika 2. Dio pruge između Ernestinova i Laslova bez otuđenih tračnica i kolosiječnog pribora*

It was found that the number of locations along the route of the railway was completely or partly missing over 10 km of track (rails, sleepers, rail fastening, ballast bed), while the bridge over the Bobota canal in km 22+326 was completely destroyed. All station tracks with side objects were destroyed (except in the Gaboš station), while a large number of trunk lines to establish military positions were built on the former demarcation line (between stations Brijest – Tenjski Antunovac and Vinkovci – Gaboš). After demining conditions were created for the reconstruction of the railway, for which project documentation had to be ensured. During 2005 the design was completed for the renovation project of the railway Vinkovci – Osijek, which was amended in 2007 in part related to the reconstruction of the bridge over the Bobota canal. The restoration project was drawn up by the company Granova, Zagreb.

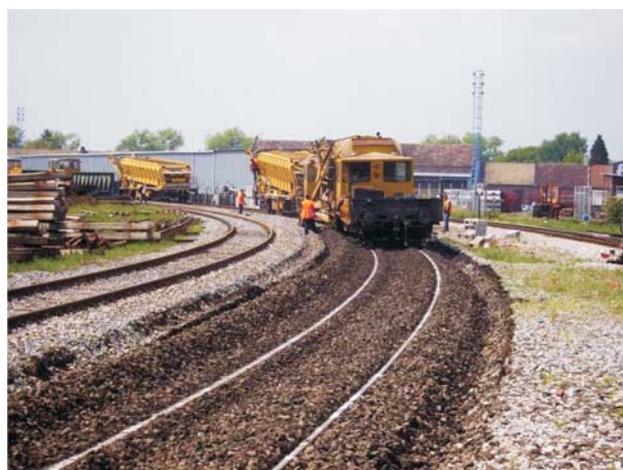
*Figure 3 Ballast bed cleaning from station Vinkovci toward Osijek  
Slika 3. Strojno rešetanje kolosijeka od kolodvora Vinkovci prema Osijeku*

In May 2007, the work on the mechanical cleaning of the ballast bed on the parts of the route where track has not been destroyed began, first on the section from the station Osijek toward the station Antunovac, then the section from the station Vinkovci to the station Gaboš (Fig. 3). In parallel with the ballast cleaning, machine works were done on levelling lining tamping, supplementing ballast material for forming appropriate ballast prism and replacing individual damaged rails, sleepers, and rail fastenings.

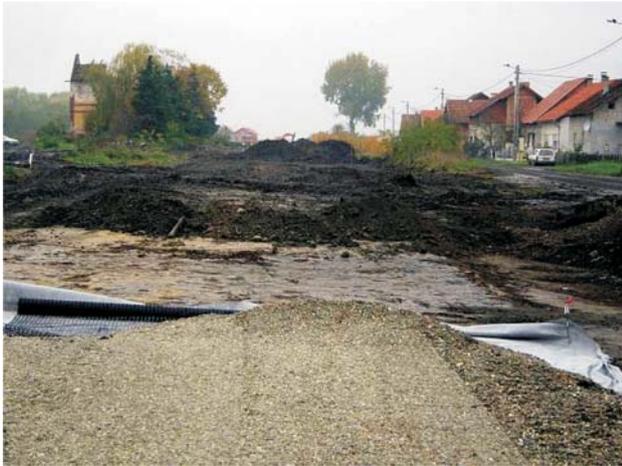
**Figure 4** The buffer laid on the subgrade at train stop Antunovac  
*Slika 4. Položeni tampon na trupu pruge kod Antunovca*

On the rolled and aligned track subgrade a layer of geotextile (with geogrids in some places) was first laid after which a protection layer of crushed stone material 30 cm thick was laid (Fig. 4). On the protection layer the used concrete sleepers with steel base plates (concrete sleeper type HZ-70) were laid at a distance of 60 cm, at which the used type 49E1 welded rails 180 m in length attached to the sleepers with type K fastening accessories were placed (Fig. 5).

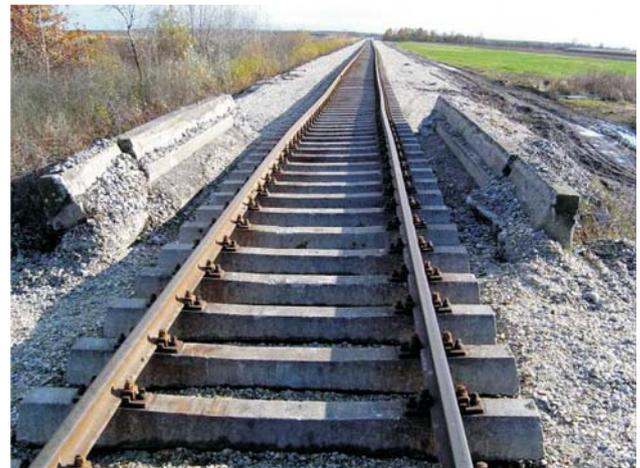
**Figure 5** Laid track made of used track materials over water culvert near the train stop Laslovo/Korođ

*Slika 5. Položena kolosiječna rešetka od građiva preko propusta u blizini stajališta Laslovo/Korođ*

Complete replacement of the track on the line was made with a total length of 11,530 km, which included extending of subgrade, laying the buffer protection and geosynthetic layer, used track materials (concrete sleepers HZ-70, rails type 49E1, rail fastening type K) and new ballast bed.

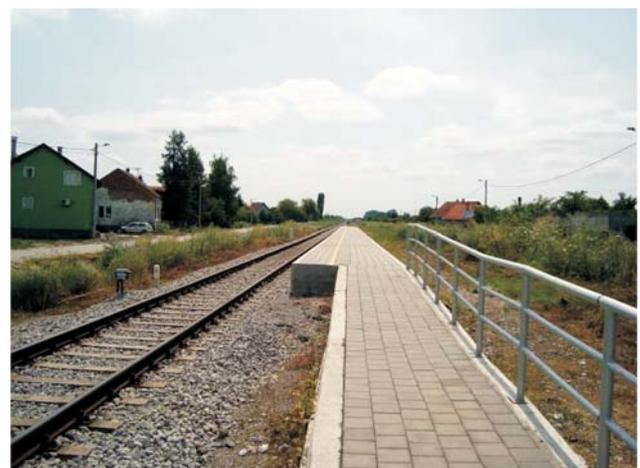
**Figure 6** Insular platform in train stop Laslovo/Korođ  
*Slika 6. Otočni peron u stajalištu Laslovo/Korođ*

At the train stops Ostrovo, Gaboš, Markušica/Antin, Ernestinovo and Antunovac new side platforms were built, with the 100 m length, 0,55 m height and 3 m width with ramps for the disabled persons' access. At the train stop Laslovo/Korođ 2,6 m wide insular platform was built (Fig. 6). All the platforms have the possibility of extending the length to 160 m. In addition, electric public lighting was built-in at all platforms. At the station Brijest the area for passengers boarding was done in 100 m length.

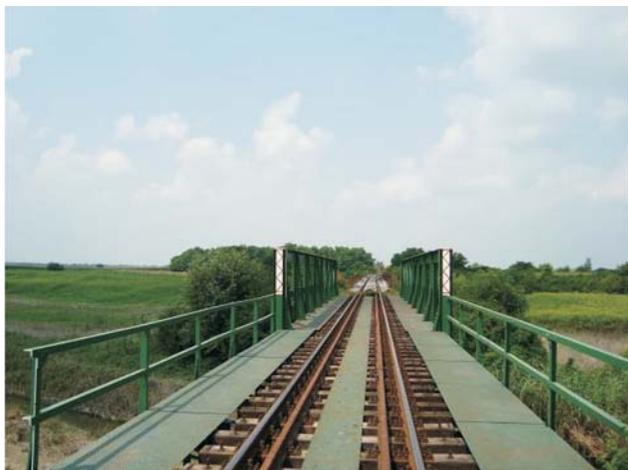
**Figure 7** The renewed steel bridge at km 9+411,9 (near train stop Gaboš)  
*Slika 7.* Obnovljeni čelični most u km 9+411,9 (kod stajališta Gaboš)

The steel bridge across the river Vuka at km 9+411,936 has a total span of 34,25 m (Fig. 7). It is composed of two structures: one structure is a beam girder with the span of 11,5 m, while the second structure is a truss girder with the span of 22,75 m. The restoration was completely done by painting the bridge and installing the new hiking surfaces and special wooden bearers.

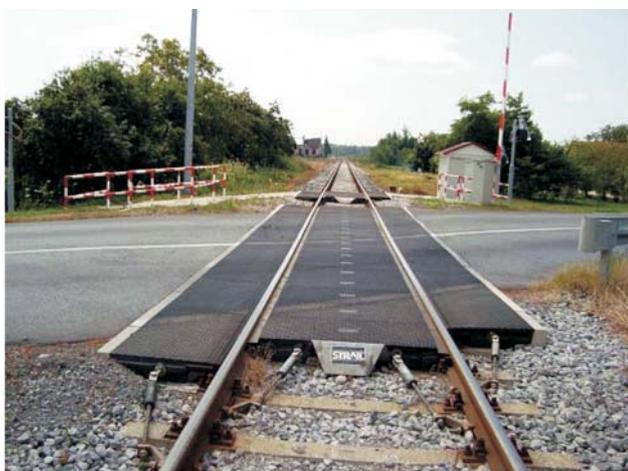
**Figure 8** Renewed level crossing at km 25+700  
near train stop Antunovac  
*Slika 8.* Obnovljeni cestovni prijelaz u km 25+700  
ispred stajališta Antunovac

Before the war there were 27 road level-crossings on the railway line Vinkovci – Osijek. After the renewal this number was reduced to a total of 24 level crossings, while the 3 crossings were abolished. Of the 24 crossings, 16 were paved with synthetic elements type STRAIL (Fig. 8), and 8 level-crossings were paved with wooden sleepers.

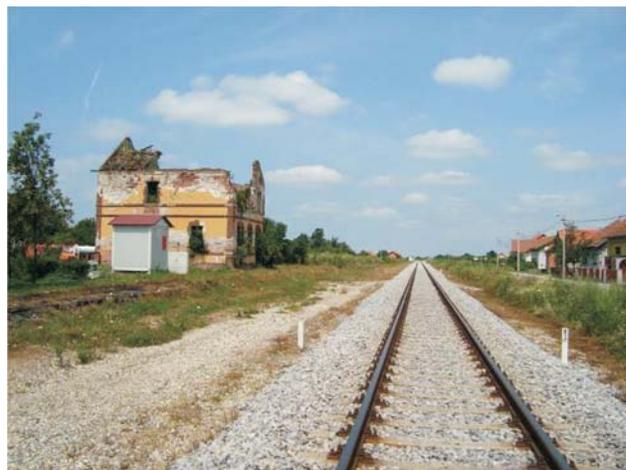
**Figure 9** Heavy damaged construction of the train stop in Laslovo/Korođ  
*Slika 9.* Teško oštećena zgrada stajališta Laslovo/Korođ

Unfortunately the restoration project of the railway line, did not provide the renovation of damaged railway buildings (ruined and dilapidated facilities at the former stations and train stops), which partially disrupts the overall impression. Hopefully, this will be resolved in the future through a demolition and removal project of dilapidated buildings (Fig. 9).
