Andrea SARDOZ, Toni ŠAINA

RESTAURATORSKO-KONZERVATORSKI RADOVI NA KASNOANTIČKOM MOZAIKU U KAPELI SV. IVANA U SAMOSTANU SV. FRANJE U PULI

RESTORATION-CONSERVATION WORKS ON A LATE ROMAN MOSAIC IN THE CHAPEL OF ST. JOHN IN THE MONASTERY OF ST. FRANCIS AT PULA

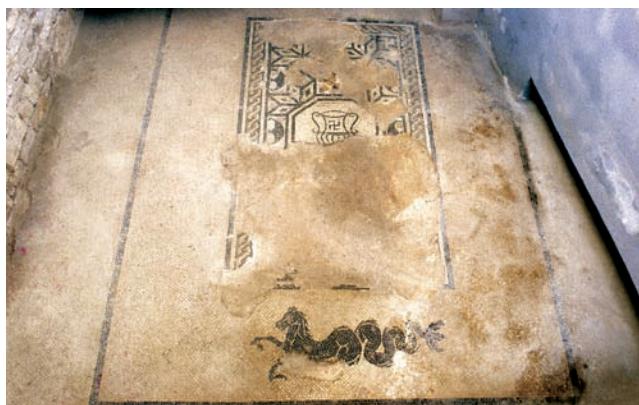
Sl. 2 Stanje mozaika - Meder, J.: "Podni mozaici u Hrvatskoj od 1. do 6. stoljeća", 2003.

Fig. 2 The state of the mosaic - Meder, J.: "Podni mozaici u Hrvatskoj od 1. do 6. stoljeća", 2003

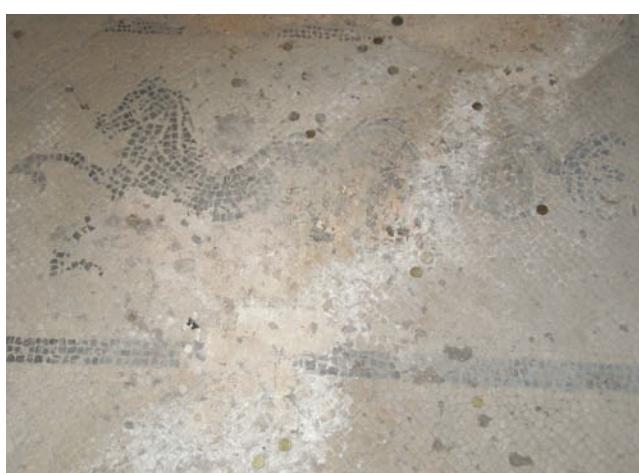
A large portion of the damages ensued as a consequence of humidity that extends itself in a broad belt alongside the northern and western edges of the basin where it is also held up. The cryptoclimatic conditions of the premises that house the mosaic were altered when the room was closed and radiators were installed. Due to a rapid drying of air, a process of salt crystallization was started on the surface. A preliminary analysis showed a deleterious concentration of chlorides and nitrates in all mortar samples, whereas a harmful concentration of sulfates was proven only in the nethermost layer of mortar¹. In the area affected by drying, humidity arrives from the more humid zone, and with it new quantities of ions pertaining to different salts as well. This results in an ever increasing accumulation of salt and the growing of crystals of these salts in the pores of the building materials, which due to their expansion cause devastation. Using the method of x-ray diffraction and FTIR spectroscopy it was proven that the salts that crystallized on the surface of the mosaic are sodium sulfates (mirabilite and thenardite). Consequently, the penetration of humidity triggers the process of salt crystallization on the surface of the mosaic and on surrounding walls, which in turn contributes not only to the destruction of binding material between mosaic tesserae, but also of the mosaic substrate and of the tesserae themselves. The tesserae "float" in some areas due to the crumbling of the substrate that is caused by the effects of salt. Certain sections of the mosaic lifted themselves from the substrate because of the effects of humidity and salt and the resulting destruction of the mosaic substrate. On still other sections of the mosaic the tesserae began to fall out because old borders began to crack.

Sl. 4 Motiv hipokampa s vidljivim nakupinama razarajućih soli.
Fig. 4 A hippocamp motif with visible accumulations of deleterious salts

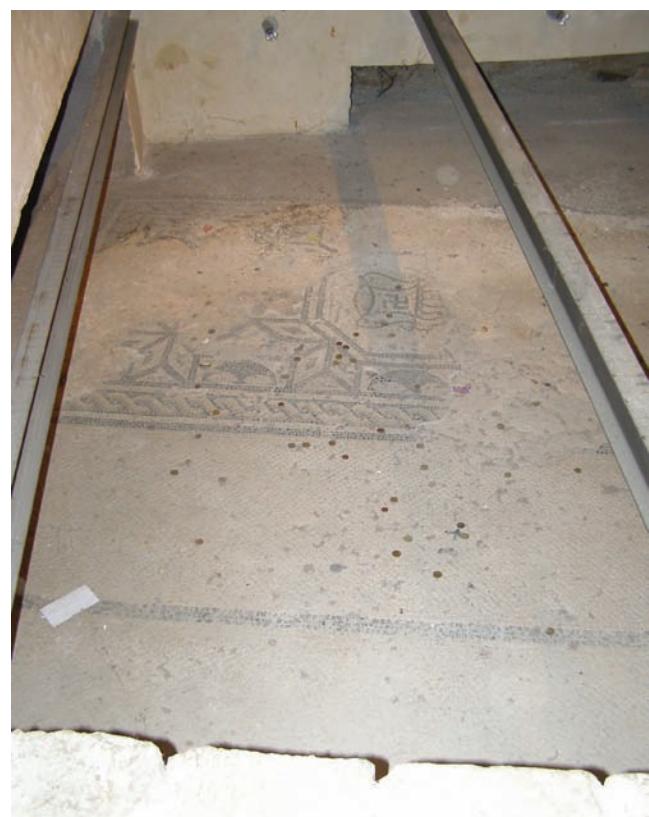
Except for the presence of salt, a whole series of other damages are visible on the face of the mosaic, such as a thick layer of dust and dirt that had been accumulating for many years, as well as other garbage (candy and chocolate wrappings, paper...). Coins were thrown onto the mosaic for a longer period of time. The metal (coins) corroded, which in turn left corrosion traces and stains on the face of the mosaic. We were likewise able to spot traces of black paint or lacquer on the face of the mosaic, which were probably caused by workers painting the wooden beams on the ceiling above the mosaic. We assume that

Sl. 3 Centralni dio mozaika, s vidljivom prljavštinom, smećem i novčićima po cijeloj njegovoj površini (2009.).

Fig. 3 The central section of the mosaic with visible dirt, garbage and coins strewn all over its surface (2009)

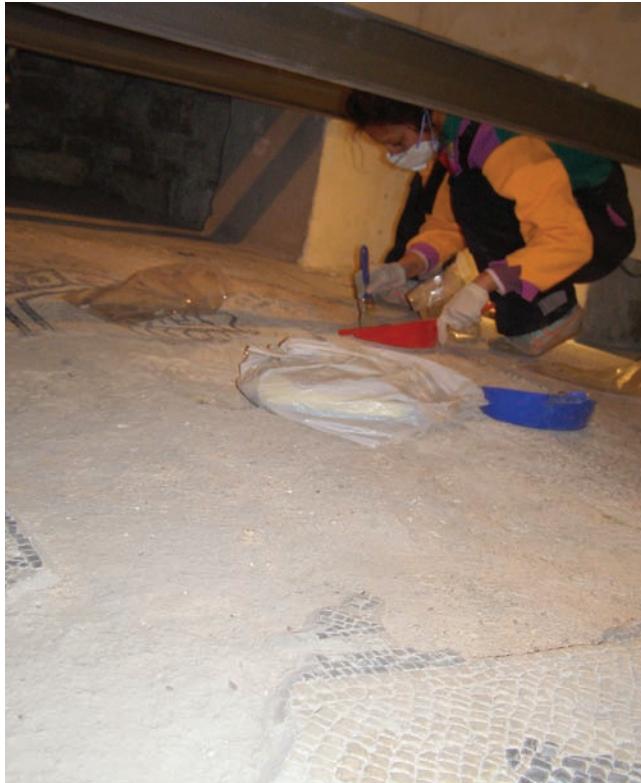
Sl. 5 Čišćenje lica mozaika.

Fig. 5 The cleaning of the mosaic surface

The crew from the Archaeological Museum of Istria completed the basic cleansing of the mosaic. The cleaning of the accumulated filth, salts and coins was done using soft paintbrushes and small brooms. Afterwards, the condition was documented in 1:1 scale. Beside the drawn documentation in 1:1 scale, the mosaic was also digitally documented because of its extraordinarily bad condition, which was executed by Geo-servis Ltd, a firm specializing in geodesic services. A photogrammetric

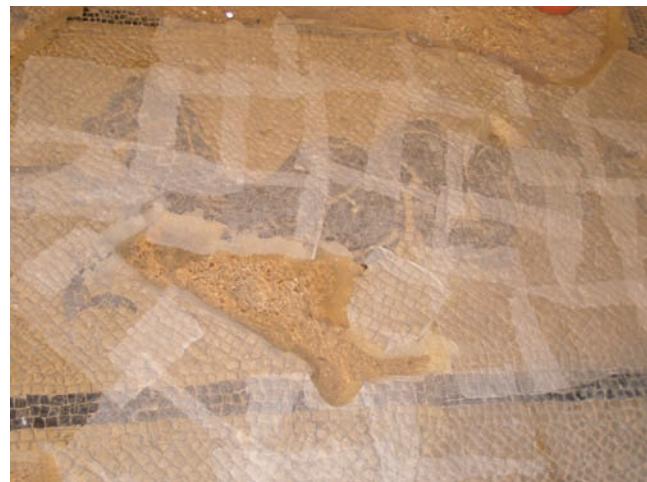
Sl. 7 Podljepljivanje kritičnog dijela
Fig. 7 The application of glue on the nether section of the critical area

A section of the border disintegrated, tesserae were strewn around and were severing themselves from the mosaic substrate. Separate sections of the mosaic also lifted and severed themselves from the substrate due to the accumulation of salt in the mortar underneath the tesserae. These severed and strewn tesserae were then returned to their original place with the help of pincers and cutters. Thus treated sections of the mosaic were then glued from underneath using *Vinavil 59* glue and gauze that was cut into smaller patches measuring approximately 15 x 20 cm. The gauze was installed in two layers and each layer was well soaked with the above mentioned glue. The glue was applied with the help of paintbrushes. In 2009 there were no plans to lift the mosaic even though the experts from the Croatian Conservation Institute initially suggested this and, hence, the mosaic was covered with a layer of cellulose pulp after it was subjected to the most urgent preventive interventions. The function of the pulp is to lessen the deleterious effects of salts. The cellulose pulp was mixed with distilled water and afterwards it was applied by hand onto the mosaic. Japanese paper was placed onto the substrate of the mosaic before the pulp was spread in order to facilitate the changing of the pulp. The performed analyses of water cellulose pulp have heretofore given satisfactory results.

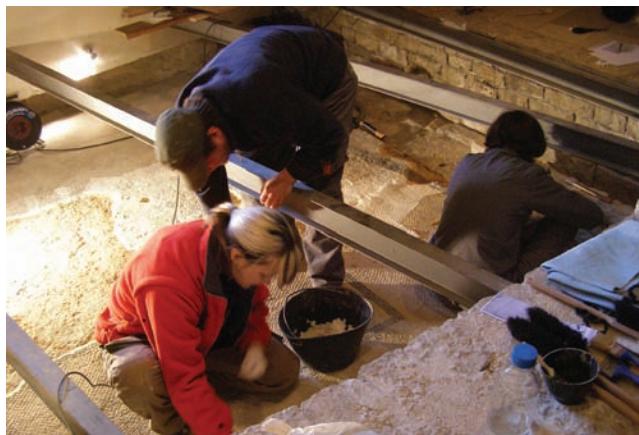
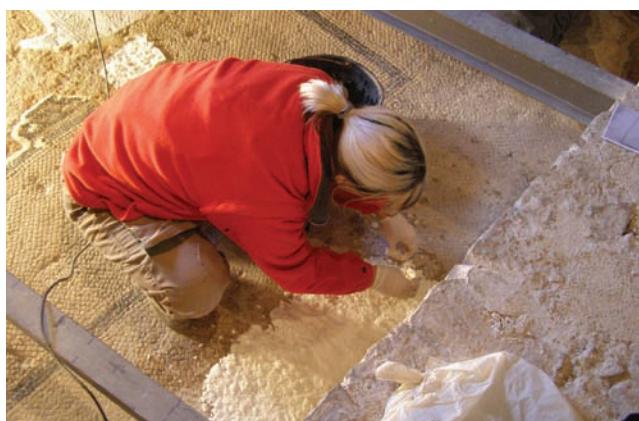
Sl. 8a i b. Izrada novih, vapnenih opšava i postavljanje zaštitnog sloja celulozne pulpe.

Fig. 8a and b The execution of new lime borders and the installation of the protective layer of cellulose pulp

With the arrival of workers from the Croatian Conservation Institute on the field, work began on the removal of old restoration borders that were replaced with lime mortar. Lime mortar consists of one part sieved hydrated lime and three parts quartz sand. The removal of borders and "patches" was done mechanically, using cutters, pincers, chisels and hammers.

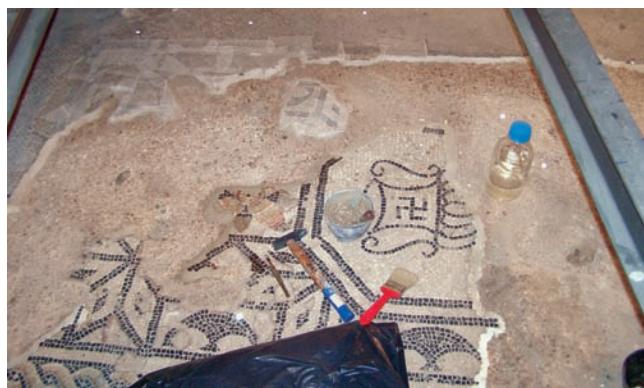
Sl. 10 Tijekom restauratorsko-konzervatorskih radova 2009.

Fig. 10 During restoration-conservation works in 2009.

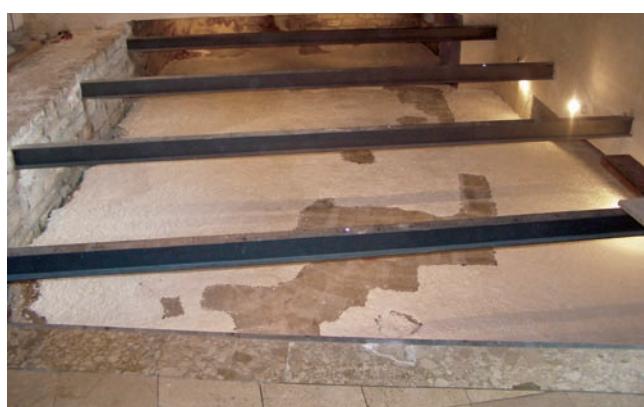
Sl. 11 Stanje mozaika s celuloidnom pulpom nakon restauratorsko-konzervatorskih radova 2009.

Fig. 11 The state of the mosaic with the installed cellulose pulp layer after the restoration-conservation works performed in 2009.
