STUDENČICA BRIDGE TESTING

Abstract: Studenčica bridge is located at Donji Studenci, to the southwest of Mostar in Bosnia and Herzegovina. The bridge is a great feat of engineering. It is built at a height of 88 m above the valley and is 555 m long, with main spans of 120 m. Before the bridge was opened for traffic, it was subjected to a series of tests to verify whether the construction satisfied the criteria regulated by law. Static and dynamic tests were conducted to confirm the safety of the bridge. Before the tests commenced, a numerical model of the bridge was developed and calculated by using a computer program (TOWER), and the calculation results were later compared with the measured values. The static tests comprised measurement of vertical deformation and stress in the construction, and the dynamic test involved measurement of the oscillation frequencies of the bridge. The results were analyzed to check whether the bridge performs as expected and whether it can be opened for traffic.

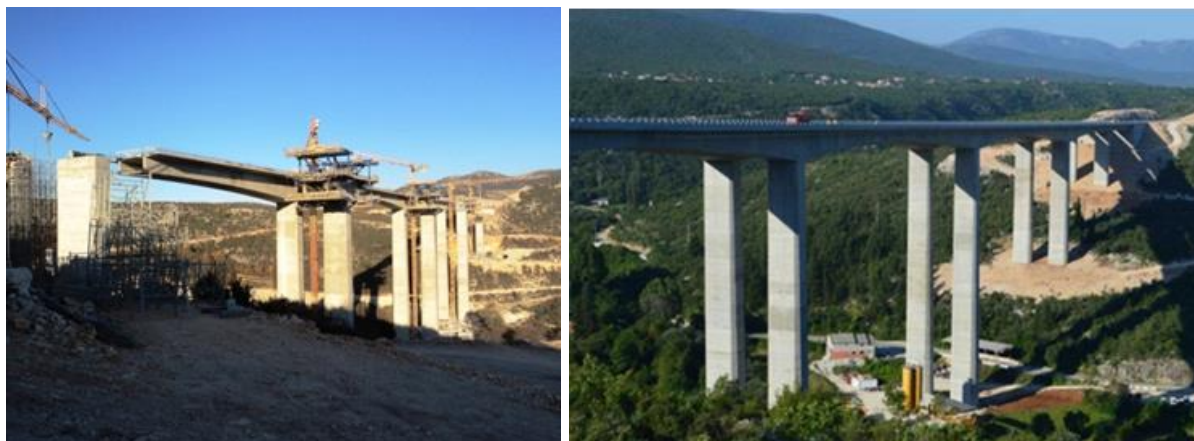
Figure 1 is presenting Studenčica bridge under construction and completed bridge.

Figure 1 Bridge under construction and completed bridge

The bridge is located at Donji Studenci and is a part of highway corridor Vc, section Počitelj, along the border of the Republic of Croatia. It spans over the Studenčica river and is built at a height of 88 m. The bridge supports a full highway profile, and therefore, it was designed as a dual construction where each one served for a different highway direction. The highway profile (one direction) consists of two lanes 3.75 m wide, one emergency lane 2.5 m wide, and a protective strip of pavement 0.5 m wide. The Jersey barrier is 0.46 m wide. Thus, the complete width of one bridge is $0.46 + 0.50 + 2.50 + 2 \cdot 3.75 + 2 \cdot 0.50 + 0.46 = 12.42$ m. The bridge has six spans of lengths 70, 120, 120, 120, 80, and 45 m, and thus, its complete length is 555 m. The static system is a frame that consists of a horizontal girder and vertical piers. The cross section of the girder is a box made of pre-stressed concrete. The quality of the concrete is C40/50 (C50/60) with B 500B reinforcement bars and Y 1860 S7 pre-stressing steel. The cross section of the girder box varies; over the abutment and in the middle of the spans, the bridge is 3.1 m high, and over the piers, it is 6.5 m high. The main part of the bridge was built using a balanced cantilever construction method; however, the spans closest to the abutments were built on a scaffolding [2].

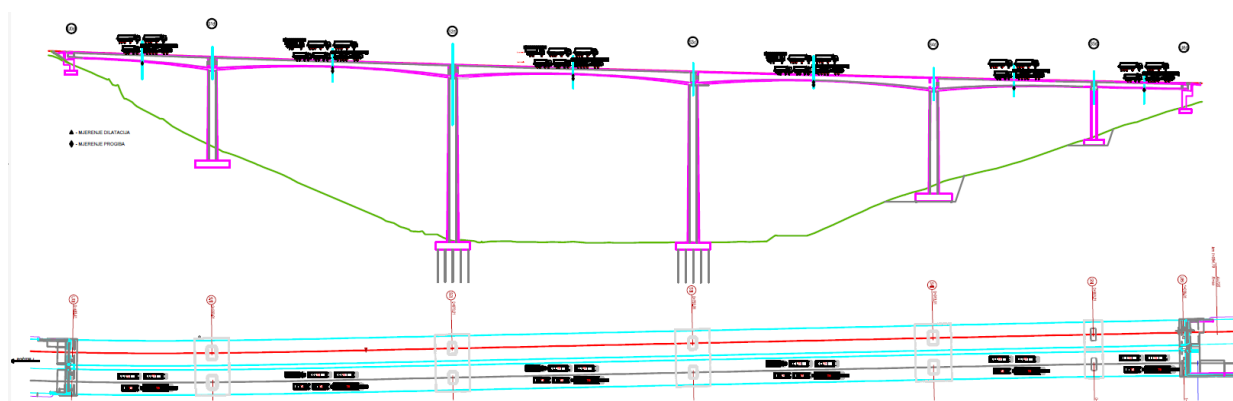
Figure 2 Illustration of span testing [6]

Static tests of the bridge are conducted by applying load on bridge spans and above piers to cause deformations and stresses in the construction. In the present case, the load was six trucks weighing 30–50 tons. The weight of the trucks was distributed on their axles and was used as such in the calculation. Appropriate positioning of the trucks on the bridge (Figures 2, 3 and 4) resulted in the desired stress and deformation in the construction, and different positions were used to test the three spans and two piers. The test load was 56% of the live load (coefficient $U = 0.56$).

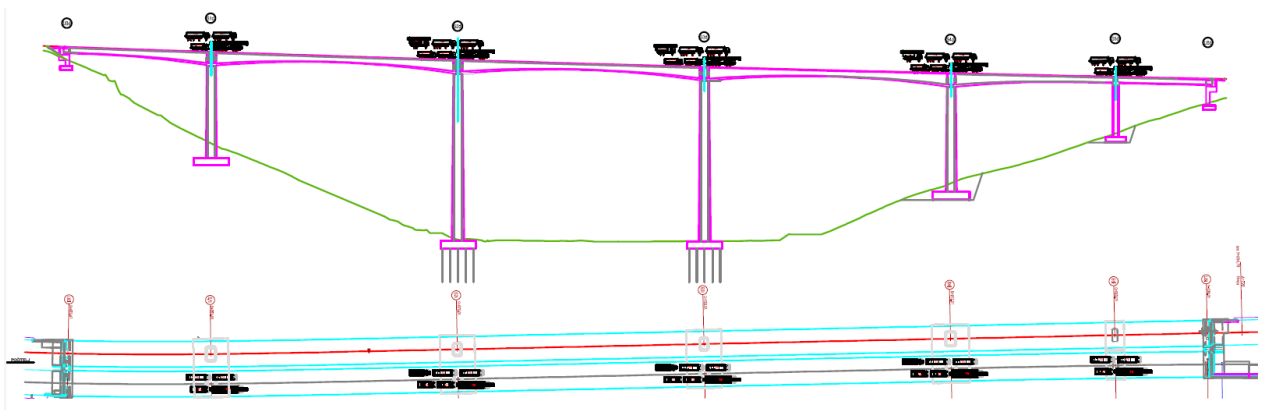
Figure 3 Illustration of pier testing [6]

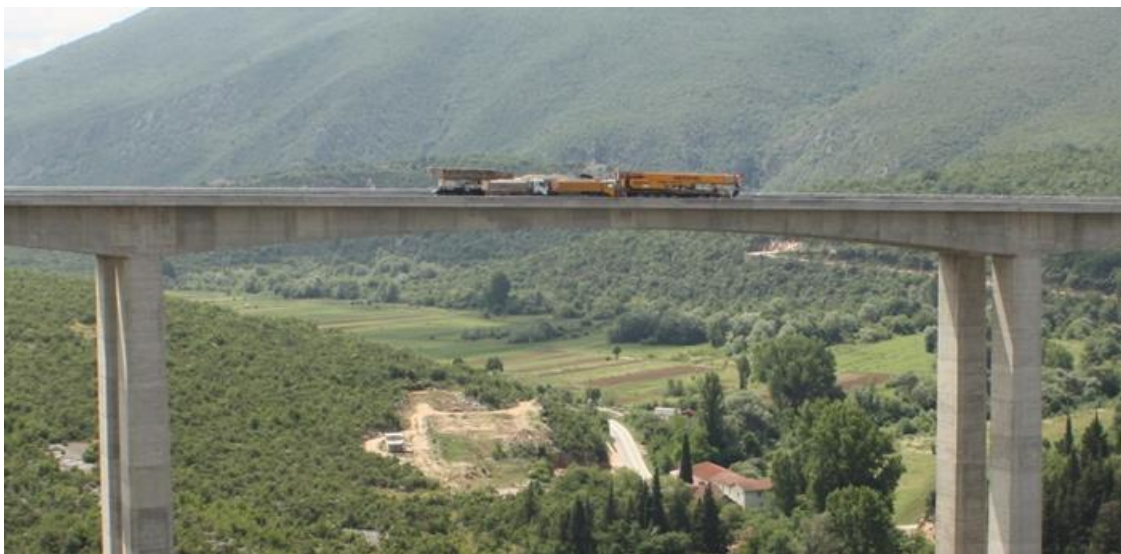
Figure 4 Test load on the bridge [6]

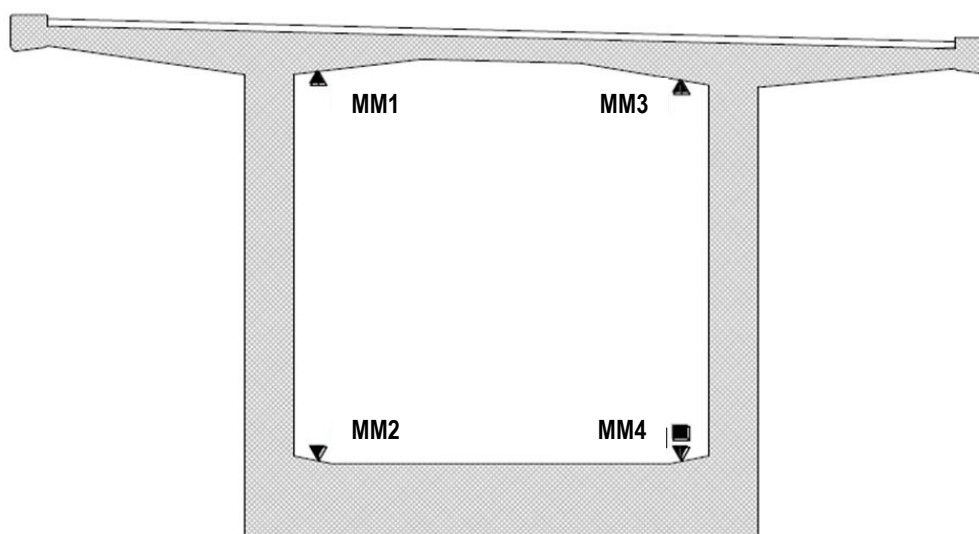
Figure 6 Position of strain gages [6]

Relative deformation of the concrete was measured at four locations in the cross section, and it was controlled within the second, third, and fourth span and also above S2 and S3 piers. For this test, electrical strain gages, namely, HBM type K-LY41 100/120, were used [8]. These strain gages can determine the strain in the concrete by measuring the electrical resistance before and after load is applied. Here, the bridge was assumed to be elastic under the test load; this assumption was verified by using the geodetic measurements. This is very important because if the concrete is elastic, its stresses can be easily calculated. In each cross section of the bridge, four strain gages were connected (Figure 6) to the central MGC plus system where the strain data were collected using the Catman AP program package [8]. The system run time was sufficient for observing the starting state, loaded state, and the unloaded state, and it was controlled by the personnel testing the bridge. The software then plotted a diagram showing the strain in the concrete in the given time period (Figures 7 and 8). Results of stress and strain measurement are presented in Tables 2 and 3.

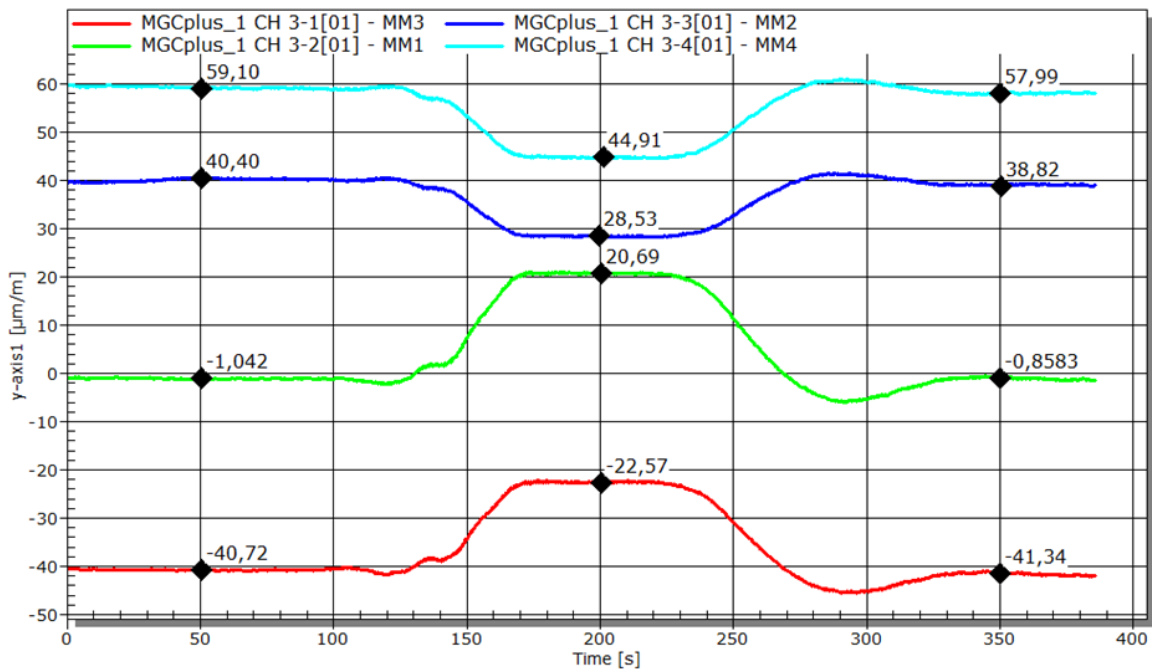
Figure 7 Example of strain diagram for the region over a pier (S3) in Catman AP [6]

Table 2 Strain and stress over a pier (S3) [6]

Strain MM1 (µm/m)	Strain MM2 (µm/m)	Strain MM3 (µm/m)	Strain MM4 (µm/m)
Starting state	-1.04	40.40	-40.72	59.10
Loaded state	20.69	28.53	-22.57	44.91
Unloaded state	-0.85	38,82	-41.34	57.99
Strain	+21.73 µm/m	-11.87 µm/m	+18.15 µm/m	-14.19 µm/m
Stress	+0.82 MPa	-0.45 MPa	+0.68 MPa	-0.53 MPa

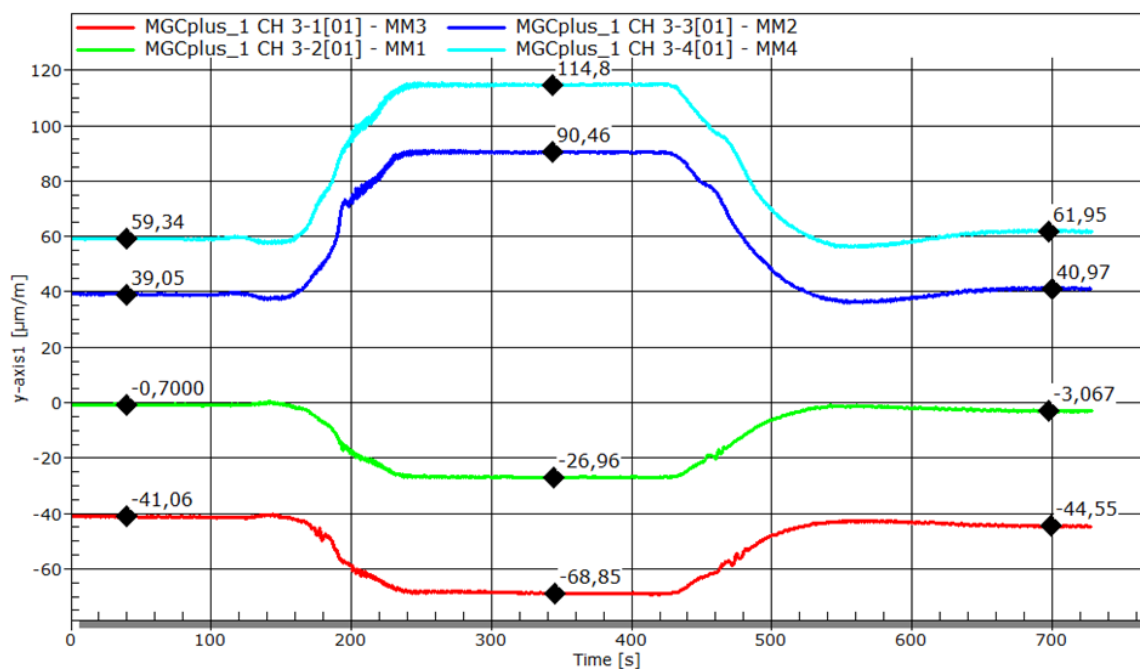
Figure 8 Example of a strain diagram (third span) in Catman AP [6]

Table 3 Strain and stress over the third span [6]

Strain MM1 ($\mu\text{m/m}$)	Strain MM2 ($\mu\text{m/m}$)	Strain MM3 ($\mu\text{m/m}$)	Strain MM4 ($\mu\text{m/m}$)
Starting state	-0.07	39.05	-41.06	59.34
Loaded state	-26.96	90.46	-68.85	114.80
Unloaded state	-3.06	40.97	-44.55	61.95
Strain	-26.89 $\mu\text{m/m}$	+51.41 $\mu\text{m/m}$	-27.79 $\mu\text{m/m}$	+55.46 $\mu\text{m/m}$
Stress	-1.02 MPa	+1.95 MPa	-1.05 MPa	+2.10 MPa

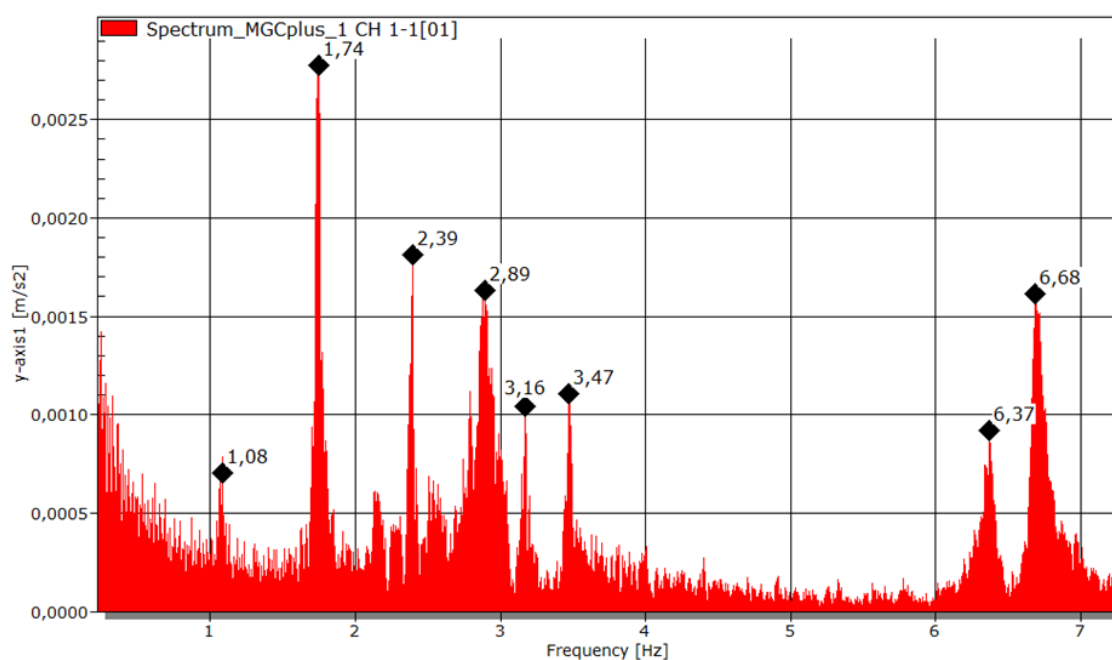
**Figure 9 Frequency diagram [6]**

Dynamic testing of a construction involves measuring the oscillations of the bridge under dynamic load [5]. The dynamic load is actually the force applied on the bridge when a truck moving at a certain speed goes over a plank. It has an impact on the construction, thus triggering oscillations. The acceleration resulting from such impacts, as in the case of earthquakes, can be measured to plot a graph for the duration when the dynamic force was applied. In this test, T3 truck passed over a 5-cm-thick board at a speed of 40 km/h. The test was conducted only on the central (third) span. The accelerations were measured by HBM acceleration transducers, type B12/500, and the data were collected by the MGC plus system [6]. Frequency diagrams were plotted using the obtained accelerations (Figure 9).

Table 6 Comparison of calculated and measured frequencies [6]

Frequency	Value 1	Value 2	Value 3	Value 4	Value 5	Value 6	Value 7
Calculated values (Hz)	1.16	1.78	2.17	2.47	3.12	3.64	3.99
Measured values (Hz)	1.08	1.74	2.39	2.89	3.16	3.47	6.68
Difference (Hz)	0.08	0.04	-0.22	-0.47	-0.04	0.17	-2.69
