Andesite Slope Stability Analysis Using Rock Mass Rating (RMR) and Slope Mass Rating (SMR) in Gunung Batu and Graha Puspa Areas, West Bandung Regency, West Java, Indonesia

Rudarsko-geološko-naftni zbornik
(The Mining-Geology-Petroleum Engineering Bulletin)
UDC: 551.2; 551.3
DOI: 10.17794/rgn.2024.4.11

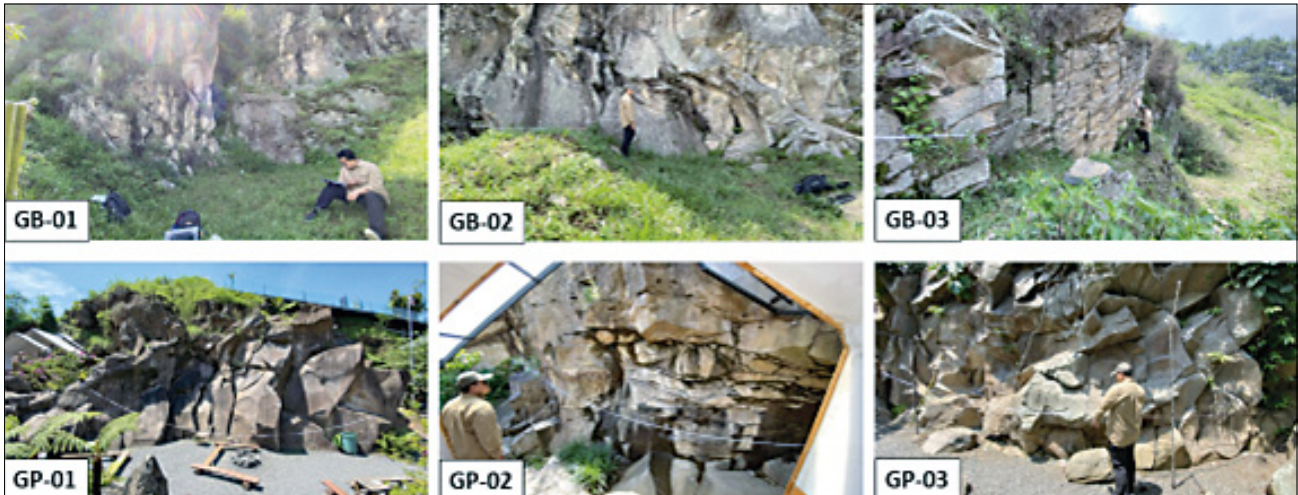
Figure 5: Outcrop conditions of andesite slopes in each section (GB: Gunung Batu, GP: Graha Puspa)

The scanline survey was carried out on natural slopes composed of slightly weathered andesite at elevations of 1200-1300 masl. The slope sections in Gunung Batu are coded GB-01, GB-02, and GB-03, while the slope sections in Graha Puspa are coded GP-01, GP-02, and GP-03. Andesite slopes in Gunung Batu generally face north, while in Graha Puspa, some andesite slopes face north,

and some face east. The condition of andesite outcrops on each slope can be seen in **Figure 5**.

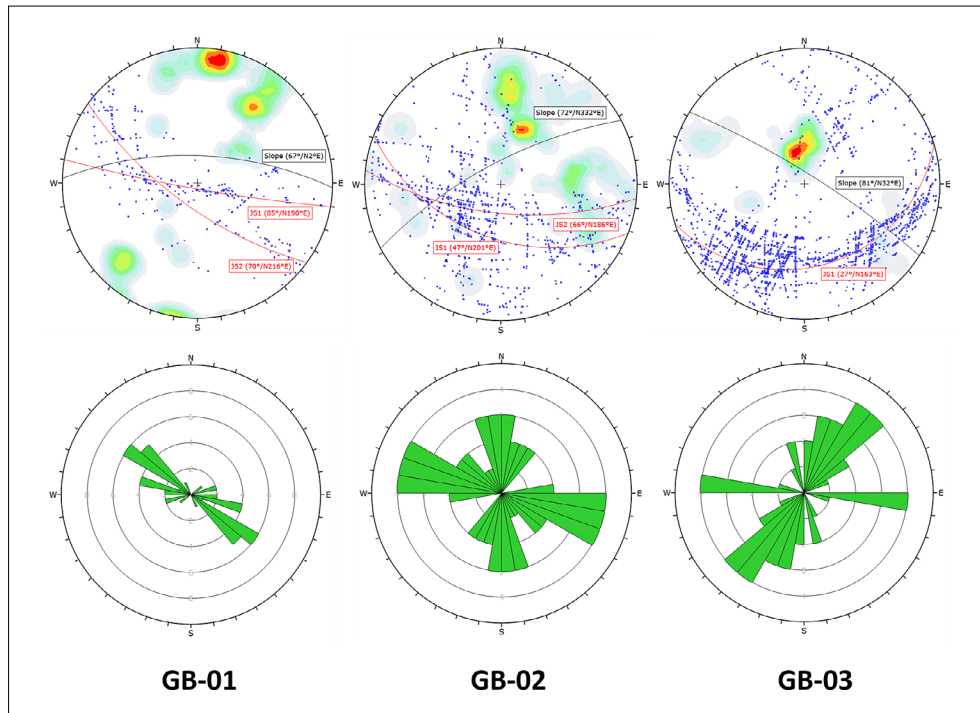
Figure 6: Stereonet and rosette diagrams depicting the direction and orientation of discontinuities in each slope at Gunung Batu

The discontinuity data were then plotted in stereonet in the *Dips* software to see their relative direction to slopes and in rosette diagrams to see the trend of structural orientation at the study site (see **Figures 6** and **7**). Based on stereonet plots, most slope sections (GB-01, GB-02, GB-03, GP-02, and GP-03) have discontinuities oriented in a direction opposite to that of the slope, which has the potential to cause toppling failure (**Hoek and Bray, 1981**). There is one slope section (GP-01) that has two intersecting discontinuities in front of the slope face that has the potential to cause wedge failure.

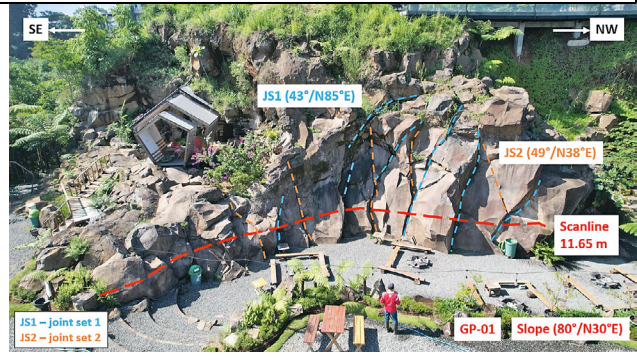
GP-01	
Failure Type	Probability (%)
Planar sliding	24.24
Wedge sliding	53.22
Direct toppling	8.9
Oblique toppling	2.27

Wedge Failure Conditions (Wyllie and Mah, 2004)	
There is an intersection line between two discontinuity planes	V
The line of intersection must dip in a direction out of the slope face	V
Internal friction angle < plunge of intersection line < dip of slope	V

RMR = 81 (Very Good) → safe cut slope = >70° → slope is safe (Waltham, 2002)

Figure 11: Kinematic analysis results and drone photo of section GP-01

Slopes GB-01, GB-02, GB-03, GP-02, and GP-03 indicate a potential toppling failure, while slopes GP-01 indicate wedge failure potential. Based on the conditions of **Wyllie and Mah (2004)**, only slope GB-01 and GP-01 meet the criteria for failure, temporarily concluding slope GB-01 and GP-01 have the potential to failure, and the other four slopes do not. Apart from these conditions, slope safety can also be seen from the safe cut slope parameters obtained from RMR (**Waltham, 2002**). Three slopes were declared unsafe because they had dips that exceeded the recommended safe cut slope, namely GB-01, GP-02, and GP-03. The results of the kinematics analysis of the six slopes, along with drone photos of the outcrops, can be seen in **Figures 8-13**.
