Innovative solution to diagnosis and prognosis of defects and failures in cast-resin transformers for sustainable assets and risk management

Carlo Maria ROGGERO, Vander TUMIATTI, Michela TUMIATTI

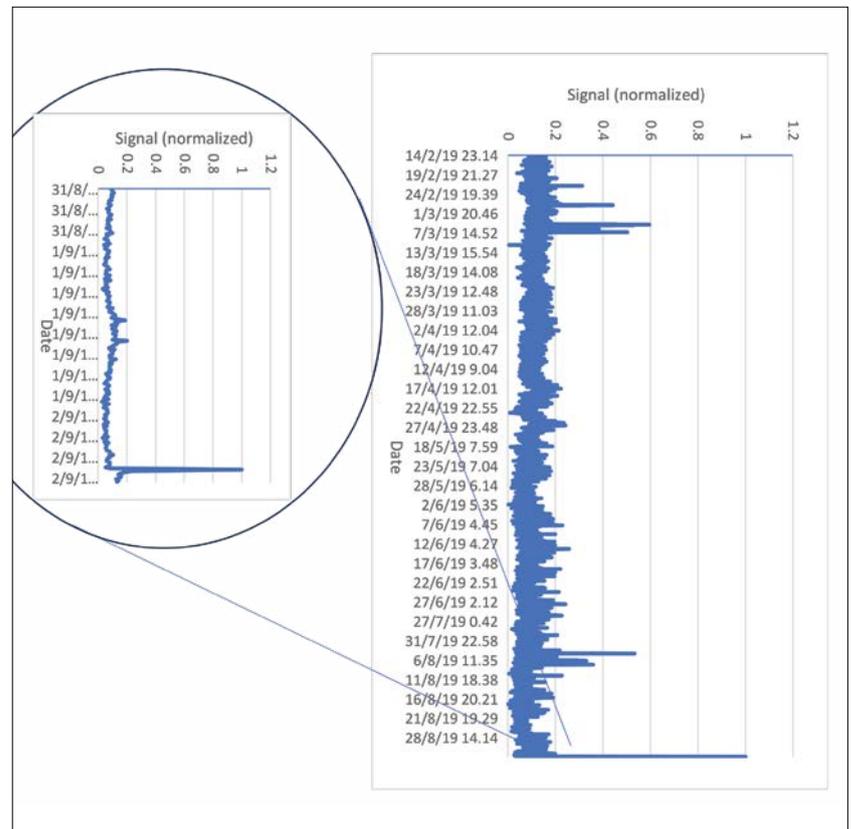
The ozone profile is displayed in Fig. 5. Ozone can be produced by electric and corona discharges [15], whose occurrence is proven by the clear signs of catastrophic discharges in Fig. 4. The overall signal spectrum and a closeup at the time of failure are shown. The highest concentration of ozone, 326 μl/l (ppm), was detected at the instant of breakdown (see expanded graph where the highest peak is shown). However, it is also interesting to point out that a few hours earlier, a couple of smaller peaks were detected at a normalized value of around 0.1. This was a special case with a disastrous event where the formation of ozone was certainly due to powerful arching. Obviously, using the maximum value is not practical for real-time monitoring. However, through *a posteriori* analysis, it can be determined if small peaks had meaning or were just noise. In fact, considering that the standard deviation

is 0.039, one could be inclined to regard those spikes as a sign of ozone formation. However, a broadened observation reveals that 0.11 is the most recurrent and thus probable value (mode), which weakens the strength of the previous proposition and strengthens the assumption of that value being either noise or interference. (The latter is from NO_2 exclusively. Nitric oxide is the principal interfering molecule of ozone detection, as stated in the sensor's datasheet.) On the contrary, the source of other peaks exceeding 0.3 could be associated with ozone formation. This implies that discharge-related incidents might have occurred in previous months, even though a massive presence of NO_2 cannot be excluded. A comparable piece of information is provided by a device installed next to another transformer (#8 in Table 2) for which the value of the mode is 0.08, quite close to the 0.11 value reported above.

Fig. 5. Ozone profile from the failed transformer: on the ordinate the normalized concentration value, on the abscissa the date of sampling. The arrow points at the moment of failure.

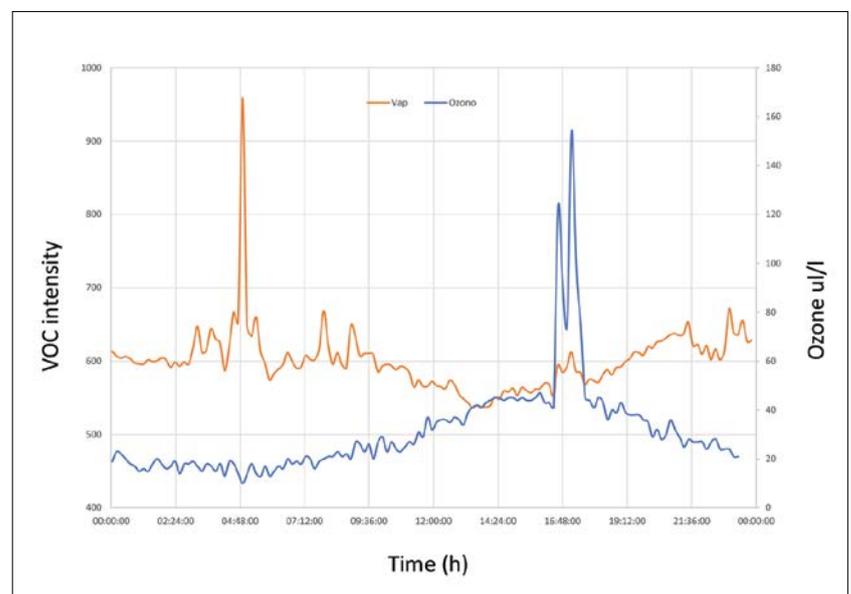
Monitoring of the second transformer, which suffered damage (#7 in Table 2), reveals the formation of ozone gas (maximum value 181μl/l). The spotting of high ozone concentration triggered an alert and a consequent on-site verification where a problem was discovered, as mentioned above. In fact, the technicians found that the cable sealing ends on the low-voltage side were loose and partially burnt, possibly due to overheating or arcing. Figure 6 displays an ozone peak at 16:48 (blue curve) and a VOC peak at 4:48 a.m.

Fig. 6. Ozone profile (blue line) and VOC profile (orange line) from the damaged transformer on the day of the alert. Ozone concentration and VOC intensity are shown on the ordinate and time on the abscissa.

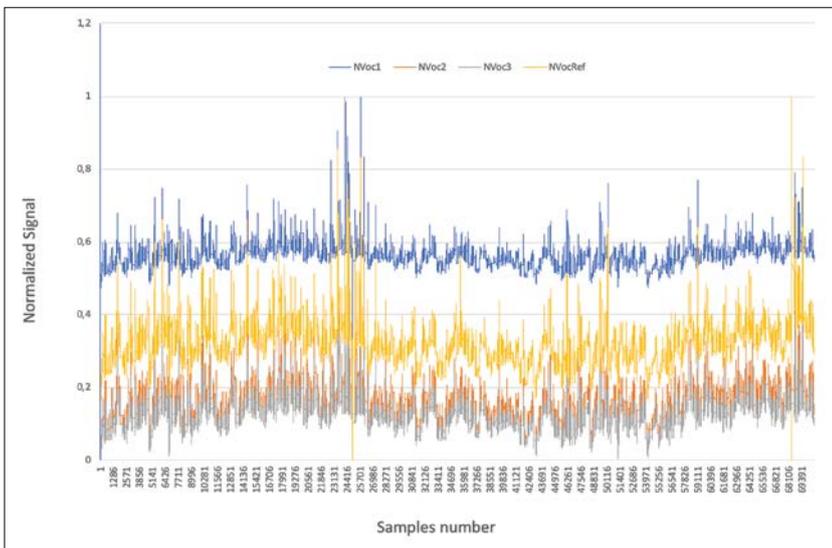
Fig. 7. Normalized signals of four equivalent MOS sensors

In Fig. 7 a comparison of signals from four equivalent MOS sensors positioned in different places is shown. Regardless of placement right above a phase, at a certain distance, or even outside the room, information is the same. It follows that the air inside and outside the room is similar and marked by a high level of external pollution, which is recognized to contribute to failures as it can create carbon deposits on accessible parts and lead to tracking and potential failure [14]. Consequently, sensors that monitor contamination levels are useful and necessary.

In Fig. 7 sensors 1-3 were placed one at each phase of transformer #2 (see Table 2). The fourth is the external reference positioned in different places inside the room. The profiles do not vary from curve to curve, and only the relative intensities are different. Normalization was performed according to the following calculation: (average – min)/(max-min). This was a posteriori signal analysis, which cannot be employed in real-time.

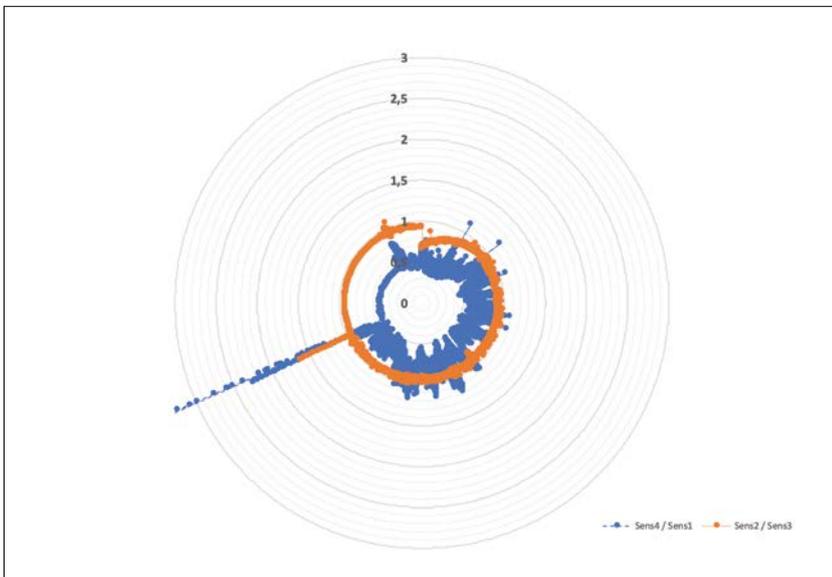
Fig. 8. Ratios between signals of a 4-MOS cluster for transformer #2 (see Table 2). The inner curve is the ratio between sensor 4 and sensor 1 (abbreviated as the reciprocal), and the outer curve is the ratio between sensors 3 and 2 (abbreviated as the reciprocal).

but when sensors are exposed to chemicals, a spike appears. The peak of the ratio between sensor 3 and sensor 2 is less prominent because of an almost exclusive responsiveness to aliphatic and aromatic hydrocarbons.

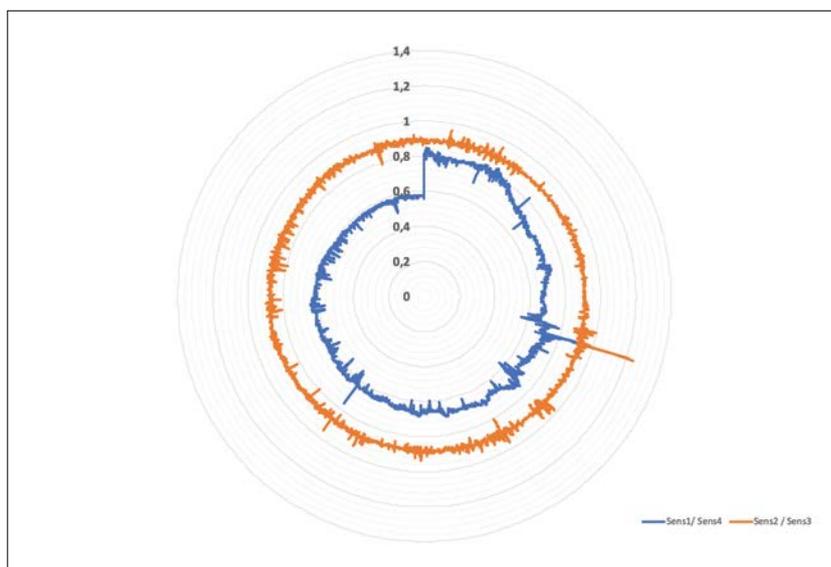
Figure 9 shows a radar chart that displays the same ratios as Fig. 8, but for transformer #7 (the one that suffered damage to its sealing ends), Here again, the signal ratios oscillate inside a given annulus and exhibit a peak at a given time unmistakably associated with the presence of organic molecules, either from the transformer or from outside the room.

Fig. 9. Ratios between signals of a 4-MOS cluster for transformer #7. The inner curve is the ratio between sensor 4 and sensor 1 (abbreviated as the reciprocal), and the outer curve is the ratio between sensors 3 and 2 (abbreviated as the reciprocal).

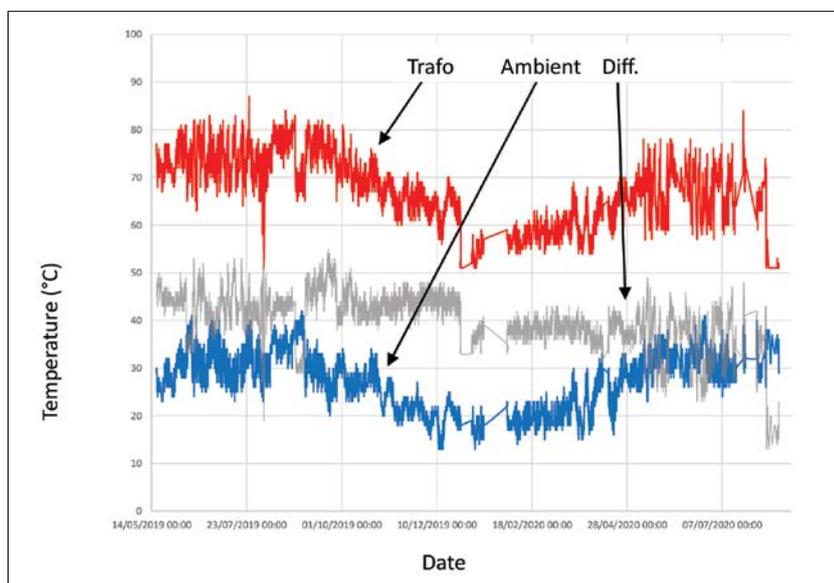
Regarding the transformer which suffered a destructive failure, the difference between the environmental temperature and the maximum superficial temperature measured on the side "seen" by the thermal camera is shown in Fig. 10. Such difference oscillated between 40°C and 50°C on average, which is far below the acceptable maximum overtemperature (100°C), as declared by the manufacturer. Obviously, the internal temperature was higher, and the presence of hot spots could not be excluded.

Fig. 10. Difference in temperature between the room environment and the transformer.
