Improving the Surface Condition of the Casting of the Control Panel Cover

Karolina CZERWIŃSKA, Andrzej PACANA*

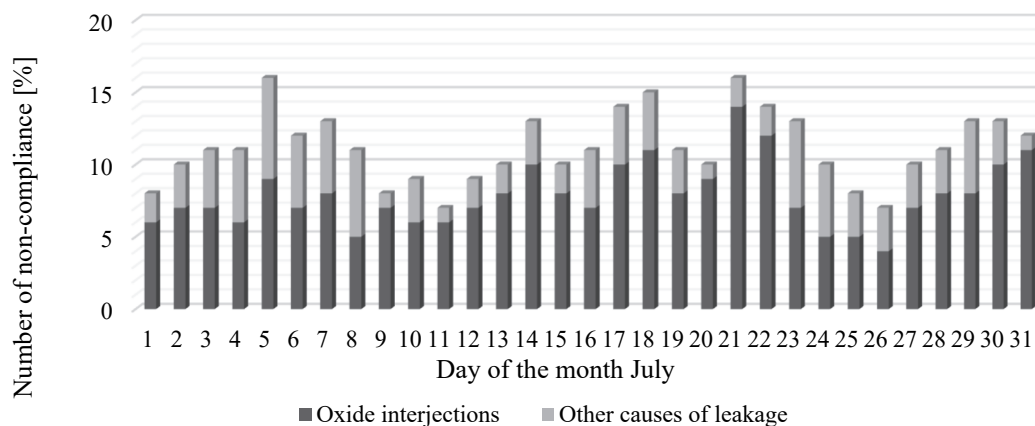
Figure 2 Total number of leaking control panel covers and their number caused by oxide inclusions only during the month of July

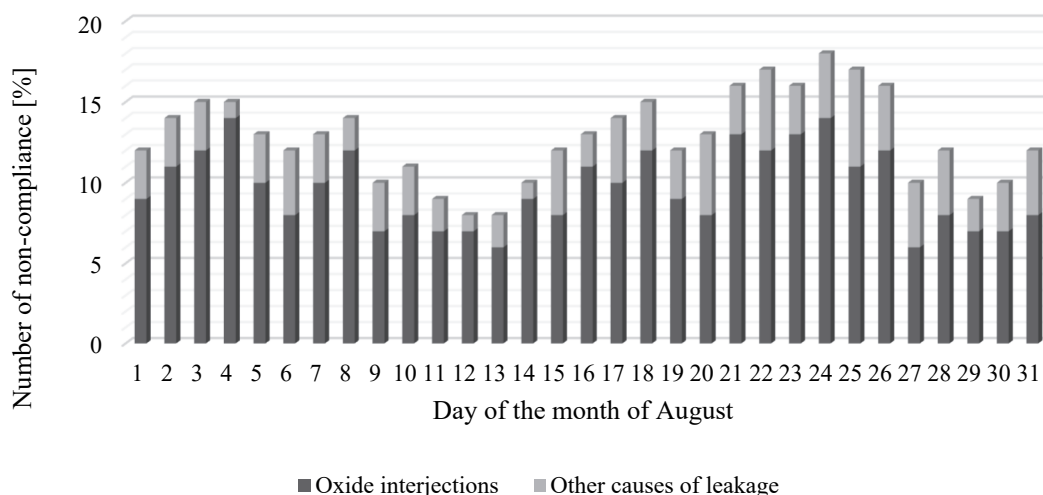
Figure 3 Total number of leaking control panel covers and their number caused by oxide inclusions only during the month of August

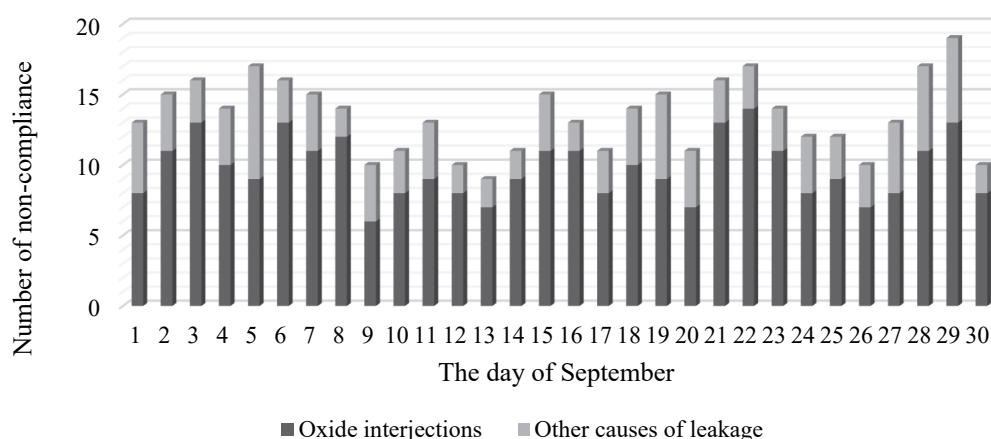
Figure 4 Total number of leaking control panel covers and their number caused by oxide inclusions only during the month of September

These figures also show the marginal contribution of other causes of cover leaks due to, inter alia, lumps, cracks, foreign material inclusions, the presence of pores or underfilling. Detecting leaks in industrial castings, including housing castings, requires specialized techniques and equipment. This precise diagnostic method makes it possible to identify where unwanted leaks are occurring, which is crucial to maintaining the structural and functional integrity of products. An example of a negative leakage test of a control panel casing casting is shown in Fig. 5. The helium casting leakage test stand was equipped with a suitable detector.

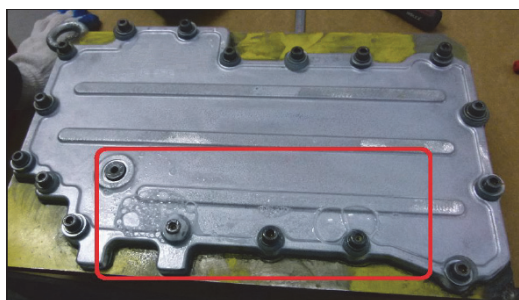
Figure 5 Leakage (discontinuity of material passing through, revealed in the water test by the penetration of water through the wall of the casting)

Fig. 5 illustrates nonconformity in the form of a leak. For the purpose of visualizing the nonconformity, substances were used in the area of defects to get inside the object by pushing out air in the gaps forming bubbles. The discontinuity of the material passage for the purposes of visualization was identified in the water test by the penetration of water through the wall of the casting. Metallographic analysis of the areas where the leaks occurred revealed that most of the inconsistencies in the alloy structure were oxide inclusions. Fig. 6 shows an example of a microstructure in which an oxide was identified across the casting wall as the cause of leakage.

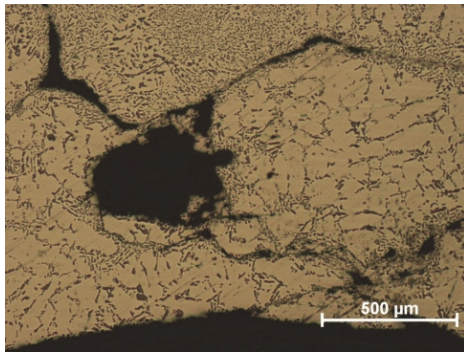
Primary oxide inclusions of die-cast aluminum alloys take the form of large inclusions with uneven distribution in the macrostructure. Such inclusions cause discontinuities in the alloy structure and reduce the atmosphere of the workpiece. They become a source of corrosion, significantly reduce the strength and ductility of the aluminum alloy, and often become a source of part fracture.

Figure 6 Oxide through the wall - the cause of leakage

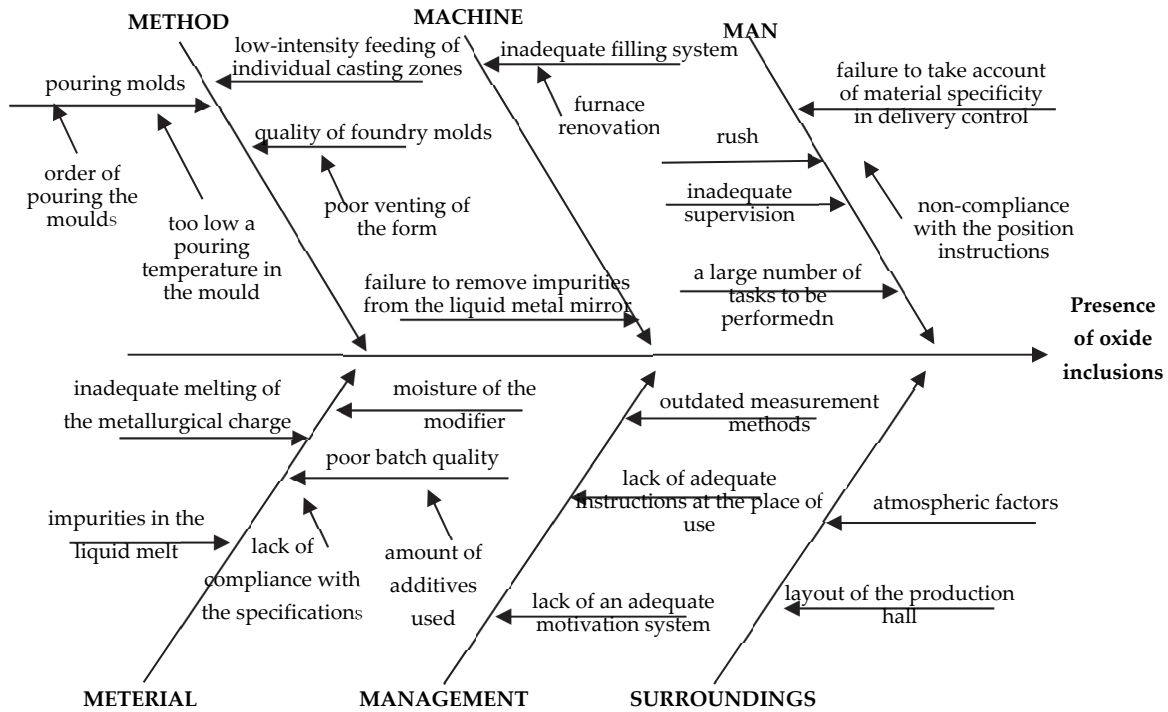
**Figure 7** Ishikawa diagram of causes of oxide inclusions in control panel cover castings

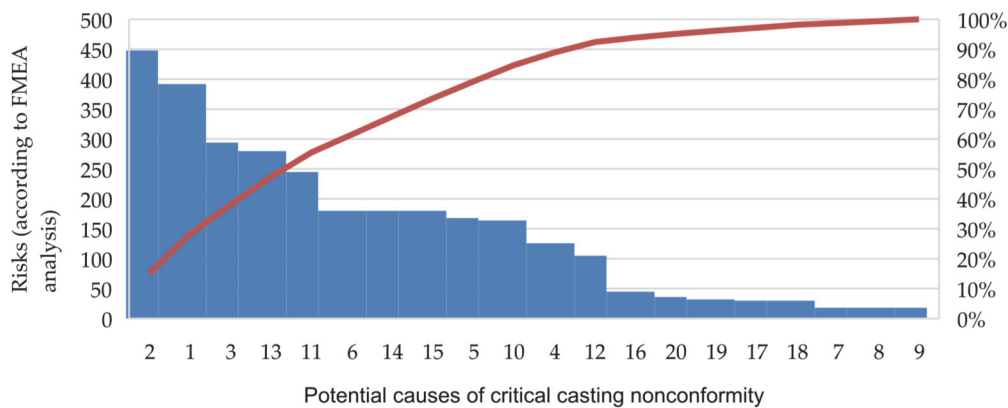
Figure 8 Diagram Pareto-Lorenza

In the next stage of the research, a Pareto-Lorenz diagram was made based on the results of the FMEA analysis (Fig. 8). The diagram made it possible to order the prioritization of factors (including second-order causes) affecting the analyzed quality problem. The numbering of potential causes of the quality problem in the Pareto - Lorenz diagram and the FMEA analysis are the same. Among the potential causes, improper pouring of the mold - too low pouring temperature - was considered the main cause. In addition, in order to determine the main cause of the deterioration of casting quality, the problem was analyzed using the 5Why method (Fig. 9). The analysis (Fig. 9) shows that the main reason for pouring the mold with an inappropriate temperature alloy was the failure to train a new employee, resulting from inadequate human resources management. The machine was operated by a newly hired employee who misread the work instructions. His insufficient experience and lack of training was a major cause of the nonconformity. During the analyzed period (July, August, September), the percentage of nonconforming castings of center covers ranged from 1.67% to 4.52%. On the other hand, the introduction of a method to search for the real causes of nonconformities contributed to an average reduction of 1.51% in this type of nonconformity (pouring the mold with an alloy of the wrong temperature caused by the lack of training of a new employee) and stabilization of the process. The model is a new and universal method that can be implied in any foundry company to ensure the stability of production processes. The universality of the model allows for its wider application, not limited only to the problem situations indicated in the study. The versatility of the model manifests itself in the possibility of its use in foundries in which it is important to ensure a certain quality of the manufactured aluminum products. The versatility of the model allows it to be used by both stable, procedurally solidified organizations and those that are just forming in response to market challenges.

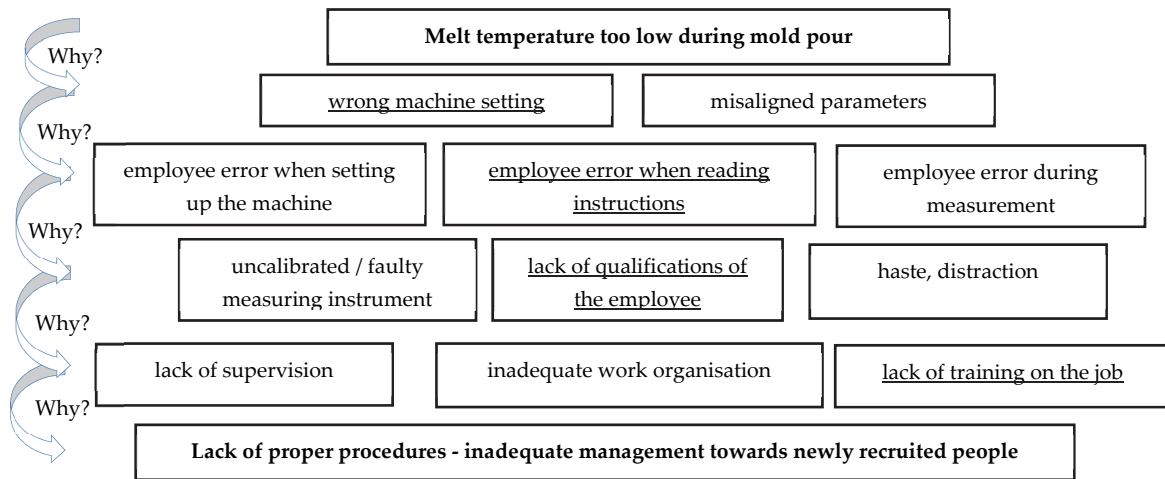
Figure 9 Run of the 5Why method for the melt temperature mismatch during pouring

- the key cause of the main nonconformities was the wrong way of pouring the mold (too low pouring temperature), which was caused by the lack of training of the new employee, resulting from inadequate management of human resources.
