Đeni GOBIĆ-BRAVAR

DVOJNA VRATA, PULA KONZERVATORSKO-RESTAURATORSKI OSVRT

THE DOUBLE GATE AT PULA A CONSERVATION-RESTORATION REVIEW

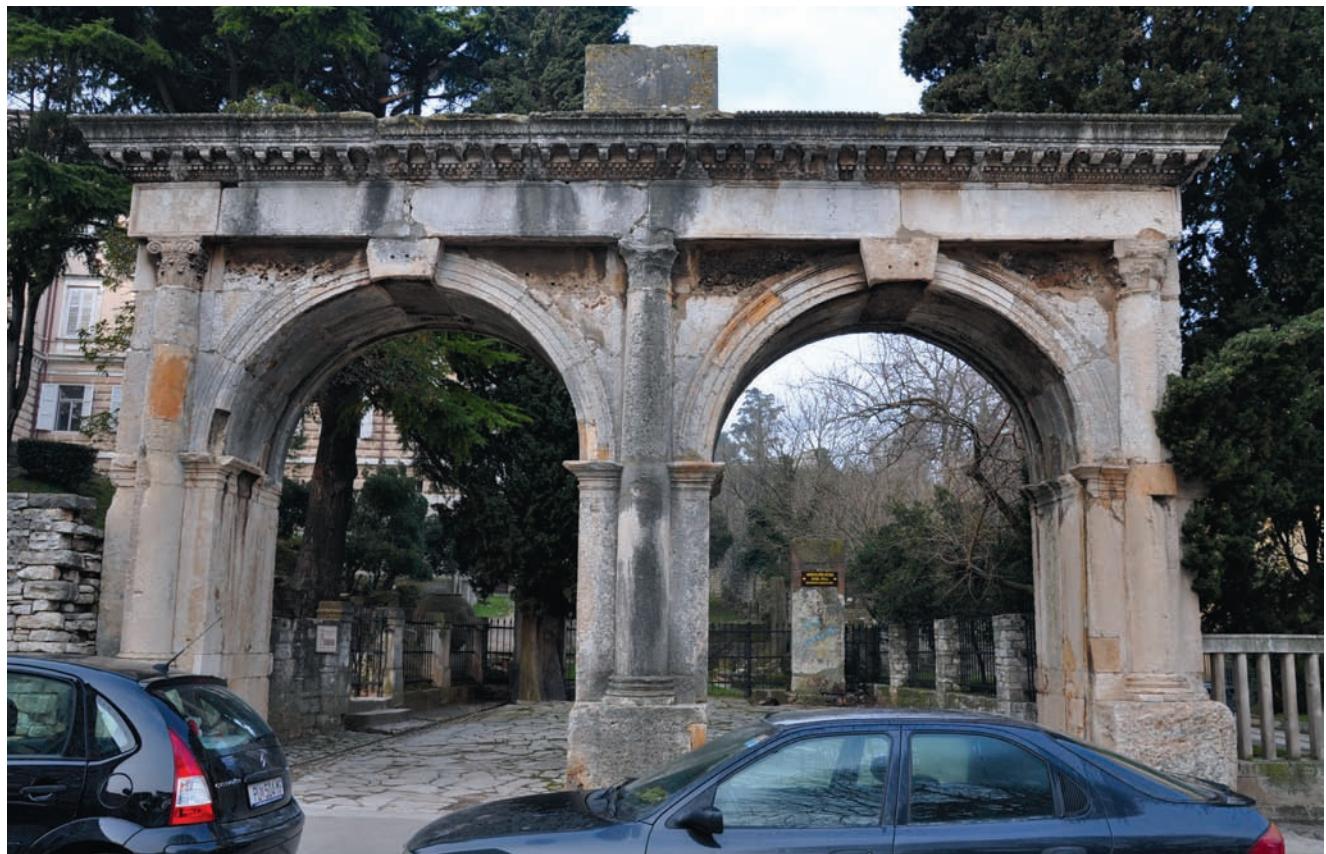
Sl. 3 Dvojna vrata danas. / Fig. 3 The Double Gate at present.

Scores of degradations that are typical for Roman monuments located in urban areas can be nowadays observed on the Double Gate. These are mainly connected with atmospheric influences, pollution and vandalism. Fortunately, there are no serious static damages that are visible.

Two large groups of degradations can be spotted on the Double Gate, those aesthetical and those structural ones. As the word itself implies, degradations of an aesthetic nature tend to disturb the appearance of the monument. Structural degradations, on the other hand, put the preservation of certain parts of the monument in jeopardy. Naturally, these two groups of degradations also overlap, in this manner we consider a black incrustation an aesthetic as well as a structural degradation, and the same is the case when speaking about vegetation and active biological layers.

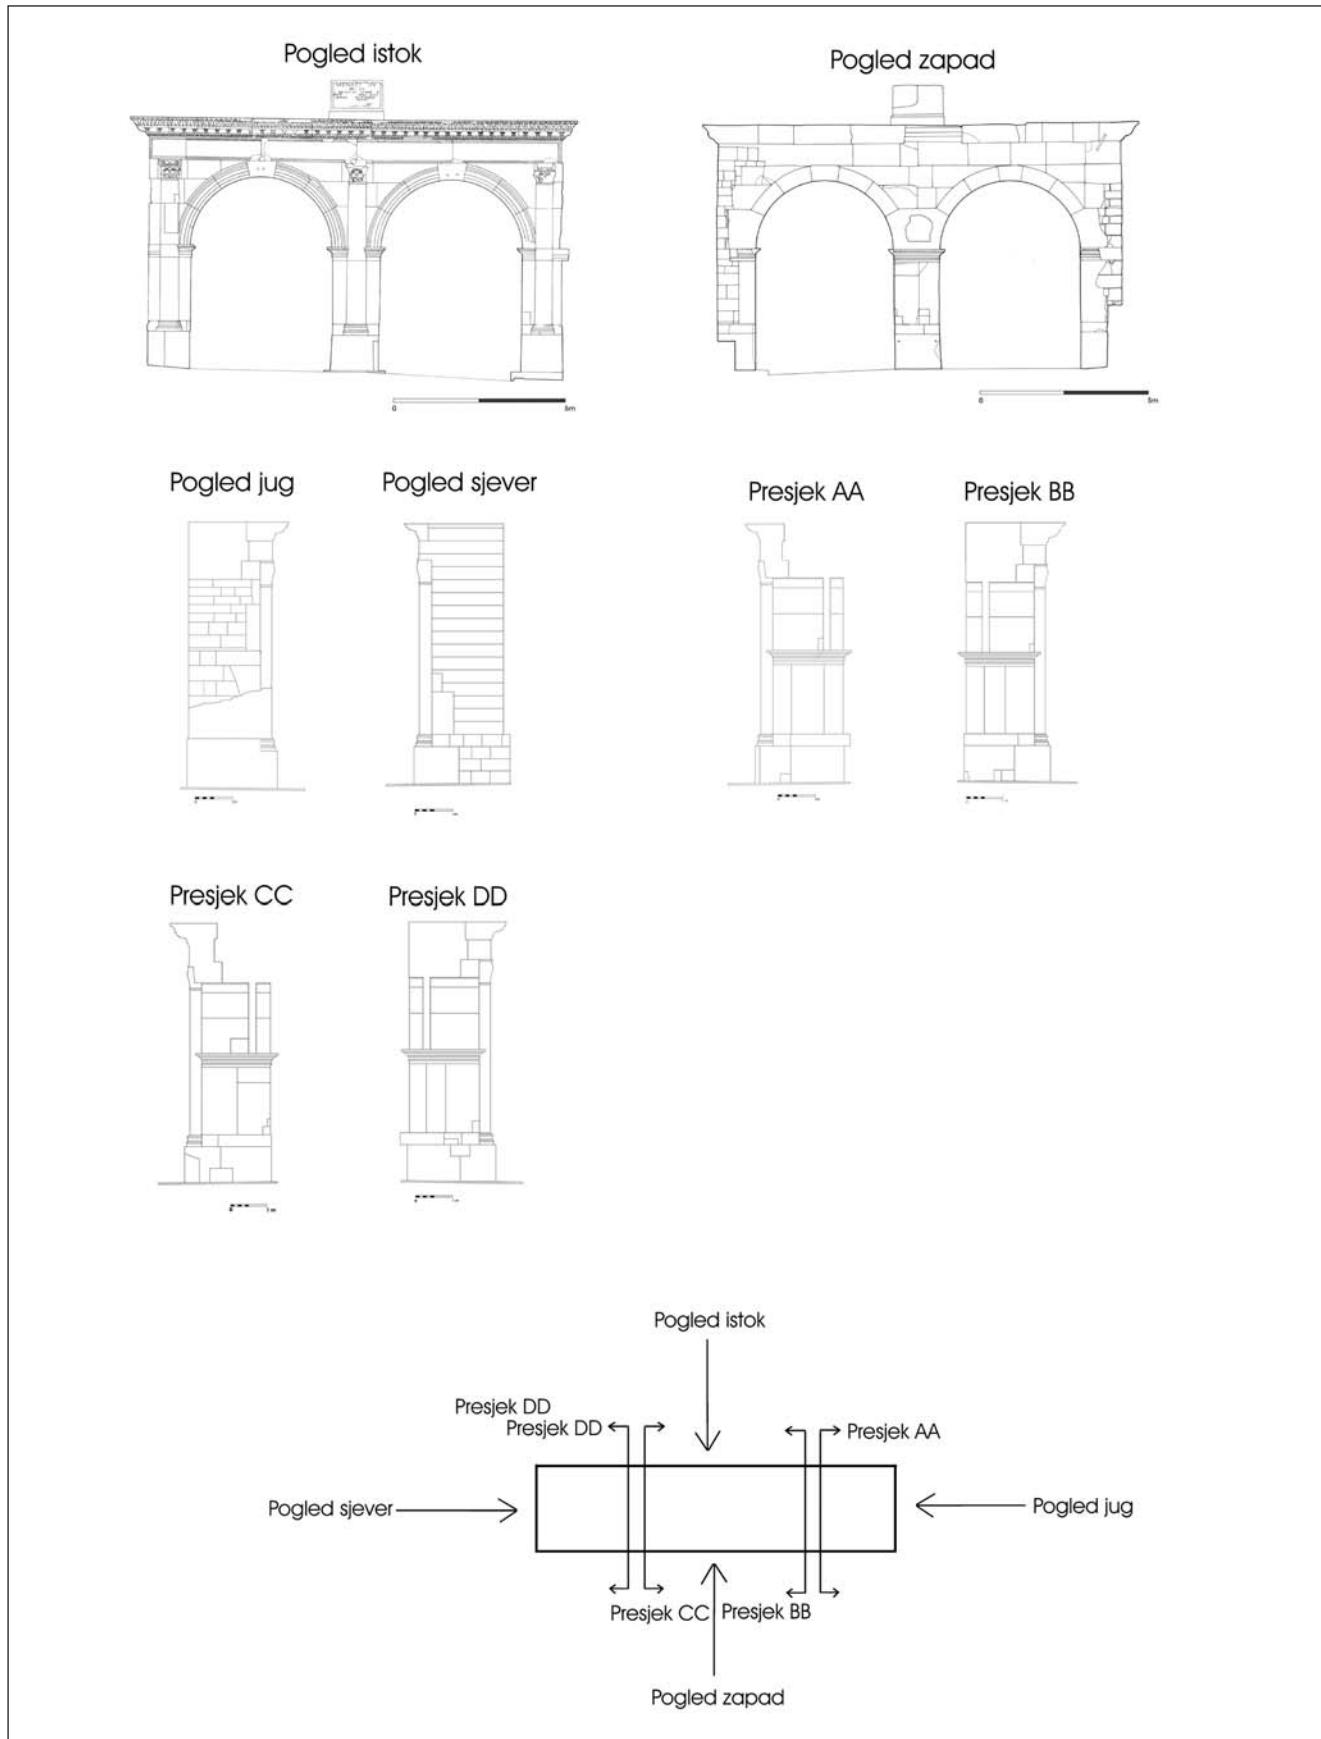
T. II. Grafički prikaz mrlja, biološkog filma i crnih inkrustacija
 T. II. A graphical display of stains, biological film and black incrustations.

2.1. Stains, biological film and black incrustations

2.1.1. Stains

The stains on the Double Gate were in the vast majority of cases caused by tar, or were left there after the tar coating was removed. Initially it was thought that the fragments were reddish in color because of close contact with red earth; however, by comparing historical photographs, and after the discovery of the data put forth by Pons in Eco di Pola in 1887, it was concluded that these are tar stains. There are also sporadic instances of graffiti.

Biological film is represented on large surfaces of the monument. It is a dark grey color caused by colonies of lichen that have died off.
