ANALYSIS OF LACK OF FUSION IN WELDS AT WATER HEATERS

The paper treats a weld discontinuity called lack of fusion, which is frequently a cause of leakage of a water heater. The heater was produced by MAG welding using two wires (twin arc welding). The paper states some reasons for the occurrence of lack of fusion, i.e. the arc blow effect, an inappropriate gun position, uncontrolled movement of the weld pool, too low energy input, an improper joint preparation. The defect is illustrated in a macrograph of a weld produced at the water heater with twin wires in a shielding gas. Welding with twin wires is schematically represented with a circumferential welded joint between the end and shell of the water heater.

J. Tušek, Faculty of Mechanical Engineering University of Ljubljana, Ljubljana, Slovenia, B. Bajcer, Gorenje Tiki d.o.o., Ljubljana, Slovenia, B. Taljat, M. Hrženjak, TKC d.o.o., Ljubljana, Slovenia

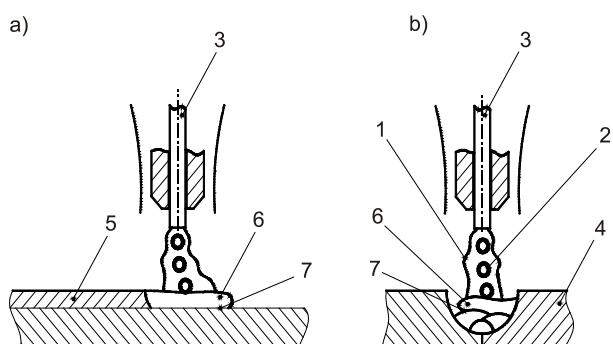
The third cause is uncontrolled “flight” of the weld pool (Figure 6.). In arc welding processes using a filler material, which are characterized by a large weld pool, it often happens that the weld pool “flees” in the direction of weld progression or any other direction. If the weld pool runs ahead of the arc it prevents heating of the groove, which is shown in Figure 6.a.

Figure 6. Weld pool “fleeting” ahead of the arc a) and on the side of the arc b) to produce lack of fusion on the side (a-left) and inter-bead (b-right) fusion; 1 - arc, 2 - molten drops, 3 - wire, 4 - workpiece, 5 - solid weld, 6 - weld pool, 7 - lack of fusion

Consequently, incomplete fusion will occur between the parent metal and the weld pool. Another difficulty encountered is that the weld pool flows to the right and to the left of the unmelted weld groove (Figure 6.b).
