Static and dynamic analysis of the old stone bridge in Mostar

Professional paper

1. Introduction

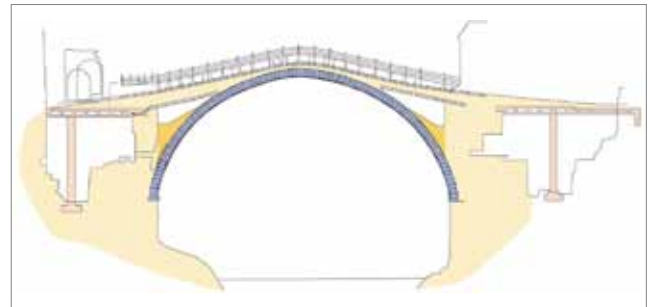
Figure 3. Longitudinal cross-section of the bridge

- Big hollow areas, with reinforced-concrete bearing structure, in which archaeological museums are positioned, were left in the zones immediately behind both abutments [6] (Figure 3). The bottom of the hollow areas is at the arch spring level. Compared to the original situation, this has reduced favourable action of the permanent vertical load behind the arch heel, and has at the same time increased horizontal deformability of the arch.

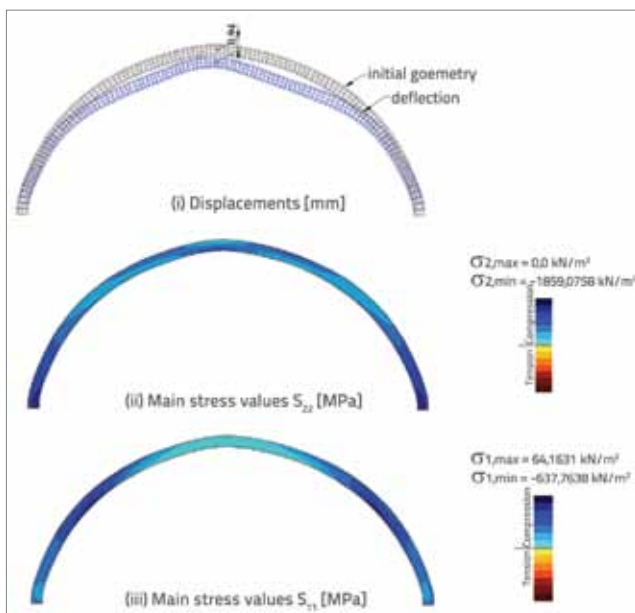
Figure 11. Some numerical results for vertical load only (permanent load and pedestrians) – NM1 model

Some analysis results for vertical load only (self-weight of the arch, spandrel structure weight, and pedestrian load) are presented in Figure 11. The pedestrian load of 5 kN/m² was assumed along the entire walking surface of the bridge. It amounts to as little as 7 percent of the total permanent load. The design deflection of arch in the crown amounts to 0.94 mm, which almost corresponds to the displacement of 0.9

mm as measured after the scaffold was released (south side) [10]. In the direction of axis, the arch dominantly assumes compressive load and this along the entire thickness. The biggest main compressive stress in the arch amounts to -1.86 MPa. Tensile stresses in stone blocks do not exceed the tensile strength of the stone, i.e. there are no cracks in stone blocks.

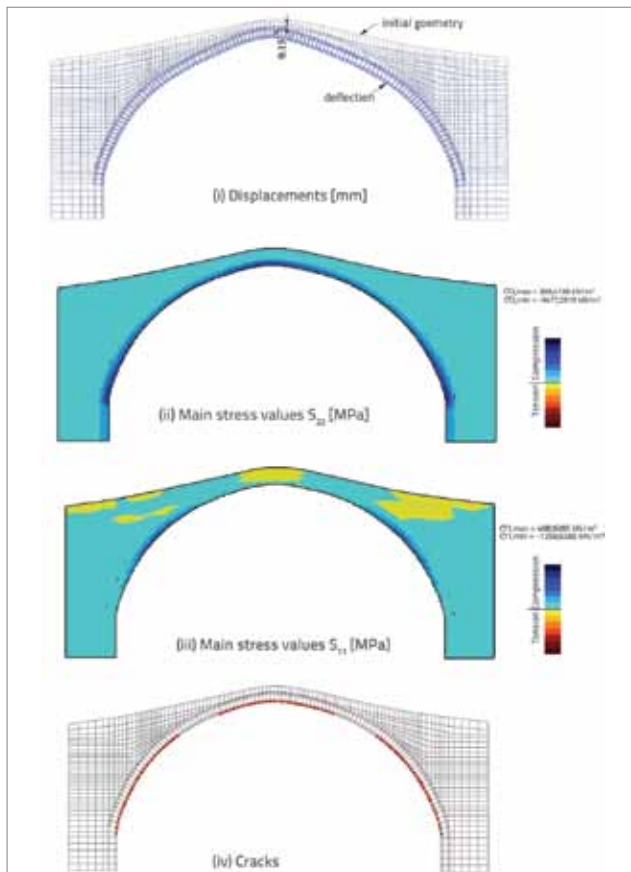
Figure 13. Some results for vertical load and temperature changes according to Figure 12a – NM1

The stress in arch due to temperature changes was activated after the final arch closing at the crown level (21 August 2003). In fact the arch was closed in crown in the summer period, at the ambient temperature of about 25 °C. Annual temperature variations in the town of Mostar are quite big, and mostly range from -5 °C to 50 °C [8]. Different annual and diurnal temperature variations are also possible along the arch length and thickness. For simplicity of analysis, we assumed that the temperature is constant along the arch length, and variable along the arch thickness. Some temperature changes, believed to be possible and ranking among the most unfavourable ones, are presented in Figure 12. Relevant temperature variations are those that cause pressure next to the arch intrados, as compared to the pressure situation at the arch closing time. The temperature coefficient of $\alpha_{tb} = 6,5 \times 10^{-6}$ was assumed for stone blocks, and this coefficient in joints was assumed to be $\alpha_{tm} = 6,0 \times 10^{-6}$. Some results obtained for simultaneous action of vertical load and temperature changes according to Figure 12a are shown in Figure 13. The highest main compressive stress in stone blocks amounts to -3.48 MPa. The design position of cracks in stone blocks at the arch face is shown in Figure 14, which corresponds well to the actual present time cracks shown in Figure 9.

Design cracks in vertical plane of the arch along the intrados (overstepping of limit tensile deformation of stone perpendicular to the arch) were also obtained. This is consistent with the actual situation according to Figure 8. It should be noted that analysis results depend on various stone and mortar parameters, and especially on the tensile strength, elastic modulus, Poisson ratio, and temperature coefficient. Numerous analyses were made by varying these parameters. Due to limited space, not all of these results can be presented in the paper. The following conclusions can be made after analysis of influence exerted by the above mentioned parameters for materials:

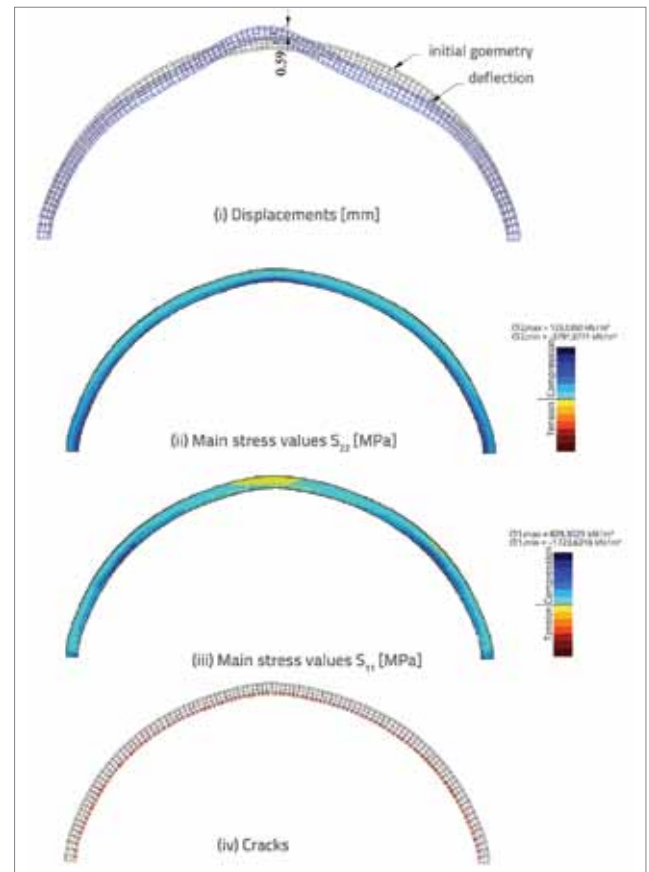
Figure 14.. Some results for vertical load and temperature changes according to Figure 12c – NM1 Model

- Lower tensile strength of stone results in a wider stone cracking zone.
- Higher elastic modulus, and higher temperature coefficient of stone, result in unfavourable temperature effects.
- Higher Poisson ratio of stone results in greater deformations and greater tensile stress in stone block perpendicular to the arch axis..

Model Some results for simultaneous action of vertical load and temperature changes according to Figure 12c are presented in Figure 14. It can be seen that, for this possible load, the crack zones extend along the entire length of the arch next to the intrados, which unfortunately can happen at some future time on the real arch. Compressive stress values in stone arches attain – 3.79 MPa.

The extent of arch damage at the renovated bridge is such that its original mechanical resistance and safety have been reduced. It is probable that the situation will continue to deteriorate over time. Already at this time, there is a real danger that the pieces of damaged stone blocks might fall out. The repair of arch damage is urgently needed, which should include preparation of the study that is to propose appropriate solutions for the avoidance or reduction of further arch damage, and define the need for its durable successive repairs, in the ways similar to the original arch.

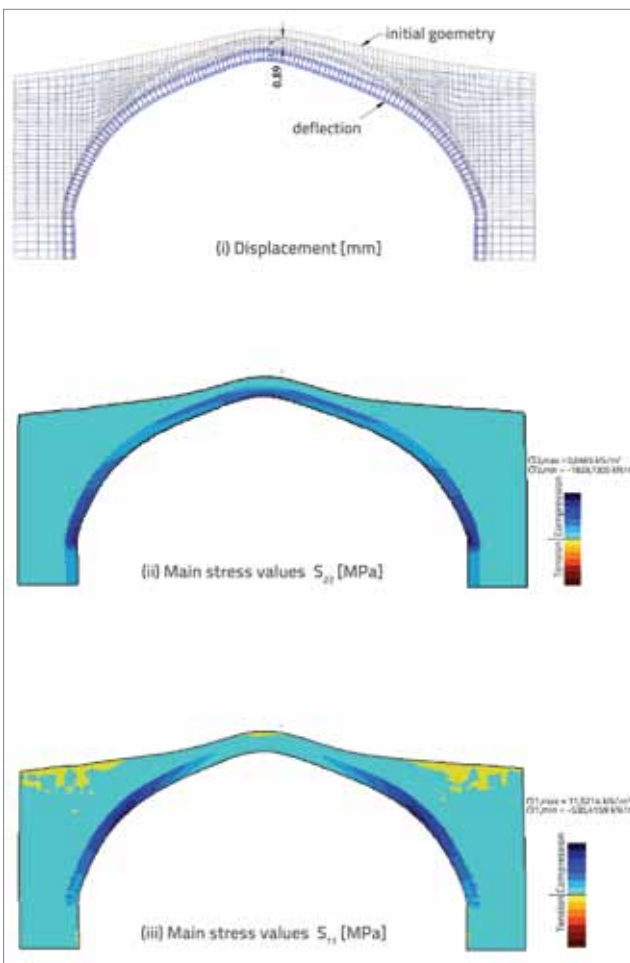
Figure 16. Some calculation results for the total vertical load - NM2 model)

Some calculation results defining the influence of vertical load only are presented in Figure 16. It can be seen that the results correspond well to those given in figure 11 for the geometry model NM1. Some numerical results for the influence of vertical load and temperature changes according to figure 12a are presented in Figure 17. Here also we can see a good correspondence of results with those from Figure 13 for the NM1 model.

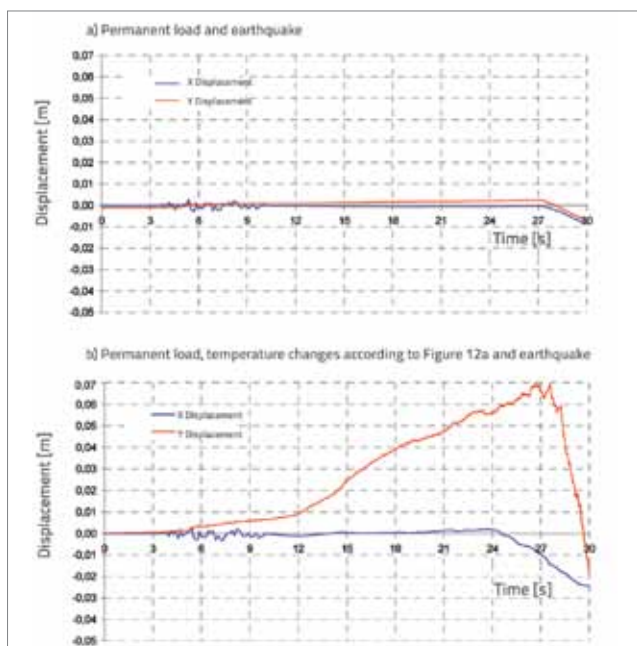
Figure 20. Arch displacement in crown for the Ston earthquake according to Figure 18

The arch displacement in crown for the Ston earthquake according to Figure 18 is presented in Figure 20. At that the following cases were analyzed: (i) only permanent load and earthquake and (ii) permanent load, temperature changes according to Figure 12a, and earthquake. In both cases, a sudden increase in displacement and crushing of materials, i.e. the divergence of numerical procedure or structural failure, occurs near the end of the earthquake action.

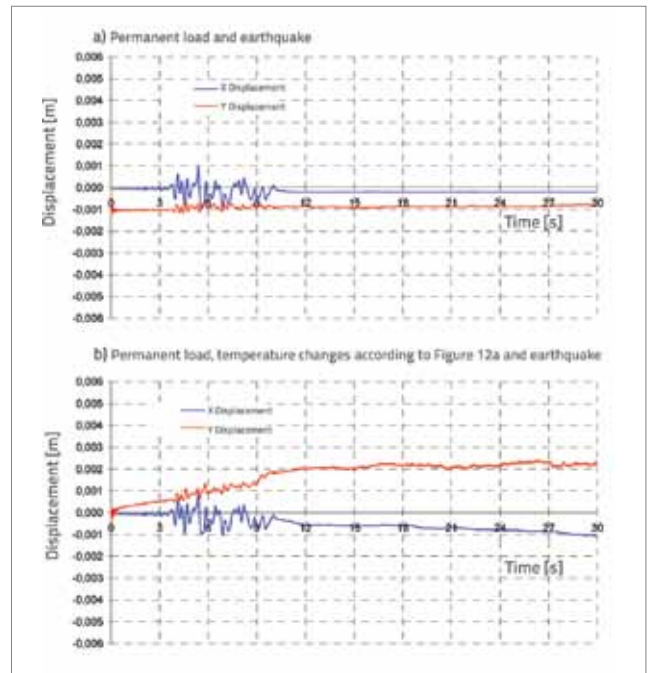
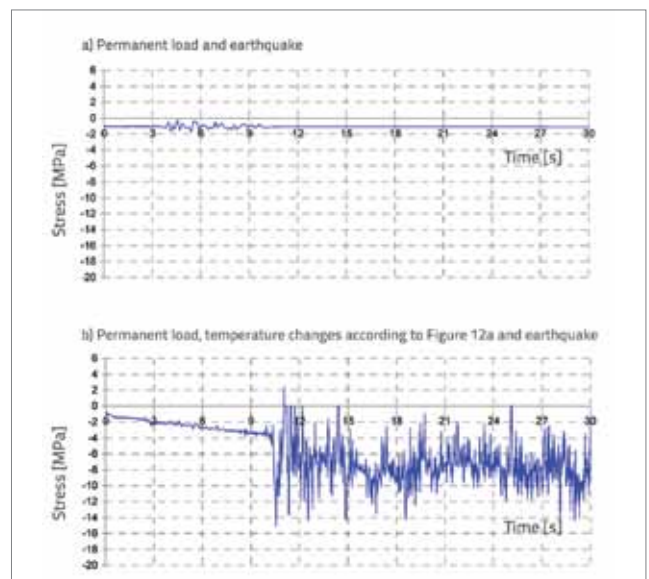
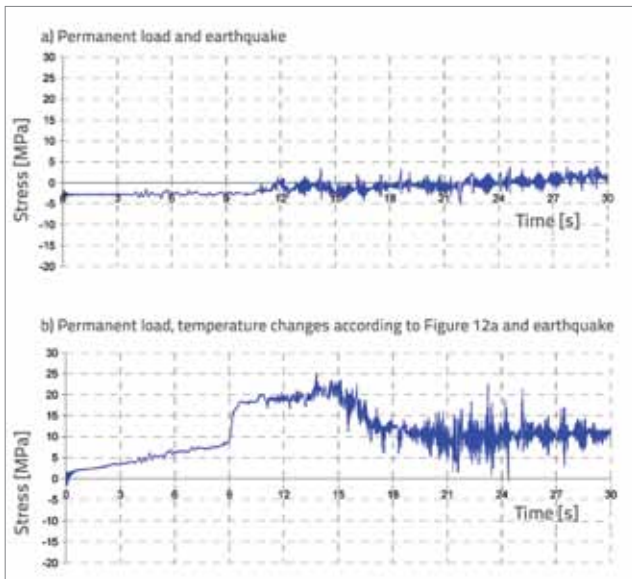
Figure 21. Displacement in arch crown for the scaled Ston earthquake (greatest horizontal acceleration: 0.3g)

Figure 22. Stress in stone block at arch spring next to intrados for the scaled Ston earthquake (greatest horizontal acceleration 0.3g)

Some calculation results for the scaled Ston earthquake, with the biggest horizontal acceleration of 0.3g, are presented in Figures 21-23. Despite severe damage (cracking), the bridge structure "survived" in the following cases of load: (i) permanent load and earthquake, and (ii) permanent load, temperature changes according to figure 12a, and earthquake.

Figure 23. Stress in metal cramp in arch crown for the scaled Ston earthquake (greatest horizontal acceleration 0.3g)
