HERKULOVA VRATA U PULI KONZERVATORSKO-RESTAURATORSKI OSVRT HERCULES' GATE AT PULA A CONSERVATION-RESTORATION REVIEW

UDC 725.941.025.3/.4(497.5 Pula)
Professional paper
Received: July 2, 2012
Approved: September 3, 2012

KEY WORDS: Hercules' Gate, degradations, graphical documentation, restoration-conservation proposals

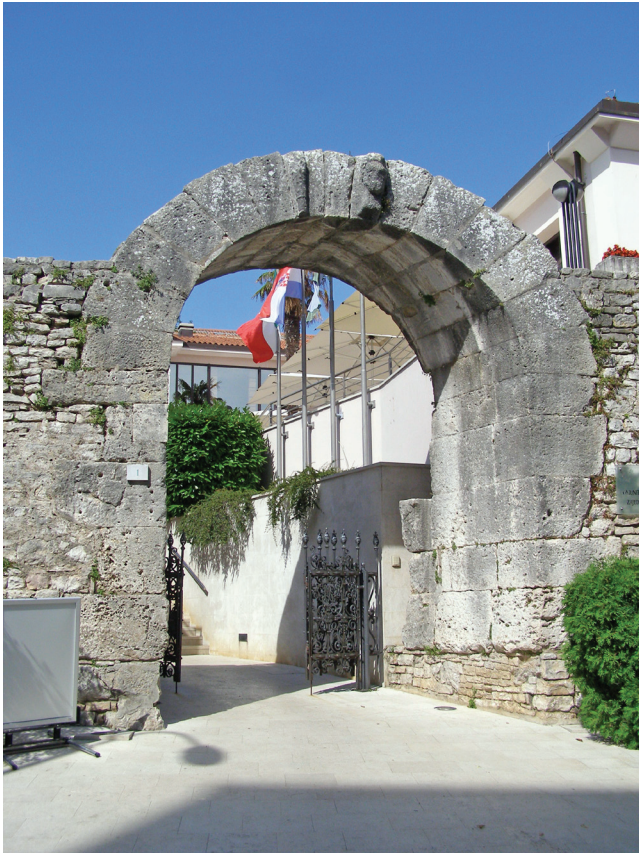
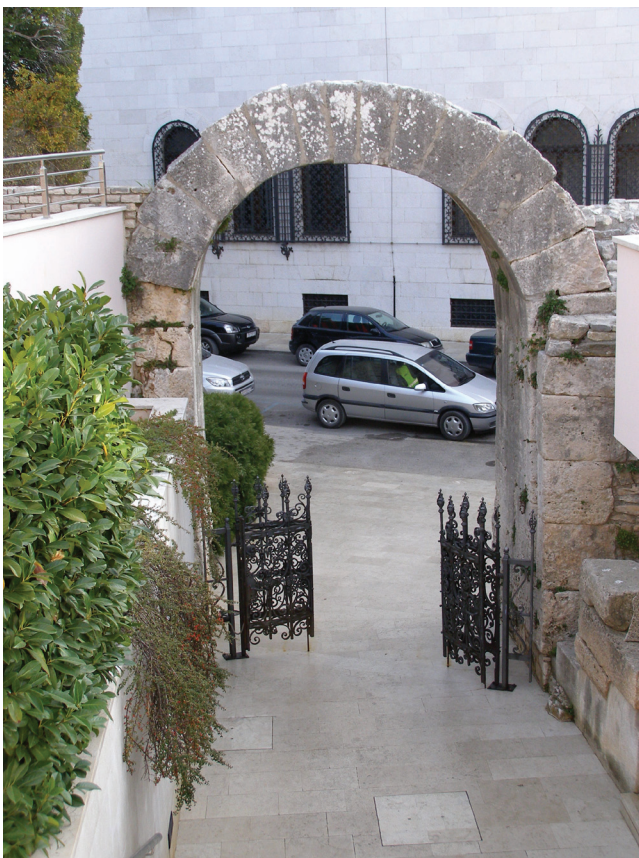
Nowadays it is possible to observe a whole series of degradations on Hercules' Gate, which are typical for ancient monuments located in urban environments. These are predominantly connected with atmospheric influences, pollution and man-made damages. Fortunately, in comparison with other monuments at Pula, these kinds of degradations and the threat they pose to the static stability of the monument are not worrisome.

These degradations can be included into two groups, i.e., those that are present everywhere on the monument on a grand scale, and those that are only sporadically present in some areas. The degradations present on a broad section of the monument's surface are: alveolization, gray patina, lichens (several types), vegetation, cement fillings and surfaces covered with recrystallized calcite. Present on a lesser scale are black incrustations, metal parts and stains.

Sl. 5 i 6 Herculova vrata danas - pročelje i stražnja strana
Fig. 5 and 6 Hercules' Gate at present. The façade and the back side.
