RAIL DEFECTS HEAD CHECKING ON THE SERBIAN RAILWAYS

Zdenka Popović, Ljiljana Brajović, Luka Lazarević, Leposava Milosavljević

Preliminary notes

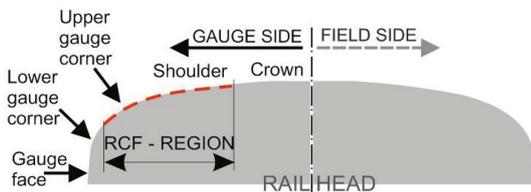
Subject of research in this paper are the HC rail defects on the Serbian Railways. HC appears by default on the outer rail in the curves of radius up to 3000 m. However, most frequently it occurs in the curves of the radius of up to 1500 m, on gauge shoulder and gauge corner. Defect is distinguished exclusively on tracks with a defined motion direction (for example, double track line). The coding system in accordance with the [4] is shown in Tab. 1. The position of HC rail defects on the outer rail head in a curve is shown in Fig. 1.

Figure 1 The characteristic RCF – region at the outer rail head in a curve [15]

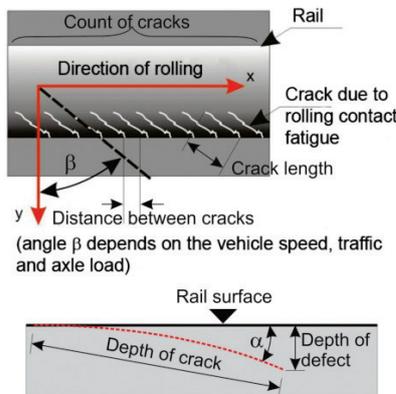
Figure 2 The typical orientation of HC fissures on the rail head [15]

The HC phenomenon is caused by lateral contact force and geometrical spin [11]. It occurs just below the upper surface of the rail head ($\leq 0,1$ mm), progresses rapidly upwards and reaches the upper head surface. Under the traffic load the cracks can be directed down with the risk of multiple rail fractures. The HC defect shows as fine, short, raked, surface fissures at more or less regular distance, which is usually $1 \div 7$ mm (but up to a few centimetres, depending on the rail steel quality). Surface fissures point out the fissures already exist below the surface, extending to certain depth and in certain direction inside the rail head. With increasing rail hardness the spacing between the cracks is reduced [5]. Orientation of HC cracks is shown in Fig. 2 [15]. It is especially dangerous when cracks run in very flat angles of approximately 15° into the rail head and the cracks distance is reduced to 0,5 mm. In this case multiple rail

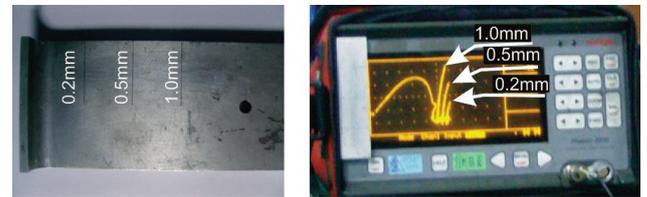
Figure 10 The steel template for the calibration of measurements

For calibration of EC signals the steel template with known crack depths (0,2 mm, 0,5 mm and 1,0 mm) was used (Fig. 10). EC signal amplitude depends only on the depth of the crack and EC signal can determine depth of the defect only approximately since the template steel and rail steel cannot have the same mechanical and electrical quality, homogeneity, roughness etc. Same signal gain (sensitivity) could not be used for the determination of different depth of defect sizes (Fig. 2, right). However, the amplitude is dependent of the crack spatial position on rail gauge, but independent of the crack spatial orientation.
