ASSESSMENT AND REPAIR OF THE BEARING STRUCTURE OF THE GRADISKA CULTURAL CENTRE AFTER FIRE

Vlastimir Radonjanin, Mirjana Malešev, Radomir Folić, Ivan Lukić

The paper briefly presents the specificity of evaluation and repair of fire-damaged reinforced concrete structures through one case study. Analysed building is the "Čubrilović" Cultural Center in Gradiška, Bosnia and Herzegovina, that was severely damaged by fire in 2005. Reinforced concrete structure as a classic skeletal structure stiffened with RC walls for seismic actions, was built with many defects which contributed to progressive appearance and spreading of damage characteristic for fire. Real condition of the structure was assessed on the basis of analyses of all field and laboratory test results. On the basis of control design of structure with increased imposed load and decreased concrete strength class it was identified that in certain structure elements there is a lack of built-in reinforcement and that the cross-sections of elements are insufficient. Repair solutions for the damaged structure elements due to the fire are briefly described and only characteristic repair details and a few original solutions for the s

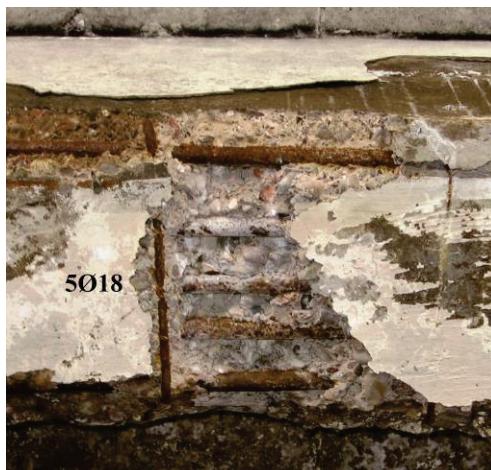
Figure 5 RC beam M/3-4' above the first floor

From technical design documentation on the building, only some graphical documentation was found, while the static calculation and details on reinforcement were not available during the survey of the object and preparing of the repair design. By checking the dimensions of characteristic elements of the structure, it was concluded that the bearing structure was done according to the available documents. Since there were no data about the reinforcement involved, its arrangement and amount in characteristic section of the structure elements was ascertained via chase cutting. Figs. 5 and 6 show the examples of reinforcement arrangement in the characteristic elements.

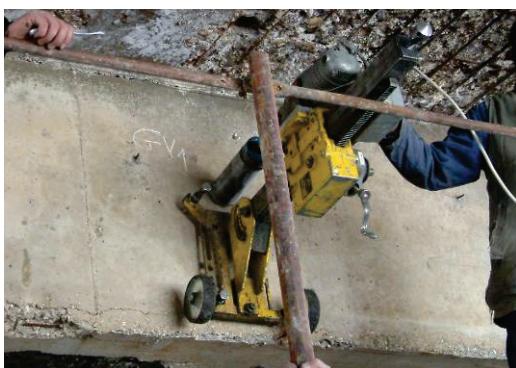
Figure 7 Core cutting drill (RC beam with long span $l=15$ m)

In order to ascertain the quality of the concrete used in the load bearing RC structure and to ascertain the thickness of the concrete damaged in the fire, 35 cores were taken out (24 cores from the part of the building caught by fire, and 11 from the part that did not burn). Cutting drill equipment and samples prepared for the testing are presented in Figs. 7 and 8. Testing results are presented in Tab. 1 (part of the building caught by fire is coloured).

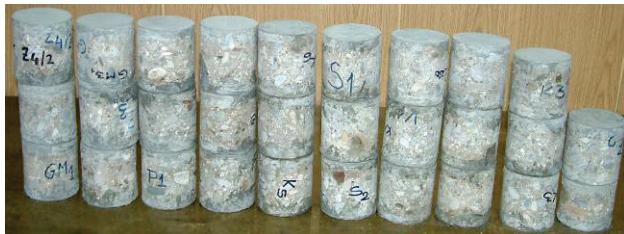
Figure 8 View of a part of cores, prepared for testing

- In both sets of the results there are large differences in individual strength, within a single element of the structure, which shows the variations in the concrete quality, which are primarily the consequence of internal defects in the concrete structure caused by poor adhesion of cement stone and large grains of aggregate (Fig. 9).
- Individual compressive strengths smaller than 20 MPa were gained on the concrete cores with defective and damaged structure.
- There is no significant difference in compressive strength between the part of the object being caught in the fire and the part that has not burned if cores with defective and damaged structure are excluded.
- All average values of concrete compressive strength in the part of the object that was caught by the fire are above 25 MPa, which proves that there is a "healthy" concrete core in the structure.

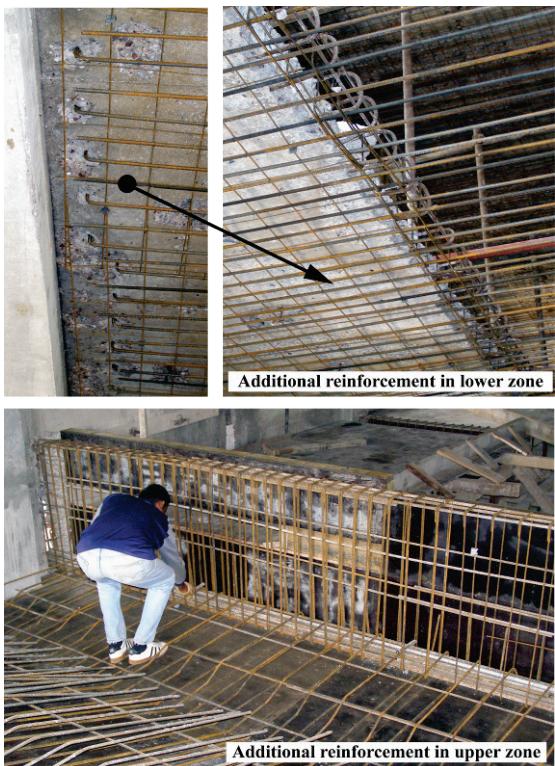
Figure 31 Extending and transforming the existing cantilever slab to one-way slab

- Reinforced concrete cantilever beam (POS G115a and POS G116a, $b/d=30/54$ cm), which supports the slabs of the small galleries. Fig. 30 shows the solution of connection between the newly-designed cantilever beam – POS G115a and the existing structure (beam POS G115 and RC wall Z104).
 - Reinforced concrete slab of the large gallery (POS P101, $d=16$ cm), by extending and transforming the existing cantilever slab to one-way slab (Fig. 31),
 - Reinforced concrete slabs of the small galleries (POS P116 and POS P117, $d=16$ cm).

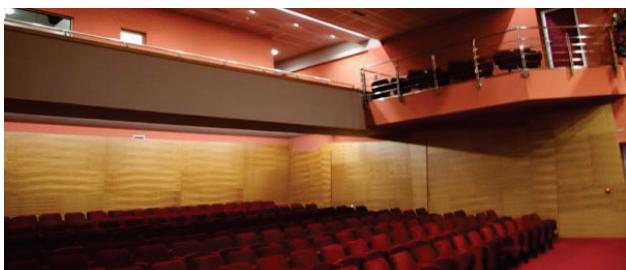
Figure 33 The look of extended large gallery and new small gallery

The repair work of the Cultural Centre was done by company "Arting Invest" from Gradiska and was successfully completed during 2007 (Figs. 33 and 34).

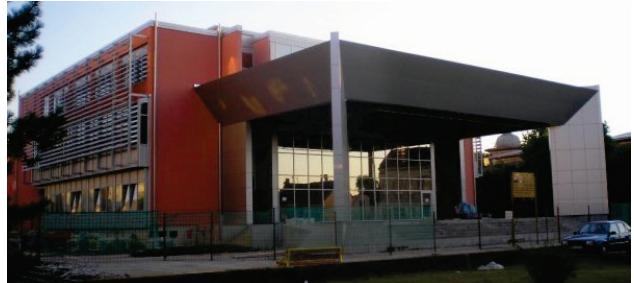
Figure 34 The appearance of the building facade after rehabilitation
