Structural assessment of traditional stone-timber houses in Turkey

Subject review

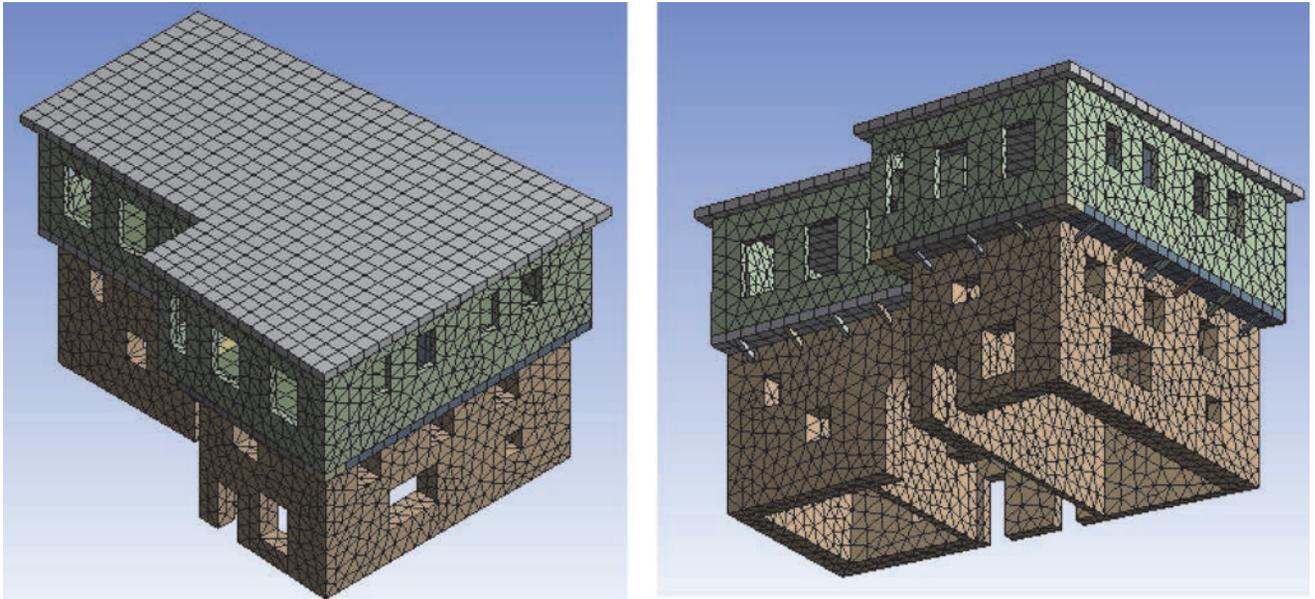
Figure 16. FEA of a typical traditional Şirince house

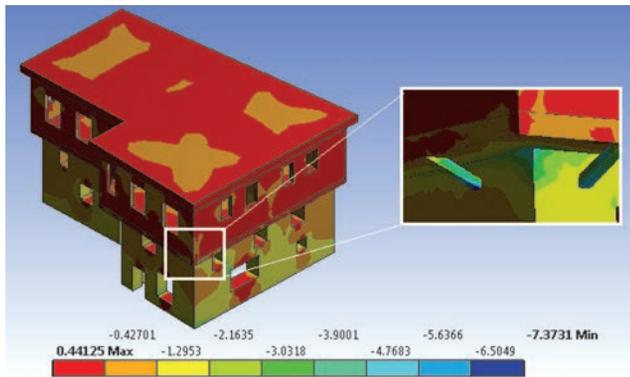
Masonry structures have large masses due to heavy construction materials. Dead loads consist of the fixed weight of structural members and the weight of any permanent fixtures attached to the structure (superimposed loads). Dead loads always remain on the structure and affect the structure throughout its lifetime. Furthermore, dead loads are static loads and these loads contribute to the stability of masonry structures [24, 16]. Thus, it is necessary to determine whether the structure is able to withstand the dead loads. Therefore, traditional Şirince houses were primarily analysed to define their load carrying capacity. Minimum principal stresses amount to about 7.373 MPa at the buttress timbers and they occur in the transition zone between the ground floor and the upper floor (Figure 17.). Maximum principal stresses amount to about 3.564 MPa and they occur above the top of the ground floor and at the upper floor façades. The maximum principal stresses also occur at the roof and at the edges of the windows (Figure 18.). Maximum displacements occur at the roof of the structure and amount to about 12.80 mm (Figure 19.).

Figure 17. Minimum principal stress contours (MPa)

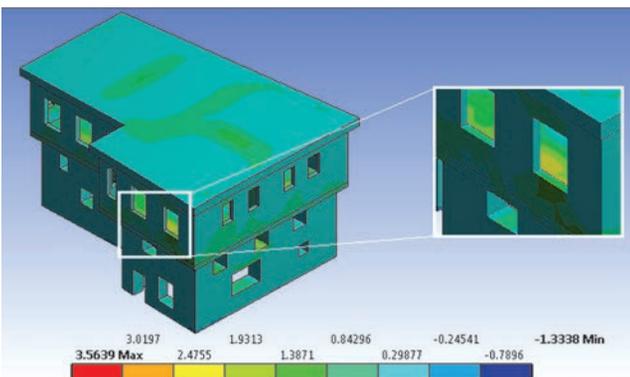
Figure 18. Maximum principal stress contours (MPa)

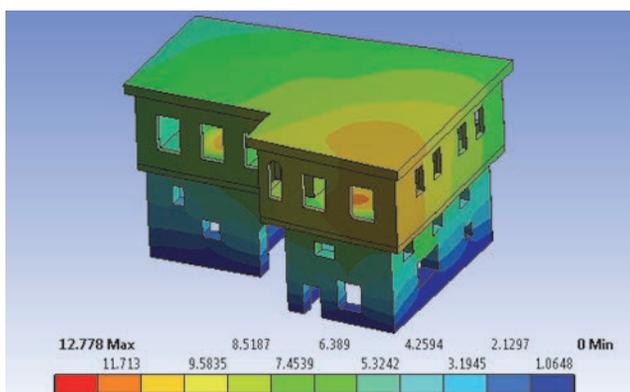
Figure 19. Maximum displacement contours (mm)

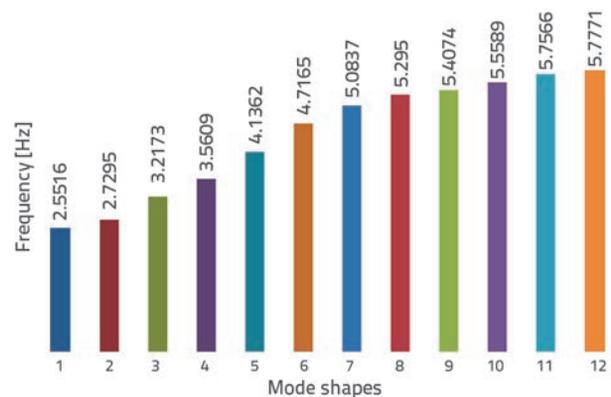
Modal analysis was conducted in order to determine fundamental mode shapes and natural frequencies of the structure during free vibration [16]. The purpose of modal analysis is to obtain the maximum response of the structure in each of its important modes, which are then summed up in an appropriate manner [25]. Modal analysis of the structure included different modes of vibrations in combination. The Square-Root-of-Sum-of-Squares (SRSS) method was considered for 12 modes. Natural frequencies obtained through modal analysis are summarized in Figure 20. Figure

Figure 20. Frequencies obtained by modal analysis

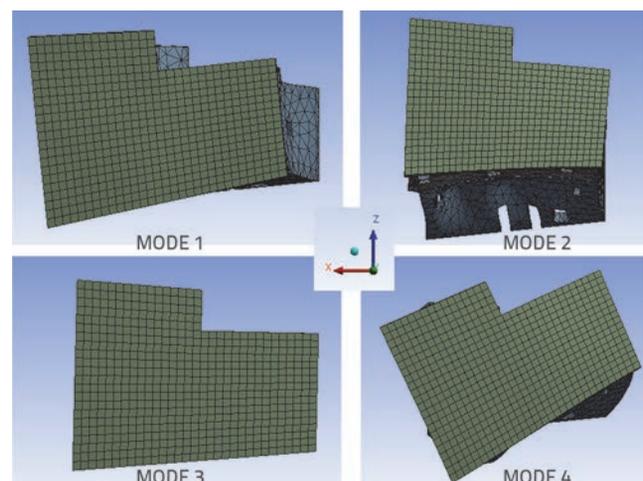
21 shows the mode shapes of the first four frequencies. According to modal analysis results, the first three modes occur as translational motions in x, z and y directions, respectively, and the fourth mode appears as the torsional motion only. Furthermore, all frequencies are below 5 Hz. The first frequency is close to 2.5 Hz which shows that the structure is adequately rigid in terms of seismic demand but, according to modal analysis results, the transition zone between the floors is the most precarious part of the structure.

Figure 21. First four mode shapes and directions of the structure

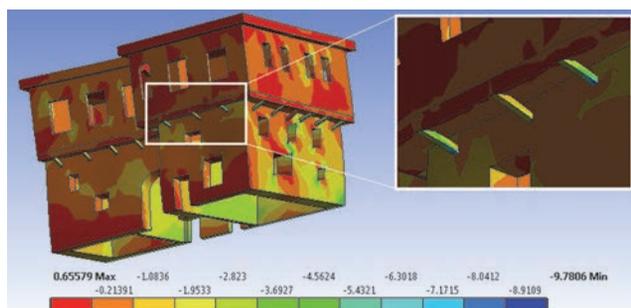
The obtained maximum compression stresses are significantly more intense at lower parts of the structure during the earthquake. Maximum compression stress contours for the structure are shown in Figure 23. As can be seen in this figure, maximum compression stresses amount to about 9.78 MPa around and below of the entrance gates and buttress support. Minimum principal stress contours for the structure are shown in Figure 24.

Figure 23. Minimum principal stress contours (MPa)
