# VERIFICATION OF THE MATERIAL PROPERTIES OF THE STRUCTURE ELEMENTS OF COMPRESSOR STATION FOR THE NEEDS OF THEIR REDESIGN

This paper discusses the importance and complexity prediction of fatigue life in connection with reconstruction or rebuilding of compressor station and in connection with degradation of material and change of its static and fatigue mechanical characteristics. The subject of the research is the piping ring, which was removed above a T-module of a turbocompressor of compressor station. The paper brings partial results of testing and analysis of the macrostructure and mechanical properties of the base material and the material in the weld area of removed piping ring.

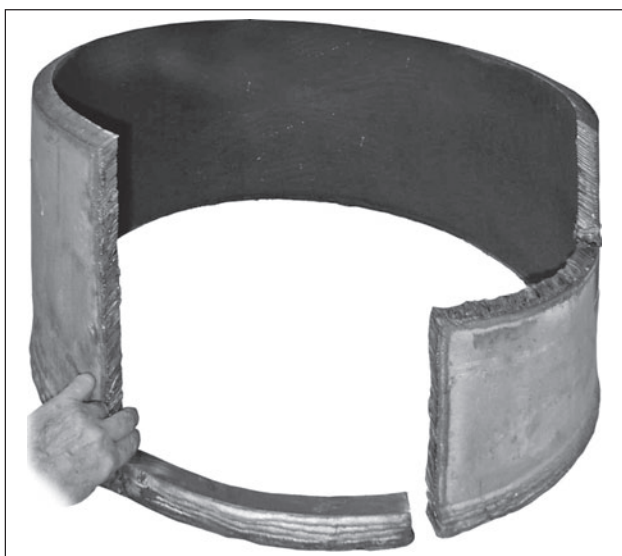
Figure 2 Piping part as source of specimens used in material tests

Mechanical properties and analysis of used construction material were determined by tests on corresponding specimens. These were acquired from a pipe section 720 x 22,2 mm, as shown in Figure 2. The piping ring was removed above a T-module ring – an inter-pressure turn to a turbocompressor, as shown in Figure 3.

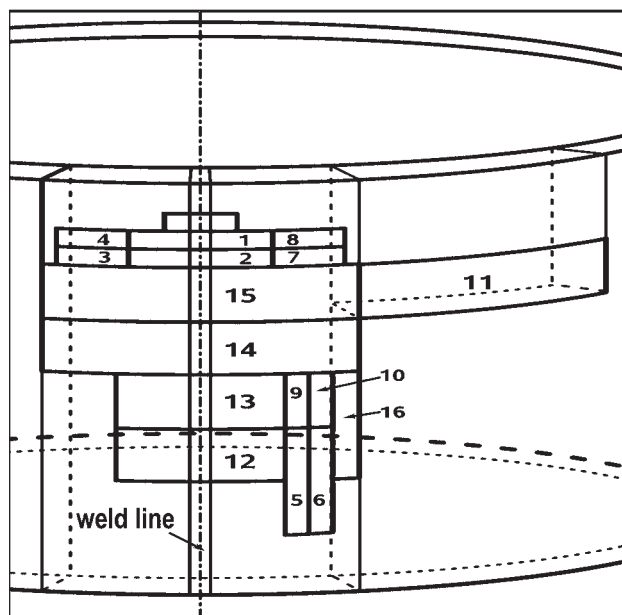
Figure 4 Identification of location of the specimens used in individual material tests

Sampling was done so that quantitative data about the properties of base material, material of welding metal and transition area of the weld could be determined. Figure 4 illustrates the identification of location of the specimens used in individual material tests. Performed were static tensile tests of the welding joint in direction perpendicular to the pipe axis and of the base material in direction perpendicular as well as parallel with the pipe axis. In addition, dynamic tests by impact in bending with type Charpy V notch, tests of fatigue properties in tension and bending of the base material and the welding joint.

For the fatigue properties tests specimens were removed from the detached ring from location 11 and specimens containing weld from locations 12, 13 for test by flat bending and from locations 14 and 15 for tensile tests (Figure 4). Shape and size of the test specimens were selected so that the transition area of the weld was located in the thinnest part of the specimen. Tests were performed on a testing pulsator, which allowed dynamic tests during alternating symmetrical bending at loading up to 400 Nm. In first stage of the tests stress amplitudes  $\sigma_a = 240$  MPa were selected. In this mode, specimens remained undisturbed even at  $2,6 \times 10^6$  cycles. In second stage, the amplitude was increased to level  $\sigma_a = 450$  MPa, which for given material already represents an area of low-cycle fatigue. Specimens failure occurred at level  $8 \times 10^3$  cycles, with the shape of fatigue fracture according to Figure 6. Fatigue crack initiated at the edge of the test specimen according to Figure 7, in location of welding joint imperfection. Nature of the fracture line is illustrated on Figure 8

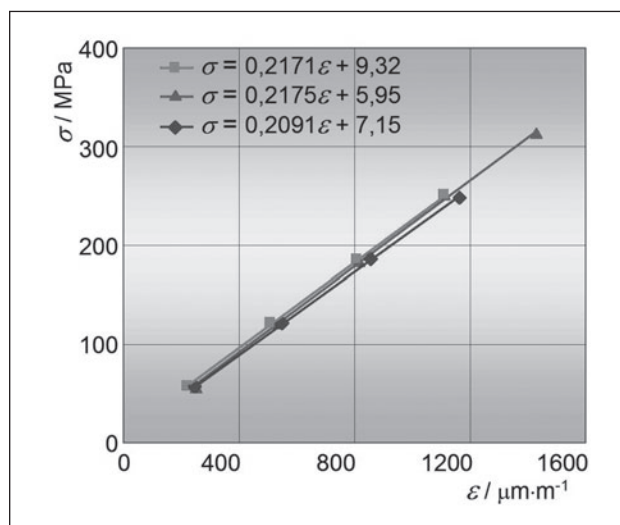
Figure 5 Experimentally acquired relationships for determination of modulus of elasticity E of the piping material

Results of the tests for modulus of elasticity are shown in Figure 5. These were acquired by experimental measurement using strain gages and testing machine

on a specimen similar to the one used in tensile test, removed from the ring in location 16 (Figure 4).
