# RELIABILITY, CONDITION DIAGNOSTICS AND RECONSTRUCTION OF THE EXTREMELY DAMAGED BUILDING

**Slobodan Grković, Danijel Kukaras, Petar Santrač, Viktorija Aladžić, Željko Bajić**

Subject review

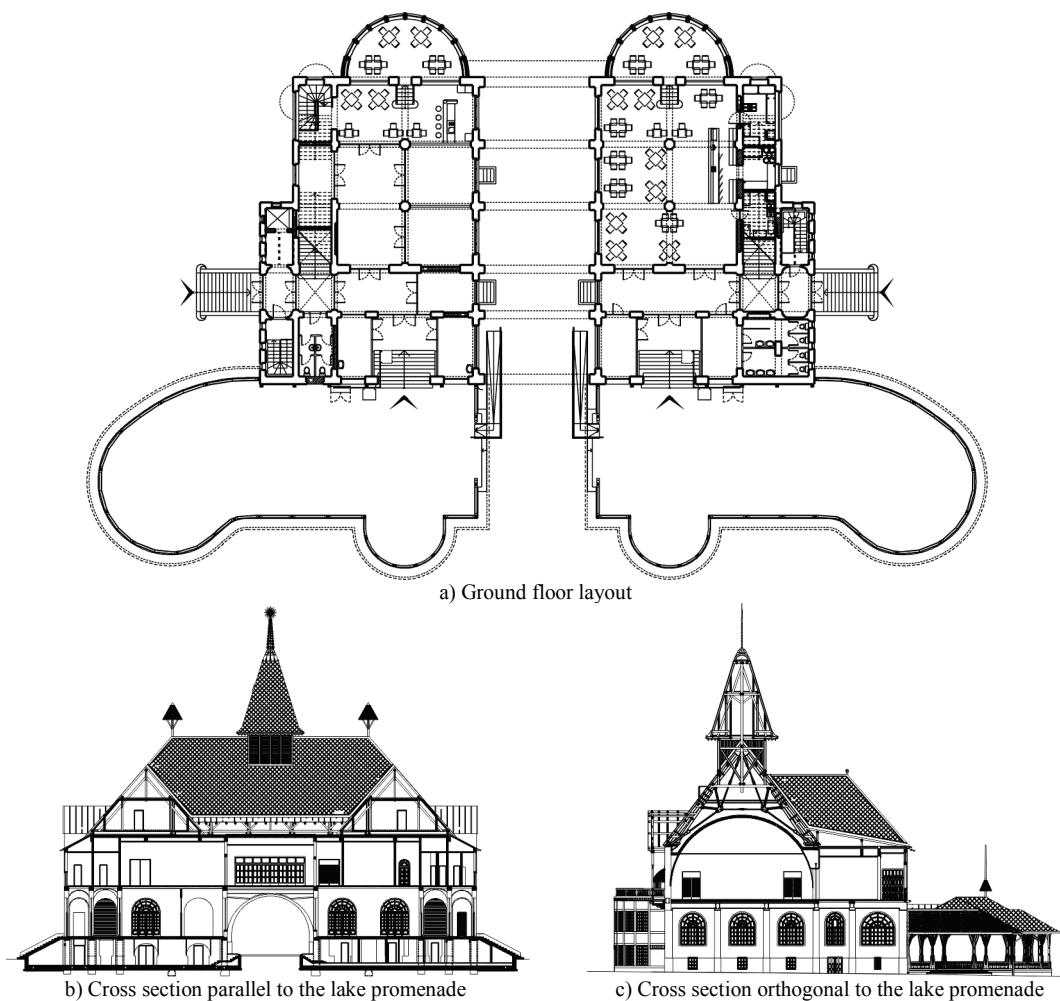
Figure 6 Technical drawings – layout and cross sections

According to diagnosed condition of the structure and Investors demand among other, plans for reconstruction and repair of the structure were completed in the forms of preliminary designs, main designs and detailed construction designs and plans, (Fig. 6) [4, 5]. Static and dynamic analysis were conducted for all structures and structural elements including seismic resistance analysis according to current stricter code demands that place this building into 8<sup>th</sup> seismicity zone. Design plans include also strengthening and replacements of parts of existing structure in order to meet the seismic resistance demands and possible increase in live loads, all in an effort to improve the reliability of the structure. In accordance with available financial means, interventions were conducted in two phases: Phase I - reconstruction and repair of the roof and Phase II - reconstruction, repair, strengthening and/or replacement of the rest of the structure [4, 5, 17].

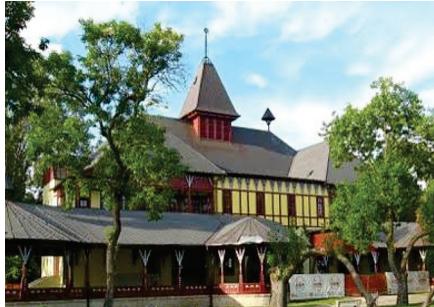
Figure 10 Appearance of the building after completion of reconstruction and restoration

Cultural Monuments of the Autonomous Province of Vojvodina. These requirements demanded that final appearance of the building be an exact match to an original one and they were completely fulfilled. Reconstructed, repaired and restored building was officially opened in a ceremony on September 1<sup>st</sup> 2012 - one hundred years after its first construction (Fig. 10).
