**INVESTIGATION OF REASONS AND POSSIBILITY OF PARAMETERS ELIMINATION
INFLUENCING CRACKING OF LEAF SPRINGS ON CONTINUOUS CASTING MACHINE**Received - Priljeno: 2006-04-20
Accepted - Prihvaćeno: 2007-04-15
Preliminary Note - Prethodno priopćenje

At the first look very simple and for several hundred years used elastic element can be critical part in complex equipment where its failure invokes extraordinary high losses. In the paper is given a treatment for the solution of this problem by experimental methods and resulting proposal for its final solution.

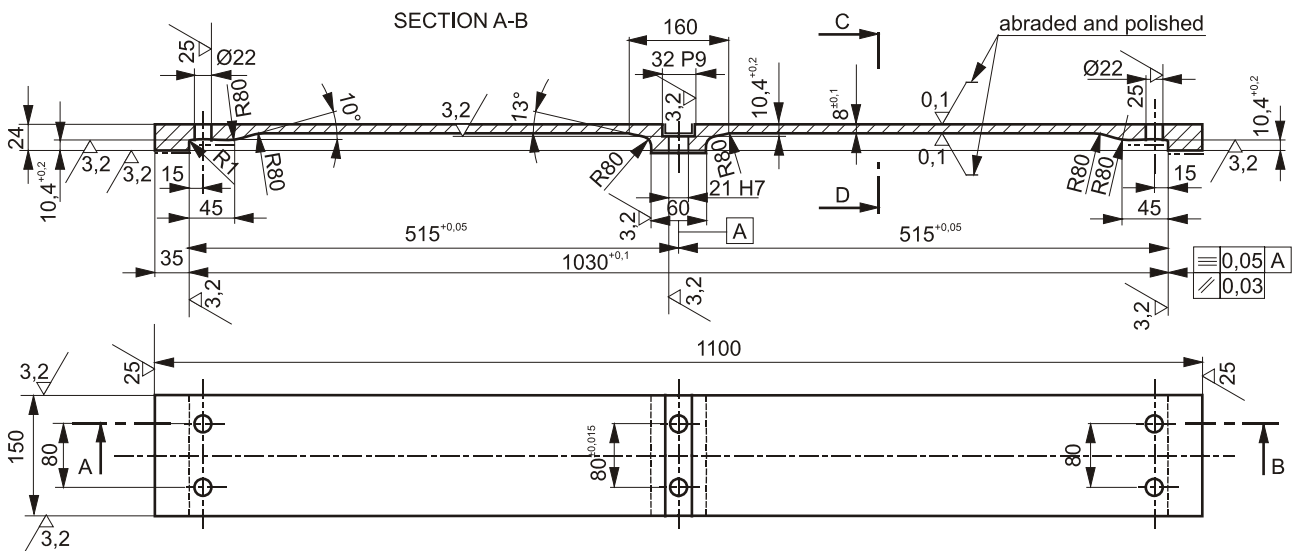
Figure 1. Shape and dimensions of leaf spring
Slika 1. Oblik i dimenzije lisnate opruge

The vibration mechanism is equipped by two leaf springs (Figure 1.) that transfer forces between moving and stationary parts of vibration mechanism. During operation premature failures of leaf springs occur. The number of spring damages is different on two continuous casting machines that are in operation. Slope angle of leaf springs to the horizontal plane is $4,574^\circ$ and $5,71^\circ$, respectively and the maximal vertical deflection (2,95 mm in the middle of spring - location S) is ensured by eccentric shafts.

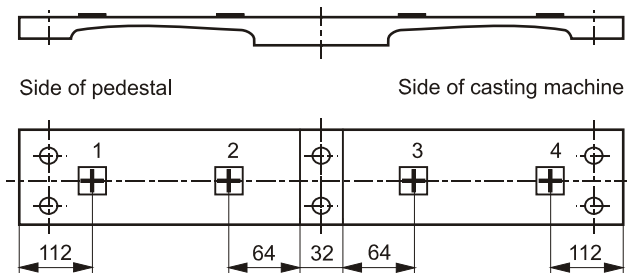
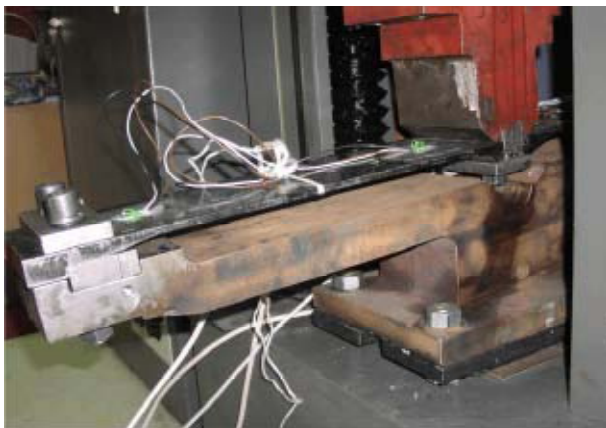
Figure 3. Leaf spring with applied strain gages in tensile machine
Slika 3. Lisnata opruga s primijenjenim tenzometrom u stroju za mjerenje otpora na istezanje

Strain gage measurements of stresses in leaf spring were realized for fastened spring ends and prescribed vertical deformation of leaf spring in tensile machine. In

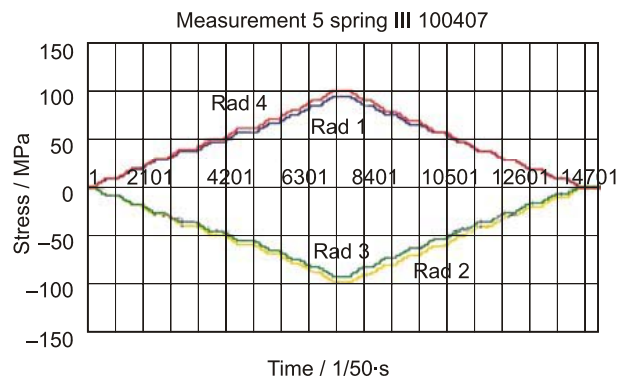
Figure 4. Time-dependent chart of stresses in locations 1, 2, 3, 4
Slika 4. Vremenski ovisni dijagram napreznja na lokacijama 1, 2, 3, 4

Leaf spring was freely placed on holding fixture and the chucking wedges were completely free. The bolts on the ends of leaf spring were completely free too. After movement of traverse of the tensile machine to the neighborhood of leaf spring and after equilibrating of strain gage apparatus the measurement began. The records in figures from individual measurements represent stress levels in axial direction of leaf spring in locations 1 to 4 (Figure 4.). The steps

correspond to the change of deflection by 0,5 mm. The measurement was provided during loading as well as unloading.

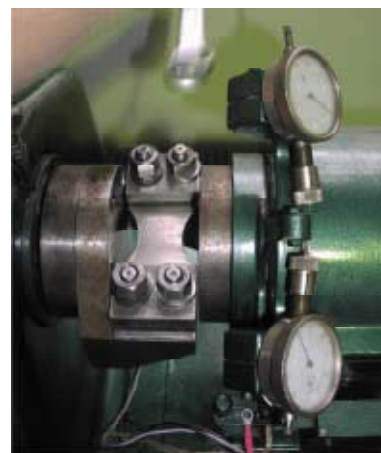
Figure 12. Fixation of test specimen in test machine PWY
Slika 12. Fiksacija testnog uzorka na testnom stroju PWY

Fatigue limit mentioned above is given for the specimen with polished surface. That is the reason why boundary specimen was after its fixation in testing machine (Figure 12.) loaded by symmetrical bending with amplitude of stress that corresponds to the fatigue limit for symmetrical bending. After $2,6786 \cdot 10^6$ cycles was clearly demonstrated that fatigue limit of this material exceeds this value. Further were increased the stress amplitudes and after certain number of cycles for the defined amplitudes was the specimen damaged.
