FAILURE ANALYSIS OF BOLTED JOINT FOR THE COLUMN OF AN AERIAL PLATFORM

Original scientific paper

This paper focuses on the identification of failure causes of a bolted joint used for the bedding of a primary column of an aerial platform. The tests conducted to determine chemical composition and mechanical properties have confirmed the 12.9 grade of the bolts. Also, mechanical properties tests and metallographic examination did not indicate any hidden defects caused by heat treatment (e.g. decarburisation etc.). On the other hand, visual and metallographic examination of cross-section as well as electron microscope scanning confirmed fatigue fracture of the bolts. Therefore, further analyses were done to check the dimensioning and the installation of the bolts. The effects on stress states in the bolts are presented from the standpoint of rated operating regimes, stiffness of joined elements, lubrication conditions of thread surfaces and temperature incompatibility between the bolts and elements being joined. Pre-tightening torque value incompatible with lubrication conditions was found to be the main factor that led to high stress values that initiated and later intensified the fa

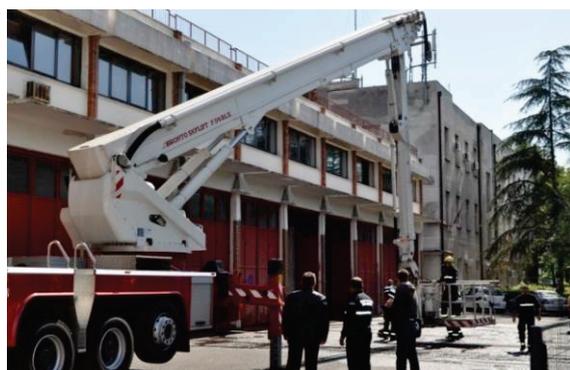
Figure 1 Subject platform

Aerial platform operating conditions and working principle define operating regimes characterised by distinct stochastic nature regarding the level and the nature of loads on whole construction [1]. Fig. 1 shows subject platform and Fig. 2 shows problematic bolted joint.

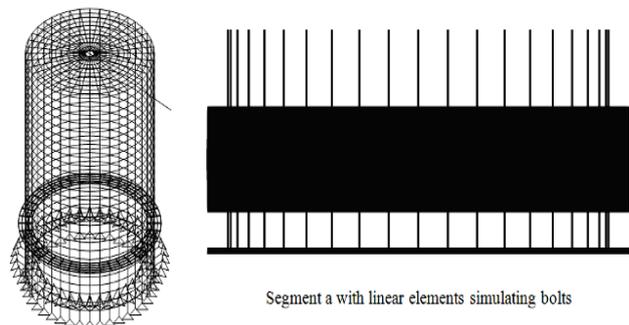
Figure 11 Formed discrete computational model

Rated operating conditions of the subject platform were determined by using bending moment $M = 530$ kN·m, whereas basic properties of formed discrete computational model can be seen in Fig. 11.

Based on obtained loads, stress caused by rated functional operating loads equals 156 MPa, which is 13 % of bolt material yield strength ($R_e = 1200$ MPa). Besides,

the effect of stiffness of elements in the bolted joint on stress states of the bolts is practically negligible and equals 2 % of the effect of maximum operating load, which is about 0,2 % compared to material performance.
