Antun Mikulecky
Končar - Electrical Engineering Institute
amikul@koncar-institut.hr

TRANSFORMER BUSHINGS – FAILURE CASE STUDIES

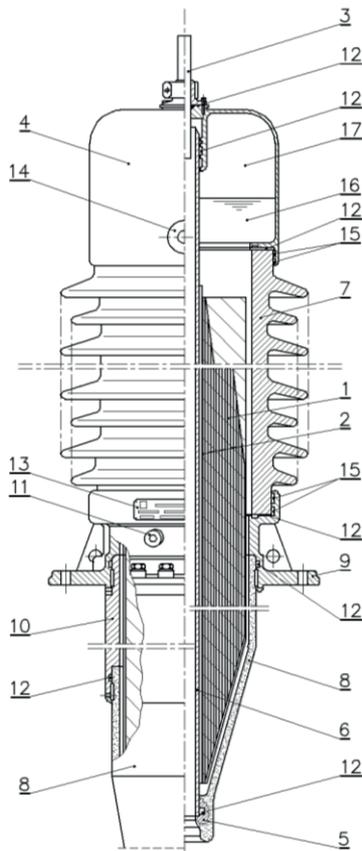
Figure 1: Drawing of the oil – air OIP type bushing

Thermal image scanning of the 250 MVA, 220 kV, 16 years old, GSU transformer in 2002 showed increased heating of the 245 kV bushing head and connection (positions 3 and 4, Figure 1) relative to a healthy bushing, approximately by 60 K. Measurement of the HV Winding resistance showed an increase of 0,87 % in the respective phase therefore indicating the cause of poor contact on the tulip contacts (pos. 3, Figure 1) between the connection and the bolt at the end of the copper cable, Figure 6. Inspection of the HV connection showed traces of metal melting on the tulip contacts and copper transfer from the bolt to the aluminum connection. This incipient failure was eliminated by replacing the tulip contacts spring part, since its weakening is the most probable cause of increased heating, and by cleaning contact surfaces. Owing to the availability of spare parts as well as to detection of the malfunction in the initial stage, repairs took only two days.

A failure of a 150 MVA autotransformer, approximately 30 years old, occurred in the spring of 2003. No special indications pointing to the failure mode were visible on the outside. Inspection of the disassembled RBP type bushing showed a burst of the bushing condenser body lower part (pos. 1 in Fig.1), approximately 0,5 m long, Figure 8. The transformer and, especially, the area around the 220 kV winding lead was intensely polluted by the bushing fragments, carbonized insulation and electrodes. Diagnostic tests of the bushing had been undertaken almost eighteen years prior to the failure but there had been no indication of the problem. The connection to the switchyard was flexible, by rope. The cause
