Danijel Brezak  
Končar - Electrical Engineering Institute Inc.  
[dbrezak@koncar-institut.hr](mailto:dbrezak@koncar-institut.hr)

Dalibor Filipović-Grčić  
Končar - Electrical Engineering Institute Inc.  
[dfilipovic@koncar-institut.hr](mailto:dfilipovic@koncar-institut.hr)

## ULTRASONIC METHOD FOR TESTING OF POWER TRANSFORMERS

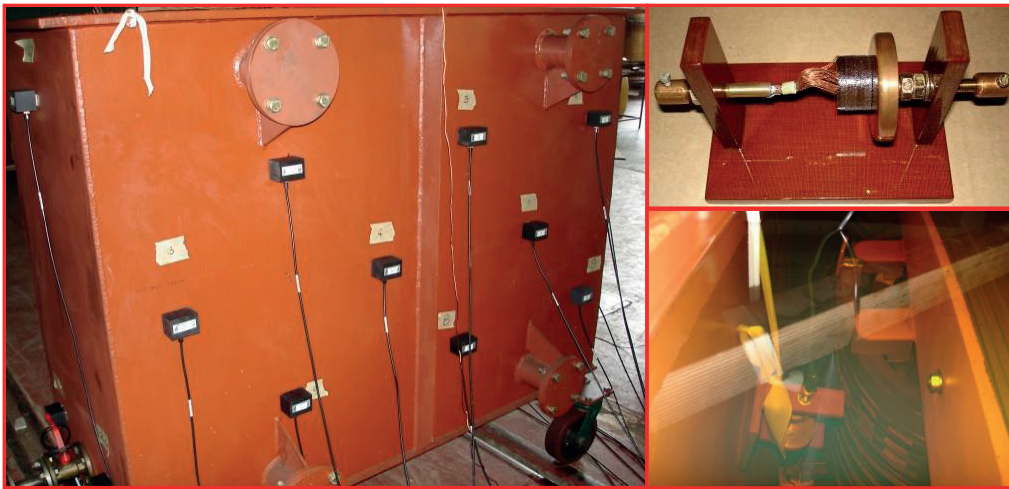
**Figure 2. Sensor placement (left), PD source (right up) and its placement in the tank (right down).**

Implementation of the method was performed in High Voltage laboratory of Končar-Electrical Engineering Institute. Source of PD (figure 2) was placed in a tank of a transformer model, 5 MVA, with dimensions 1,7x1,2x0,7 m. The measurement was performed with de-energized transformer, and the voltage was applied only to the PD source. Parallel to the acoustic method an electric method for PD measurement was used.

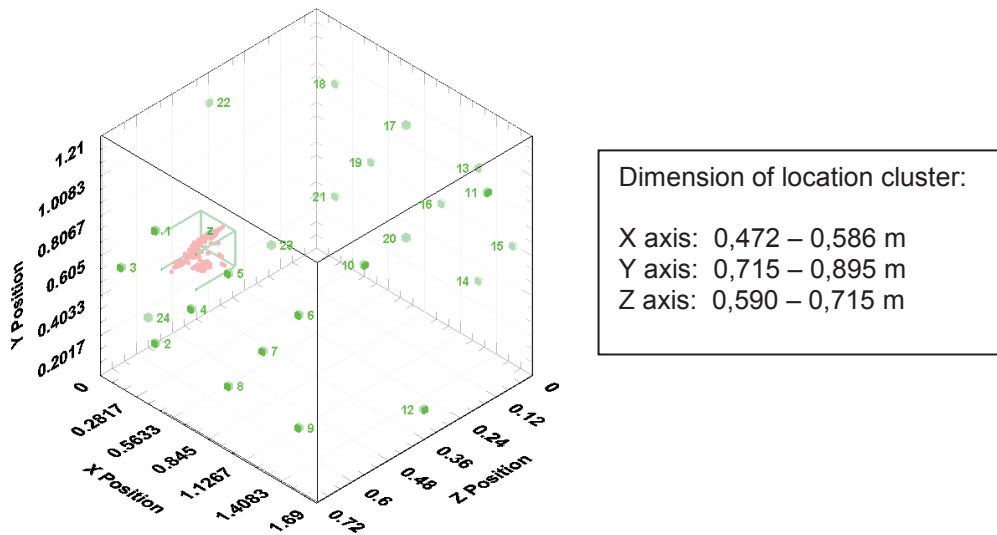
**Figure 3. Cluster location at 500 pC**

With the level of 500 pC, system detected a possible location of PD (figure 3). The cluster with the highest density of detected locations is bounded in the green box. Green dots represent the locations of the sensor and the red dots detected locations. It is necessary to note that the dimensions of the axis are not in the same ratio (the system gives a 3D layout as a cube).

The actual location of the PD source was at: X= 0,530 m , Y= 0,810 m, Z= 0,690 m.

The deviation of the detected location from the actual location of the PD source is within  $\pm 0,1$  m. The system was tested to determine the lowest PD level at which it gives a satisfactory precision. Sistem was tested at 100, 900, 700, 500, 70 and 50 pC. It was determined that the system still shows a correct location of the source at 70 pC while at 50 pC the locations are more dispersed, but even then the system still detects the existence of PD. (Figure 4).

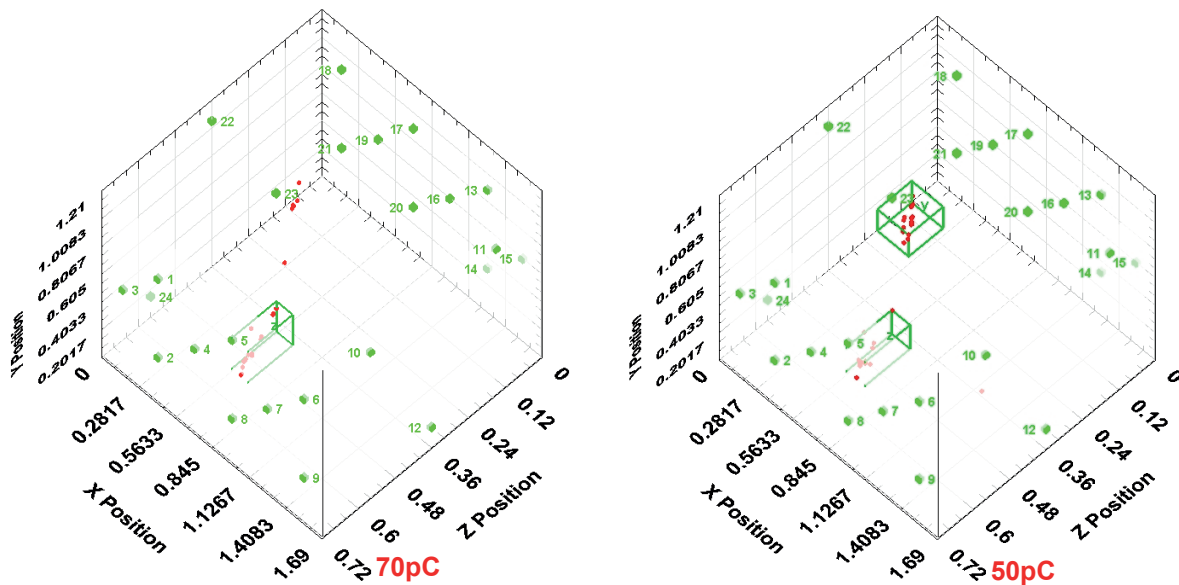
Figure 4. Location clusters at 70 and 50 pC

Even though the method detects such small levels of PD, it is an artificially generated source with a de-energized transformer. On-site it is highly unlikely to detect discharges of such small level due to surrounding interference as well as interference from the transformer itself.

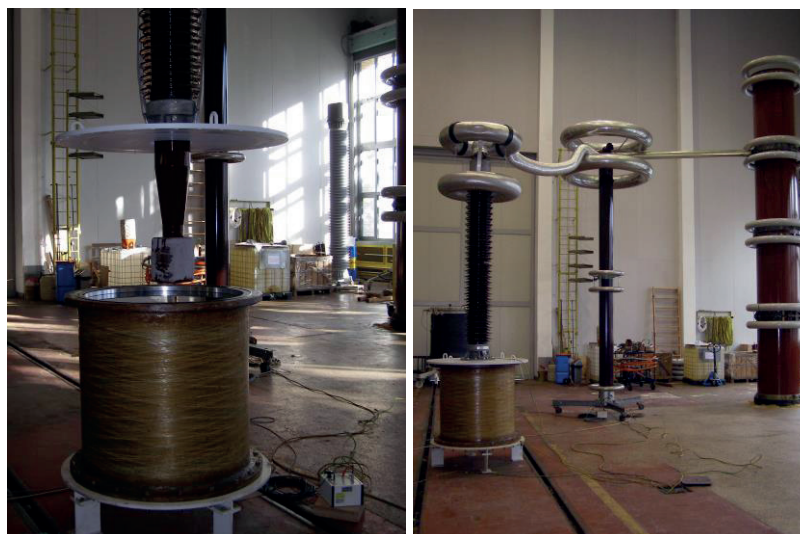
**Figure 11. Screen electrode test setup**

Therefore a laboratory test was initiated. A test setup was assembled to produce the same electric field strength as in-service (figure 11). Several end shields were tested using an electric method and ultrasonic method simultaneously.

Four sensors were placed at the bottom of the test tank. One of the end shields (screen 1, figure 12) showed high PD-s but with very low acoustic activity. This activity is within the range of surrounding noise of an on-site test.

As it is showed on figures 12 and 13, test of screen no. 1 showed very low acoustic activity even when PD levels were above 1000 pC.
