AN ASPECT OF TRANSFORMER INRUSH CURRENT

SUMMARY

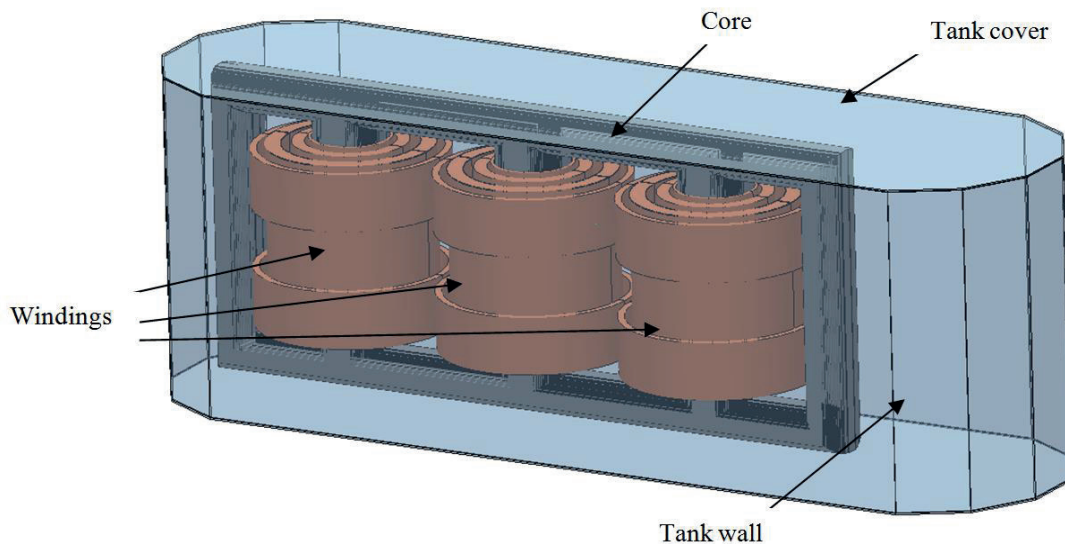
Figure 3 – 3D transformer model used in analysis

Considered three-phase 3/2 transformer model includes three basic parts; winding, core and tank (Figure 3). Tank is divided into two parts: the cover and the wall. These two parts are electrically connected only by a copper connection (jumper) and by another "test jumper" with a variable DC resistance. In order to approximate saturated conditions in the core, relative core permeability is substantially reduced to values equal or less than $\mu_r=100$. Winding currents are given with their rated values. Model is solved in time-harmonic (quasi-stationary) sinusoidal domain in order to avoid computationally expensive time "step-by-step" (transient) calculation method.

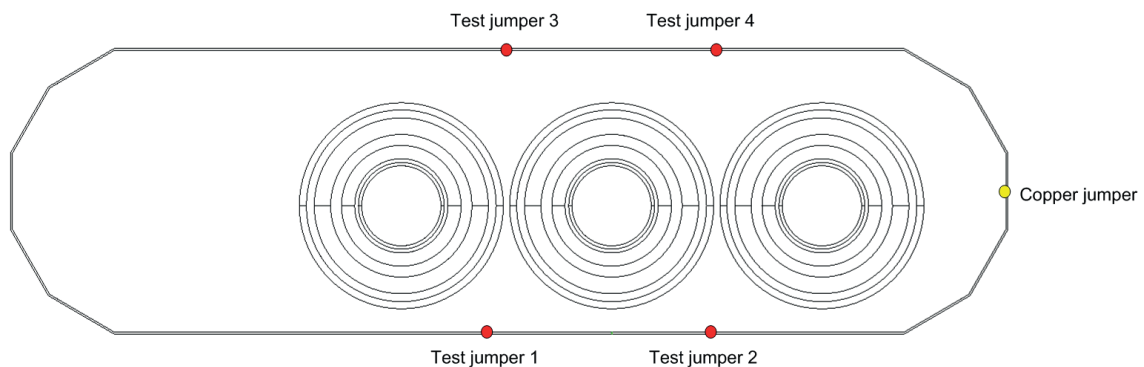
Figure 4 – Positions of test jumpers and copper jumper

Test jumpers are placed at four different positions connecting the tank wall and cover. DC resistance of test jumpers is changed in order to observe values of currents passing through the jumper and evaluate voltage between the wall and cover at various positions. In the meantime the copper jumper has a fixed position as shown in Figure 4.
