ABSTRACT

Condenser bushings condition monitoring

9. Case study of a 245 kV bushing failure at the 220 kV substation

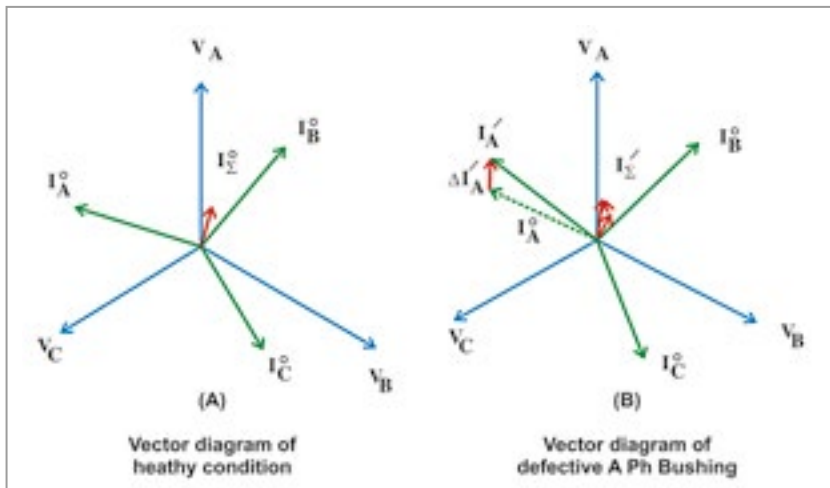
Figure 6. A phasor diagram showing drifted location of the current vector with reference to the voltage vector of the A phase, indicating deterioration of insulation of the A phase bushing in (B)

The voltages in a three-phase transformer are assumed to be almost equal and to have a phase displacement of 120° between them sequentially. The bushings of these transformers are considered to have almost equal insulation level. Since insulation is capacitive in nature, with the application of the three-phase balanced voltage the leakage capacitive currents will flow between the respective phase and the ground through capacitances C_1 , leading the applied driving voltage by little less than 90° , but maintaining the phase displacement of three phase balanced voltage. The vector sum of all three capacitive leakage currents should be zero ideally, considering them equal in magnitude and angle of displacement (which is 120° between them sequentially). However, in practice, the vector sum of the leakage capacitive current will not be zero, but a very small value making a very small angle, for example with the A phase voltage phasor, Fig. 6 (a red coloured phasor).

The resistive current component is in phase with the driving voltage, while the total resultant current through the capacitance of the bushing is leading the driving voltage by the angle θ less than 90° (i.e. the resultant current is lagging the original capacitive current vector by the angle δ). Thus, the $\tan \delta$ is the dielectric dissipation factor of the A phase bushing, which means that the vector sum of the capacitive currents of all three phases will deviate from the original value having a slightly increased value, Fig. 6(b) (red coloured increased vector).

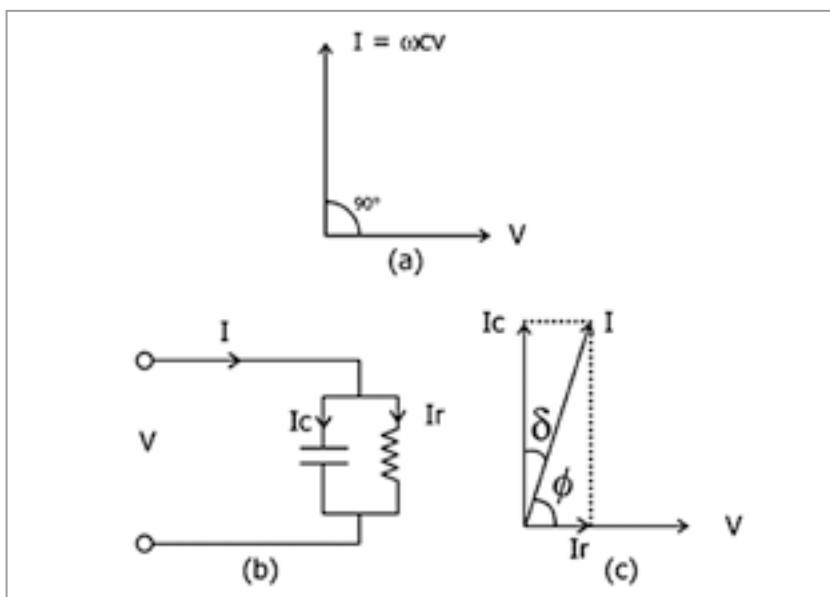
Figure 7. The loss angle shown ($\delta = 90 - \phi$) developed as the angle between the phasors I_c and I : (a) current leading voltage in a capacitor; (b) moisture and other impurities offer parallel resistance and I gets two parallel paths, being divided into I_c and I_r ; (c) vector diagram of the circuit in (b) wherein $\delta = 90 - \phi$ is called loss angle; (d) $\tan \delta = I_r / I_c$

The deterioration of insulation means an increase in the resistive component (i.e. contaminant/impurity) in the bushing, making the resistive current flow in parallel to the capacitive current, Fig. 7.

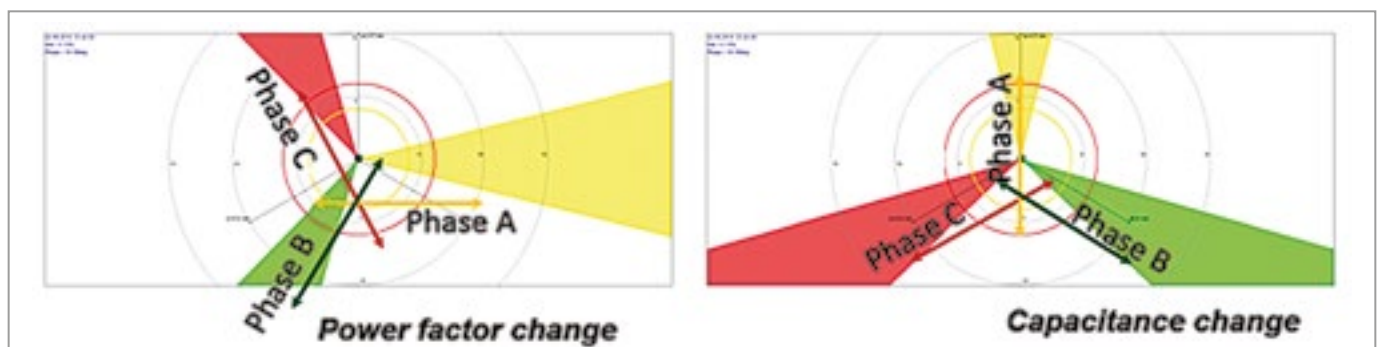
- Data storage period: five years on an hourly basis
- Self-diagnostic feature
- Change in PF and capacitances: change in A phase can be detected, as shown in yellow on polar diagrams in Fig. 9

Figure 9. Phasor diagrams showing change in PF and capacitance
