Krško NPP Experience with RTD Bypass Elimination

Gordan Janković

Nuclear Power Plant Krško
Vrbina 12, 8270 Krško, Slovenia
gordan.jankovic@nek.si

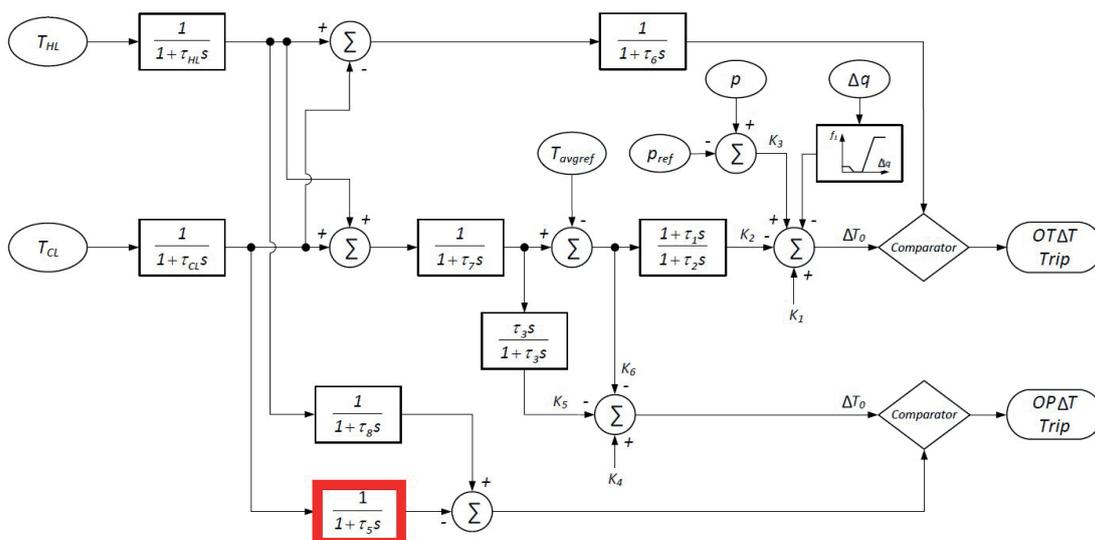
Figure 12: OPΔT/OTΔT trip function diagram after Tcold filter change (in red)

The most complex contributing cause to address was OPΔT protection change that would remain efficient for the mitigation of design accidents and not be over-sensitive to short-term signal disturbances. A sensitivity study [10] was performed where a series of Tcold lead/lag or lag-only filters were compared with magnitude of the Tcold signal disturbance they can filter out without generating a trip signal, and compared with the departure from nucleate boiling ration (DNBR) they still attain (as a measure of reactor protection efficiency). This showed that the implemented aggressive Tcold lead/lag filtering was very conservative and that DNBR margin remains with lag filter on the Tcold signal, while it offered maximum disturbance rejection. Based on this conclusion, Tcold lead/lag filter was replaced with lag-only filter.

The time constant reduction on That signal lag filter did not make significant impact to DNBR for affected accident analyses, so it remained unchanged to keep the filtering capacity of possible That fluctuations (That indications have been very steady since RTDBE). Accident analyses in which OPΔT is actually actuated were impacted and had to be repeated. Those are Hot Full Power Steam Line Break and Decrease in Feedwater Temperature.
