The preliminary inventory of coseismic ground failures related to December 2020 – January 2021 Petrinja earthquake series

The most recent major earthquake series struck near Petrinja (December 29th 2020 M 6.2), and triggered extensive ground failures in the wider area of Petrinja, Sisak and Glina. Coseismic ground failures including subsidence dolines, liquefaction and landslides have been documented over a large area by various experts and teams. These data are stored in the newly created inventory, which is openly presented in this paper. This inventory is administered and updated by the Croatian Geological Survey, and will be available online via a Web Map Service (WMS) (www.hgi-cgs.hr). The aim of the inventory is to not only provide data for the development of susceptibility maps and more detailed exploration for possible remediation measures, but also to define the priorities for immediate action. The earthquake triggered the rapid development of dropout dolines which endanger the local populations of the villages of Mečenčani and Borojevići. This is still an ongoing process in the vicinity of the houses and therefore in-situ exploration started immediately. Liquefaction rel

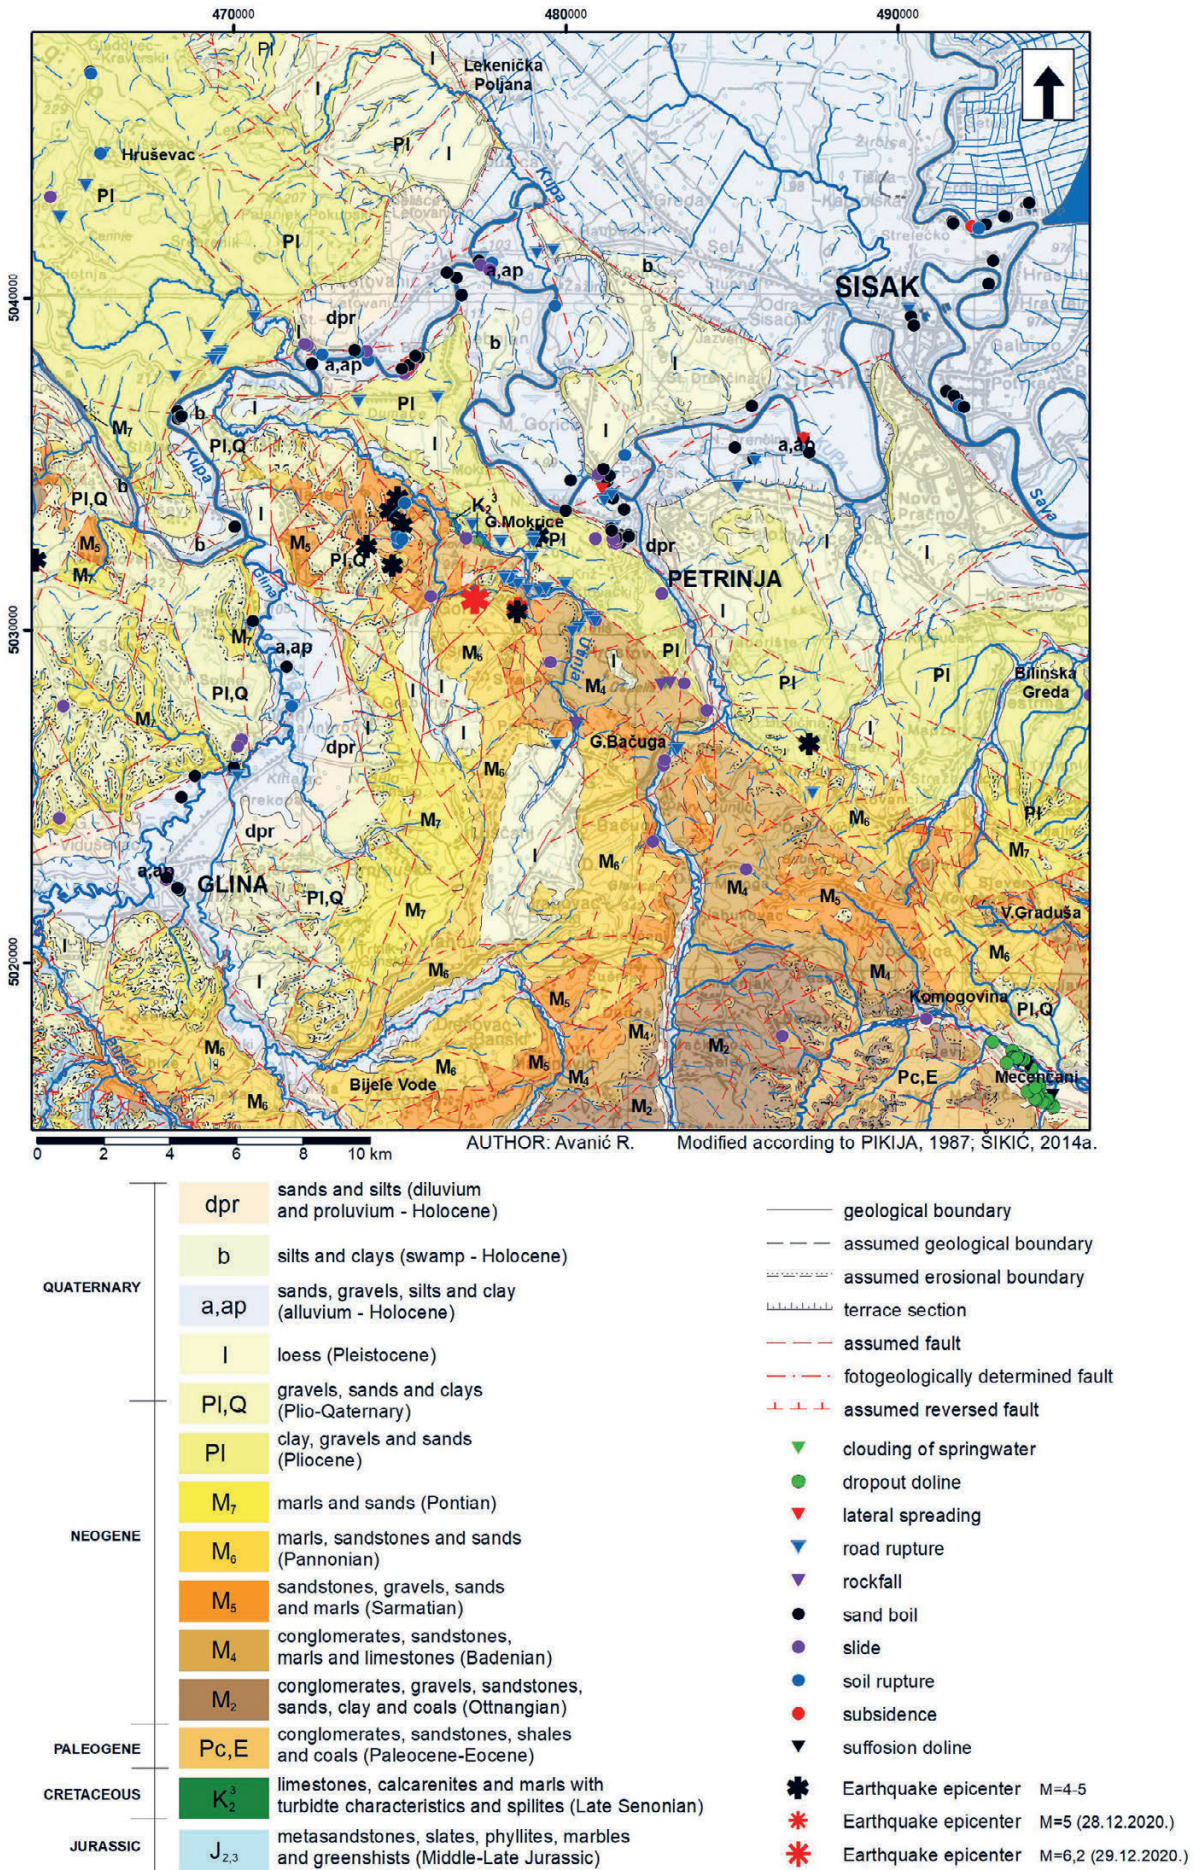
Figure 2. The geological map of the research area (originally in the scale 1:100,000) with the locations of ground failures.

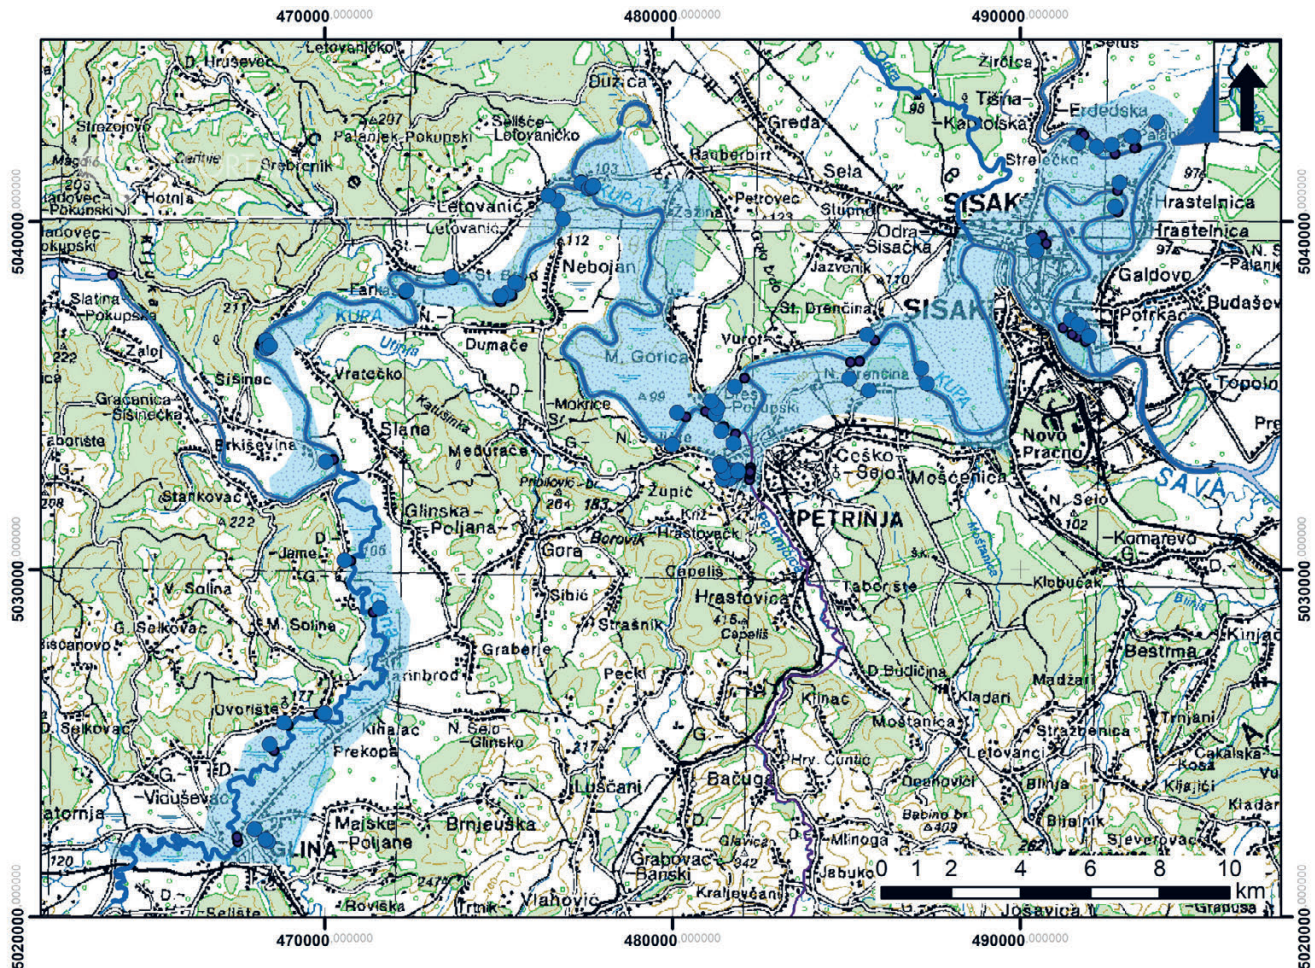
Considering all the collected data in the research area, favourable conditions for liquefaction are related to the Sava, Kupa and Glina alluvium or floodplain sediments which, according to rough and preliminary estimations cover more than 100 km² (Figure 13). The presented map is based solely on current database records and existing geological data at the scale of 1:100.000 and should be considered as a rough estimation. Detailed studies are needed in order to define liquefaction susceptibility zones and mitigation measures.

Figure 13. Rough and preliminary estimations of the area with favourable conditions for liquefaction processes (shaded blue). The estimation is based on recent surface processes caused by liquefaction (blue dots) and existing Basic Geological Map in the scale 1: 100.000.

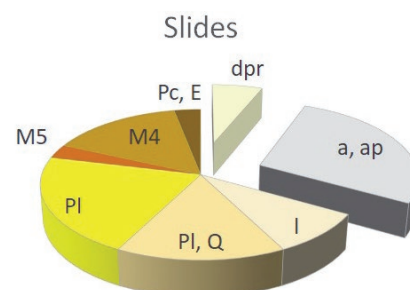
Landslide locations are scattered across the research area but are mostly related to particular lithologies (Figure 14), being predominantly observed in PI and PI-Q sediments. Both units are characterised by clays, sands and gravels, and are well known for frequent landslides in the much wider region. Several landslides in loess sediments are recognised here, which are also observed in the wider Kutina area. Landslides on top of “rocky” M₅, M₄ and Pc-E units are probably related to soil material in their weathering zones.

The alluvial (a, ap) and diluvial (dpr) units are presented separately, because sliding processes on flat areas in these sediments are frequently related to liquefaction processes and lateral spreading along river banks, causing river bank failure (Figure 14).

Figure 14. The proportional distribution of landslides in particular geological units.
