Evaluation of masonry buildings and mosques after Sivrice earthquake

Research Paper

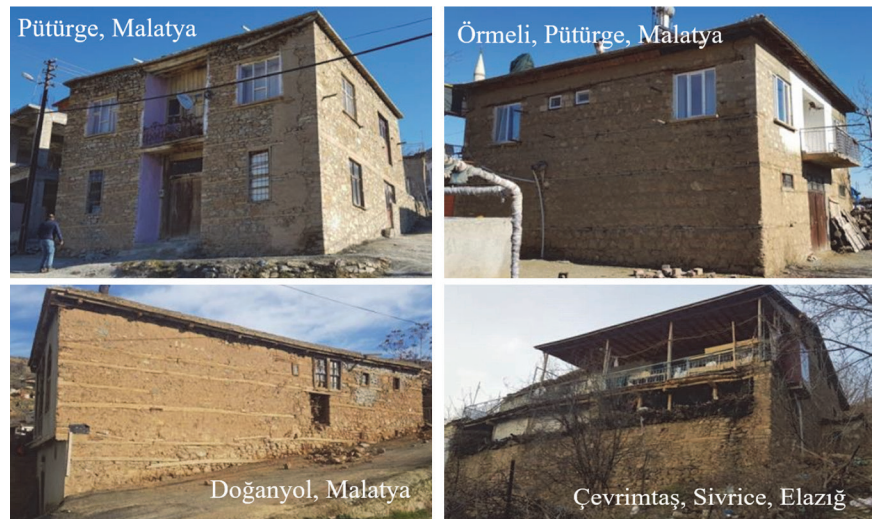
Figure 13. Typical masonry buildings constructed in the region

Numerous villages and towns were visited to evaluate performance of masonry buildings affected by the earthquake. Typical masonry buildings constructed in the villages and counties of the region are shown in Figure 13. The construction of some of these masonry buildings dates back to the 1950s. The damaged or collapsed buildings were mostly constructed using stone masonry bearing wall systems with a maximum of 2 storeys. In this construction type, natural stones of various sizes (50-400 mm) were bonded together using a clay binding mortar to form the walls (Figure 14a). Bearing walls varied from 500 to 800 mm in thickness. The buildings were strengthened with horizontal wooden tie beams (wooden belts), which were used at various heights all around the building perimeters (Figure 14b). The vertical distances between two consequent tie beams varied from 500 to 1500 mm. Tie beams were also used at the locations where the walls were connected to the roofing system. Wooden out-of-plane ties ensured the out-of-plane stability of these thick bearing walls (Figure 14c). Wood boards (planks), supported by timber beams, formed the floor/roof diaphragm in these buildings, as shown in Figure 14d. The reinforced concrete and masonry buildings damaged

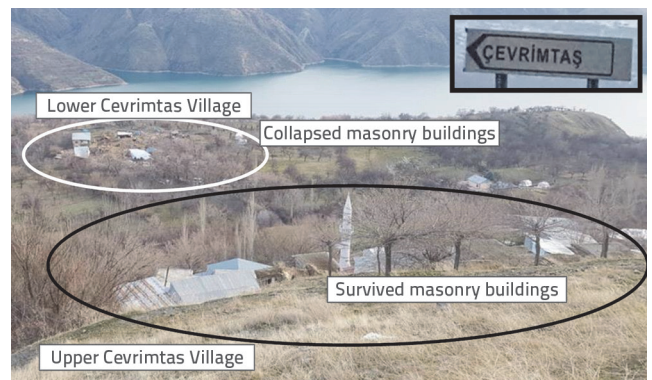
Figure 20. View of Çevrimtaş village

During the site visit, special attention was paid to Çevrimtaş village, which is approximately 1 kilometre away from the epicentre of the earthquake. The masonry buildings in this village experienced the greatest damage. A photograph of Çevrimtaş village is shown in Figure 20. For the purposes of this paper, the village was divided into two separate regions, the upper and lower Çevrimtaş. According to information provided by the General Directorate of Mineral Research and Exploration of Turkey [13], the lower village lies on soft soil (very dense sand, hard clay layers and/or soft rock having extensive cracks) right next to the reservoir of Karakaya Dam. The upper village is located on the highlands of the neighbouring hill, and it lies on strong soil (strong and hard rock) [13]. The geological soil formation map of Çevrimtaş village is shown in Figure 21. During the earthquake, almost all masonry buildings in the lower village collapsed, whereas most of the masonry buildings in the upper village did not experience any damage. Some photographs of the various collapsed masonry buildings located in the lower Çevrimtaş village are shown in figures 22 through 25. An example of a typical undamaged masonry building located in upper Çevrimtaş village is shown in Figure 13 (bottom right).

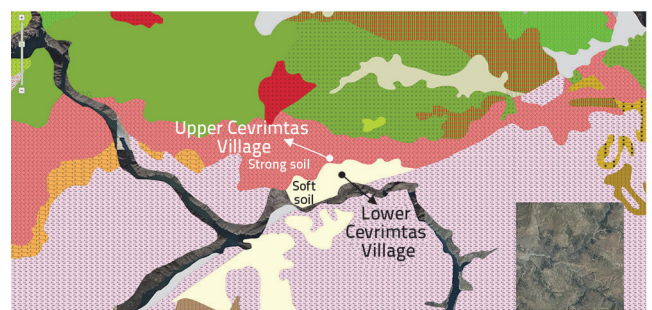
Figure 21. Geological soil formation of Çevrimtaş village [13]

TBEC [12] is used to evaluate the effects of earthquake forces on masonry structures in Turkey. As discussed above, the buildings were constructed on two types of soil: strong and soft soil. The horizontal elastic design response spectrums of these two soil types, which are obtained using TBEC [12], by paying attention to the soil amplification factor, are plotted in Figure 12. The figure indicates the fact that the structures located on soft soil (local site class ZC) are subjected to greater accelerations over a longer period compared to those on strong soil (local site class ZA). Therefore, greater earthquake loads would be exerted on masonry structures constructed on soft soil. This fact related to local site class was believed to be the main reason of collapse of the masonry structures in the lower Çevrimtaş village.
