**KIP CARA AUGUSTA IZ ARHEOLOŠKOG
MUZEJA ZADAR:
KONZERVATORSKO-RESTAURATORSKA
ISTRAŽIVANJA I RADOVI**

U ovom članku opisani su konzervatorsko-restauratorski radovi i istraživanja provedena na rimskoj antičkoj mramornoj skulpturi koja postumno prikazuje cara Augusta. Kip datira u 1. stoljeće i isklesan je s namjerom da se promatra s prednje strane. Pronađen je 1768. godine, tijekom arheoloških istraživanja grada Nina koje je financirao zadarski liječnik i jedan od prvih dalmatinskih kolekcionara, Ante Danielli Tommasoni. Nakon njegove smrti dospio je u sjemenište u Udinama, a potom je prodan Talijanima. Nakon nekoliko godina dopisivanja između talijanskih i jugoslavenskih vlasti, kip cara Augusta donesen je u Zadar 1928. godine, prilikom izložbe u crkvi sv. Donata. Kip je bio postavljen ispred crkve do 1953. kad je premješten u zgradu tadašnjeg Filozofskog fakulteta (danasa Sveučilište u Zadru) – Liceja sv. Dimitrija. Godine 1973. premješten je na svoju sadašnju poziciju – u Arheološki muzej Zadar. U predvorju muzeja stajao je od 1991. godine, opasan metalnom cijevnom konstrukcijom (skelom) zbog sumnje u statiku. Demontaža kipa zahtijevala je veliki oprez te razrađen i precizan pla

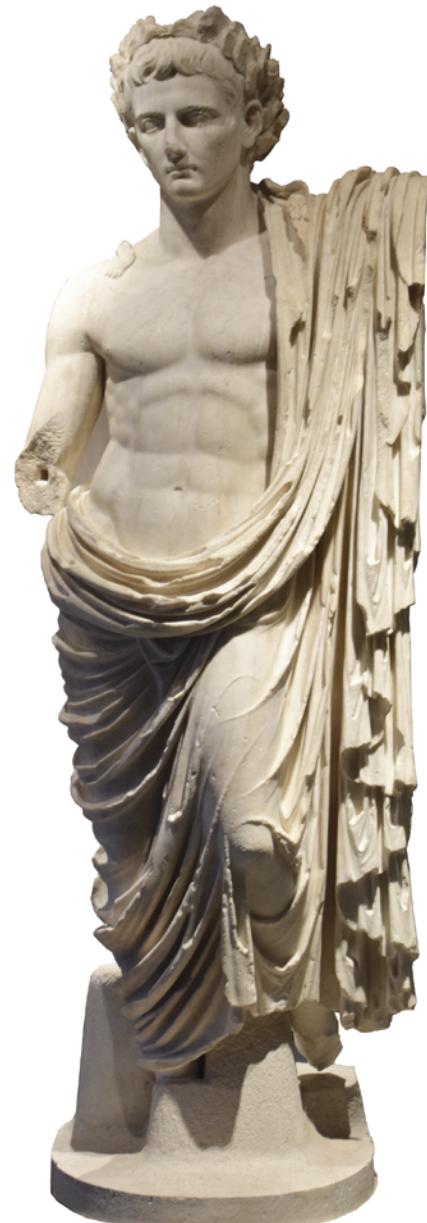
Slika 18.

Kip cara Augusta nakon izvedenih konzervatorsko-restauratorskih radova

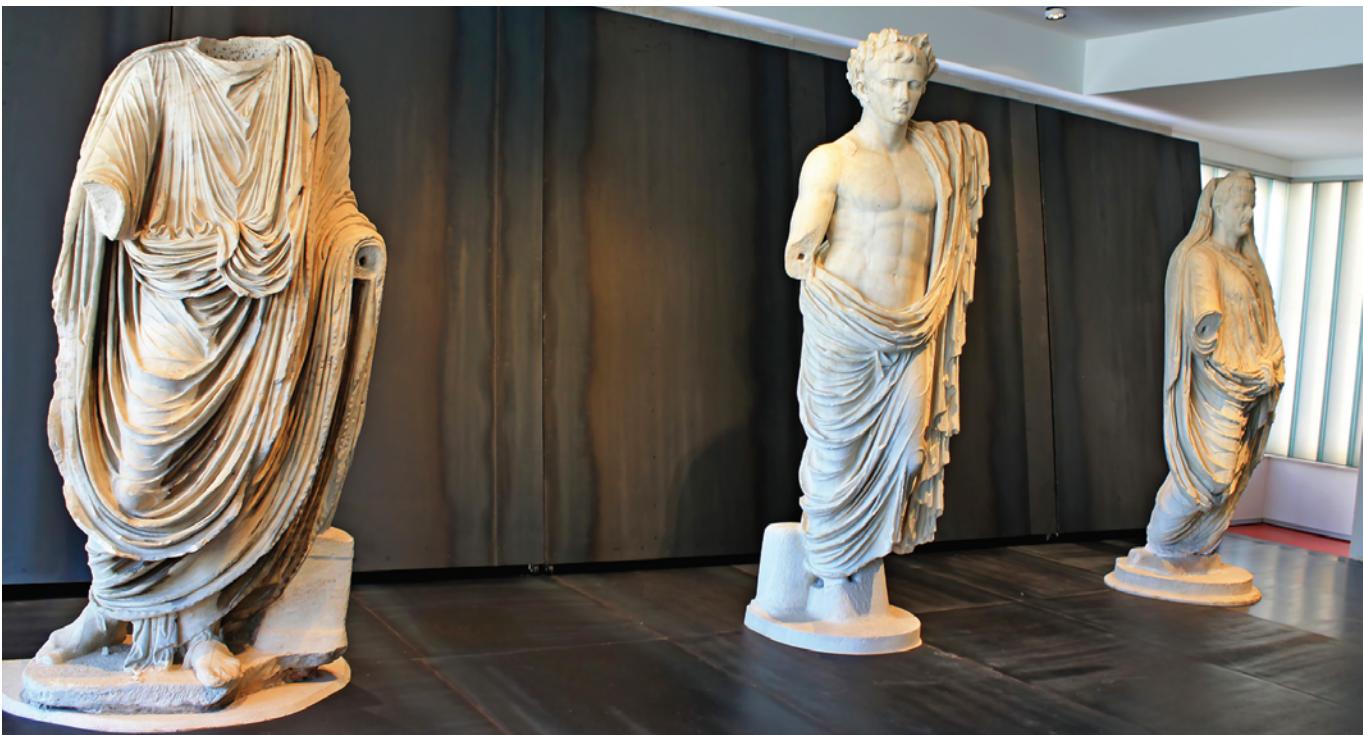
270
Slika 19. Kip cara Augusta unutar novog antičkog postava Arheološkog muzeja Zadar nakon izvedenih konzervatorsko-restauratorskih radova

After the conservation and restoration work, the statue had to be returned to the Museum's new Roman Antiquity display and erected there.⁴⁵ The Roman Antiquity collection found its new home on the Museum's first floor. Steel-structure partition walls divide this floor into numerous compartments, thus making the most of the low-ceiling space. Bringing in through the main entrance and up the stairs a statue weighing almost two tons was not possible. Exhibiting such large statues in the museum is a major physical challenge for the museum's spatial and structural integrity. The only possible solution was to lift the sculpture inside in a horizontal position through a widened first-floor window by means of a crane (Figs. 17–18).⁴⁶ Unfortunately, the group of imperial statues is not presented in an adequate context because the largest statue, whose head has not been preserved, is missing. Thus, the imperial statues of Tiberius, Augustus and an unknown emperor occupy most of the space, as a culmination of the Roman Antiquity collection. The statues can be observed from all sides (Fig. 19).
