Restauriranje antičke carske skulpture iz Visa

Restoration of an ancient imperial sculpture from Vis

U restauratorsku radionicu Arheološkog muzeja u Splitu sredinom listopada 2019. godine stigle su dvije rimske carske skulpture iz Priručne zbirke *Issa* smještene u Gospinoj batariji u Visu. Skulpture je potrebno pripremiti za obljetničku izložbu *Vis-à-Vis 200. Arheološka baština otoka Visa*. Skulpture pripadaju skupini od pet carskih skulptura koje potječu s područja podno Gradine u Visu. Dvije skulpture nalaze se u fundusu Područne zbirke *Issa* na otoku Visu, jedna se čuva u Arheološkome muzeju u Splitu, jedna u Arheološkome muzeju u Zagrebu, a jedna u Beču.¹ Kako se skulptura u Beču sastoji od tijela i glave koji ne pripadaju jedno drugome, možda se može pretpostaviti da se radi o šest viških skulptura.² U ovom tekstu opisana je problematika prezentacije skulpture kojoj nedostaju nosivi dijelovi te su kronološki obrazloženi procesi koji su primijenjeni na skulpturi inv. br. AMS 74350.

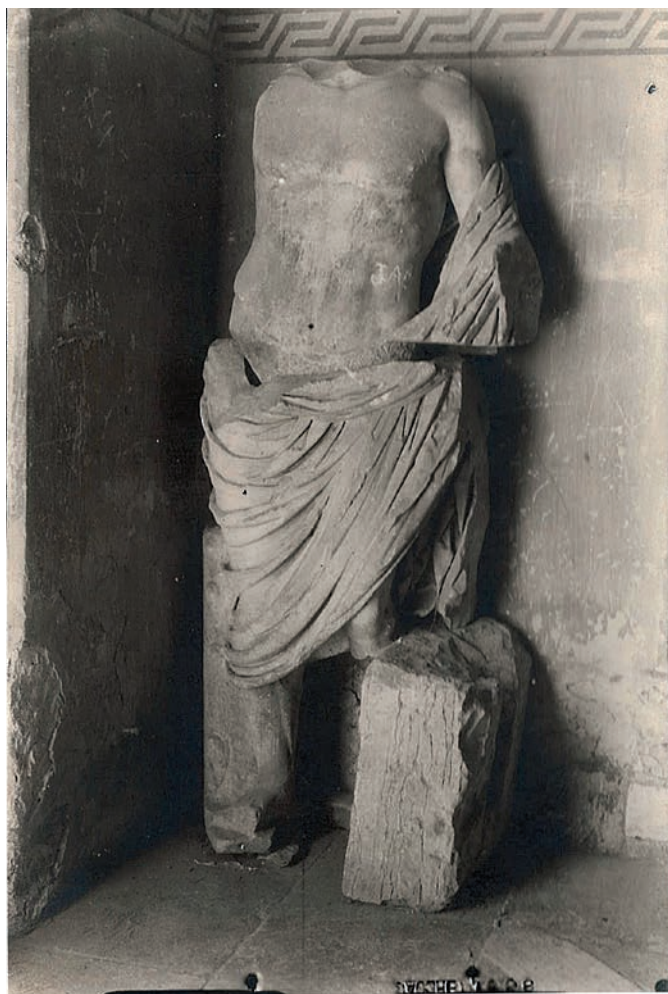
Slika 1.
Skulptura u predvorju
obiteljske kuće Dojmi (izvor:
Arhiv Arheološkog muzeja u
Splitu)

Figure 1.
Sculpture in the entrance-hall
of the Dojmi family house
(source: Archives of the
Archaeological Museum in
Split)

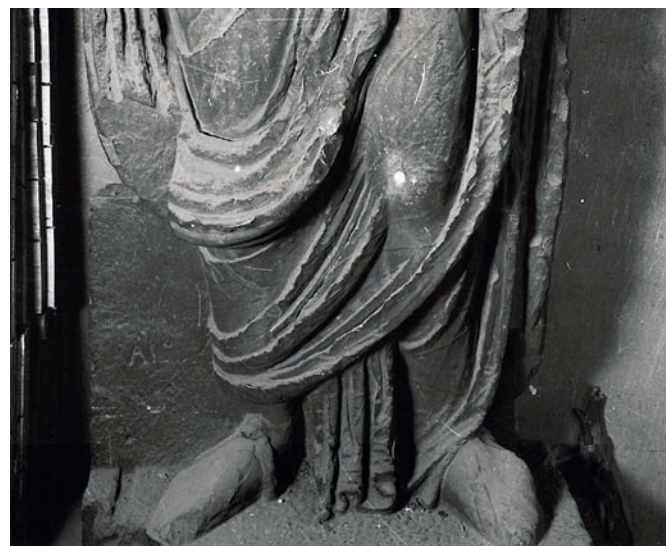
Slika 3.
Kiparov potpis na
skulpturi koja se nalazi u
Kunsthistorisches Museum
u Beču, inv. br. I 669 (prema
Ivčević 1998, str. 76)

Figure 3.
Author's signature on the
sculpture located in the
Kunsthistorisches Museum,
Vienna, Inv. No. I 669 (after
Ivčević 1998, p. 76)

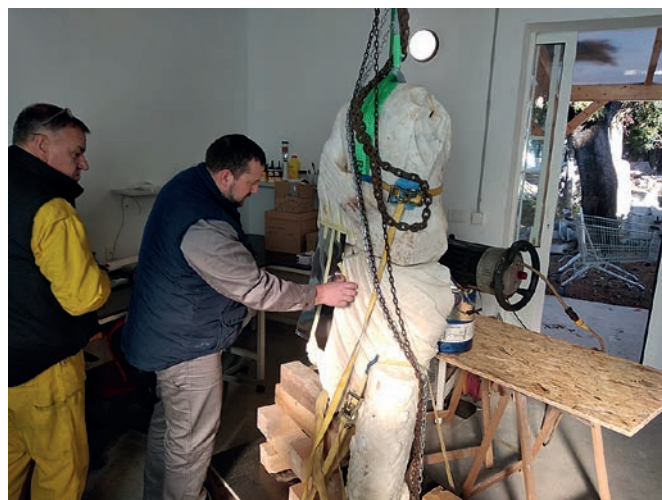
Nakon snimanja navedenih mjesta na skulpturama i obrade filmova u Laboratoriju *Brodosplita* pokazalo se da rezultati nisu zadovoljavajući (sl. 7). Razlozi nejasnih i nepotpunih rezultata prema tvrdnji stručnjaka za radiografska snimanja mogu se tražiti u gustoj strukturi mramornog materijala, zatim u neodgovarajućoj pokretnoj RTG opremi za tako zahtjevno snimanje te u filmovima i kemikalijama koji nisu bili dovoljno osjetljivi za takvu vrstu snimanja.¹¹

Slika 6.
Postavljanje filma u položaj za snimanje (foto: B. Vješnica)

Figure 6.
Setting the film for imaging (photograph: B. Vješnica)

according to radiographic imaging specialists, the reasons for the vague and incomplete results can be found in the dense structure of the marble, inadequacy of the mobile X-ray equipment for such demanding imaging, and in the films and chemicals that were not sensitive enough for this type of imaging."

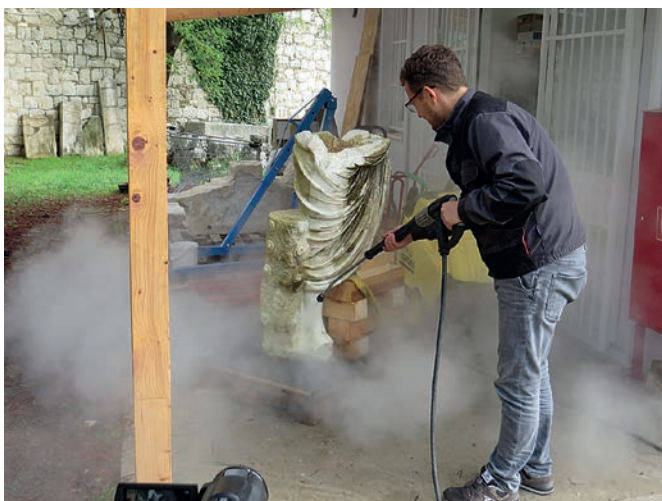
Slika 11.
Dubinsko pranje mramorne
površine parom (foto: B.
Vješnica)

Figure 11.
Deep steam washing of the
marble surface (photograph:
B. Vješnica)

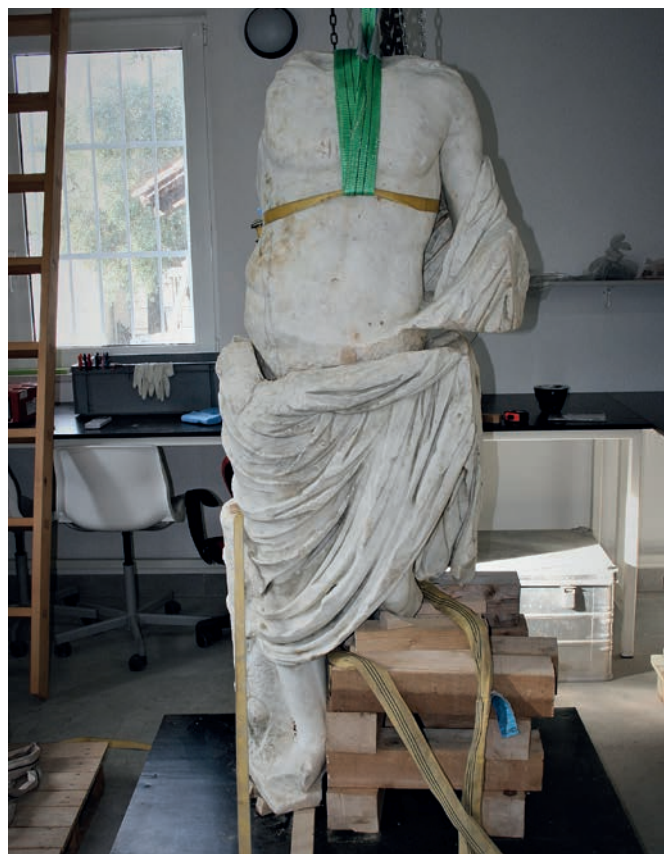
Slika 13.
Uspravljena skulptura (foto: B.
Vješnica)

Figure 13.
Upright sculpture
(photograph: B. Vješnica)

176 cm, širina od 72 cm, debljina od 48 cm i težina od 510 kg. Daljnjim pregledom utvrđene su dimenzije oštećenja nastalih ljudskom rukom (sl. 10): uklesani potpisi, ogrebotine, ostaci cementne žbuke. Radi još boljeg uvida u stanje, mramorni ulomci podvrgnuti su metodi čišćenja visokotlačnim strojem na vrelu paru (sl. 11). Tim je postupkom s površine mramora pomno uklonjen višegodišnji sloj nečistoće, masnoće, tragova životinjskih nastambi, mahovine i mikrobioloških ostataka. Uklanjanjem prvog sloja naslaga na površini mramornih ulomaka mjestimično se ukazuju tvrdokornije kalcitne naslage. U cjelini, mramor je kompaktno, uz površinsku degradaciju nastalu zbog izloženosti atmosferilijama; nema tragova osoljavanja te još uvijek ima finu teksturu, ne računajući pritom na oštećenja nastala ljudskim djelovanjem. Relativno mekše kalcitne naslage uklanjaju se postupnim mehaničkim čišćenjem uz pomoć ultrazvučne igle ili ručno, skalpelima raznih profila. Svi preostali kalcifikati uklanjaju se s pomoću finih abraziva (stakleni ili kameni prah) metodom suhog pjeskarenja (sl. 12). Kako bi se različiti restauratorski postupci uopće mogli primijeniti, potrebna su posebna pomagala i alati, bez kojih rad ne bi bio moguć, a to su: automehaničarska dizalica, pomična stropna kolica za lančanu dizalicu, lančana dizalica, laserska libela, ručna auto-dizalica. Uz pomoć kliznih stropnih kolica i lančane dizalice skulptura je uspješno postavljena. Kad je donji ulomak skulpture uspravljen u izvorni položaj, na njega se više puta tijekom ukupnih radova montirao i demontirao torzo (sl. 13).

fragments revealed sporadic more persistent calcite deposits. On the whole, the marble is compact, with surface degradation caused by exposure to weather conditions. There are no traces of efflorescence, and the texture is still fine, excluding the man-made damages. Relatively softer calcite deposits are removed by gradual mechanical cleaning with an ultrasonic needle or manually, with scalpels of various profiles. All other remaining calcifications are removed with fine abrasives (glass or stone powder) by dry sandblasting (Fig. 12). In order to make various restoration procedures possible, special appliances and tools are required, without which work would not be possible, such as: a garage lift, travelling ceiling trolleys for chain hoists, a chain hoist, a laser line level, and a manual car jack. The sculpture was successfully set with the help of the travelling ceiling trolleys and the chain hoist. When the lower fragment of the sculpture was erected in its original position, the torso was mounted and dismantled several times during the works (Fig. 13).

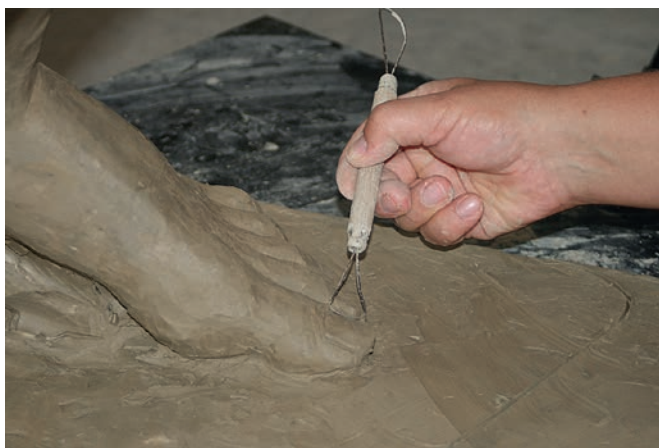
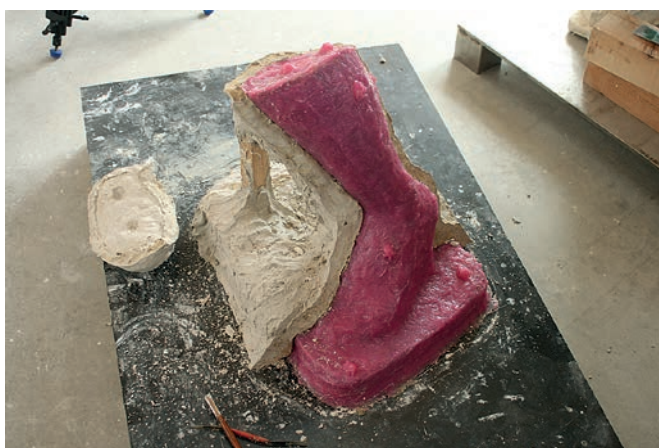
Slika 15.
Modeliranje noge u glini (foto:
B. Vješnica)

Figure 15.
Leg modelling in clay
(photograph: B. Vješnica)

Slika 16.
Skidanje gipsane kape s
gumenog kalupa (foto: B.
Vješnica)

Figure 16.
Removal of the plaster cap
from the rubber mould
(photograph: B. Vješnica)

material *Acrystal Decor Carrara*²⁰ (Figs. 15, 16). The cast was subsequently processed with traditional stonemasonry techniques and aesthetically adapted to the sculpture, with an appropriately emphasised difference between the reconstruction and the original, made by means of a difference in colours.

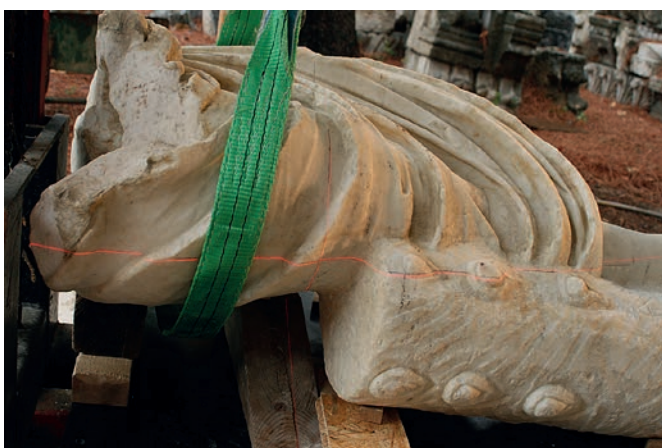
Slika 18.
Pozicioniranje linije laserske
libele na desnom boku
skulpture (foto: B. Vješnica)

Figure 18.
Positioning of the laser line
level on the right side of the
sculpture (photograph: B.
Vješnica)

Since this phase of works required a wider workspace, the sculpture was transferred to the concrete plateau at the entrance to the restoration workshop. The wooden beam of the eaves above the entrance was quite useful, since it served as the holder for the smaller hoist. With the help of two chain hoists, the lower part of the sculpture was laid from the new inox support in a temporary lying position on a specially customised wooden pallet made of waterproof plywood, for the purpose of the intended drilling. The already drawn lines on the marble surface were used as an aid in levelling the fragment in a horizontal position with a laser line level to centre the drilling direction (Fig. 18). The position was precisely adjusted to a height suitable for a way-type drill²¹ with a drill

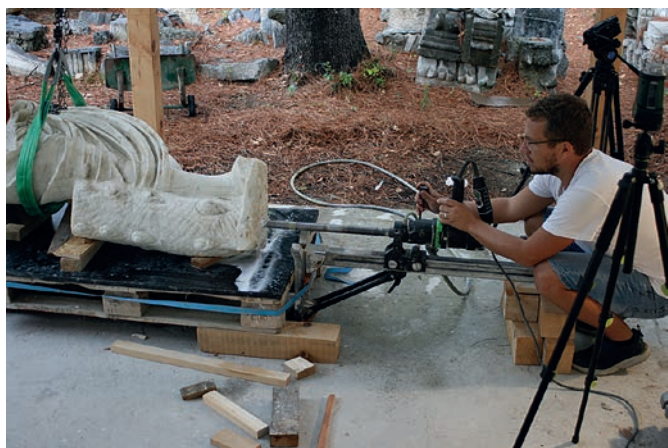
Slika 19.
Mokro bušenje dna baze (foto:
B. Vješnica)

Figure 19.
Wet drilling of the base
bottom (photograph: B.
Vješnica)

bit with a diameter of 30 mm and water cooling. When the lines for the drilling were levelled after a long adjustment, the check-up of the drilling direction for the holes was initiated with the laser line level. Before drilling the bottom of the base, a piece of tape was glued to the top of the drill bit to mark the drilling depth, corresponding to the length of an inox steel joint (tang), which would subsequently be fixed in a prepared perforation according to the plan. When water was fed to the drill head and bit²² through a rubber hose from the mains supply, drilling of the marked area of the bottom of the sculpture base was initiated. Due to the relatively small pre-defined drilling depth of 160 mm, the procedure did not take more than a few minutes. Following the end of the procedure, the bit was smoothly pulled out of the drilled part of the bottom of the base, and the marble insert, which had already cracked in depth, was removed without difficulty (Fig. 19). The marble insert removed from the first perforation after wet drilling seemed clean and regular, but a brown patch was observed at its end, most closely resembling stains caused by the spread of corrosion (Fig. 20). A follow-up examination of the surface of the sculpture led to the conclusion that the finding from the marble insert is not unique, but rather manifest in the form of efflorescence on the surface of the entire sculpture. All the described phases of the drilling procedure were repeated at the second marked position, in the middle of the lower left leg fracture. Since the original lower leg is missing, it will be structurally replaced by the inox prosthesis. The pro-

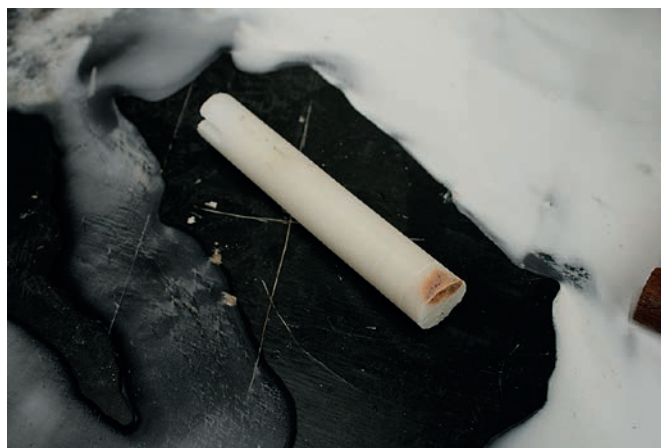
Slika 20.
Mramorni uložak, detalj (foto:
B. Vješnica)

Figure 20.
Marble insert, detail
(photograph: B. Vješnica)

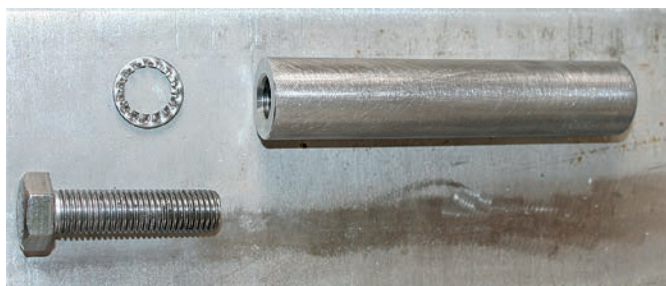
Slika 21.
Detalj nosive konstrukcije koji se ugrađuje u bazu (foto: B. Vješnica)

Figure 21.
Detail of the load-bearing structure to be inserted in the base (photograph: B. Vješnica)

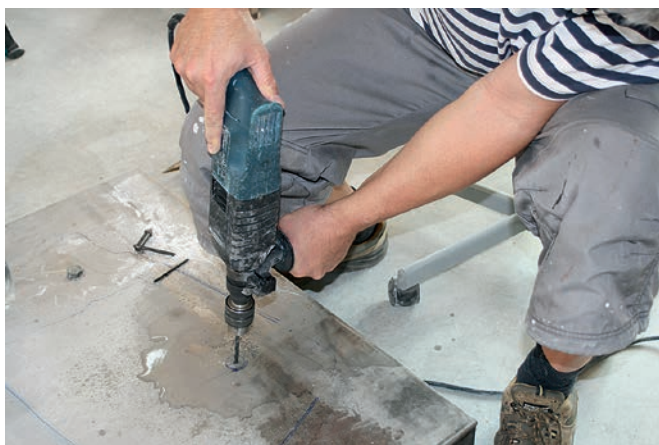
Slika 22.
Bušenje ucrtanih položaja na nosivoj podlozi za fiksiranje skulpture (foto: D. Ordulj)

Figure 22.
Drilling of marked positions on the support for the fixing of the sculpture (photograph: D. Ordulj)

While the lower part of the sculpture is laid on cardboard, the outlines of the original base and the place of perforation are marked. The original base template is copied to the surface of the inox support, with an additional counterpart of the pre-defined perforation. The marked spot on the support plate is then drilled with drill bits for inox and a milling tool (Fig. 22).

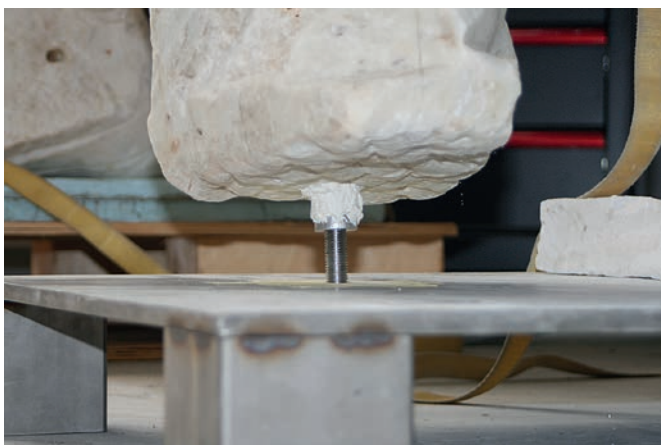
Slika 23.
Spuštanje baze skulpture na usadak od inoksa s ljepilom, detalj (foto: B. Vješnica)

Figure 23.
Lowering of the base of the sculpture onto an inox pin with glue, detail (photograph: B. Vješnica)

layer of adhesive is also applied to the inox pin, which is then inserted into the perforation, and placed into the base filling (Fig. 23) by lowering the sculpture with the chain hoist and exerting pressure on the support. Excess adhesive slides down the wall. It takes 24 hours for the adhesive to reach maximum strength.

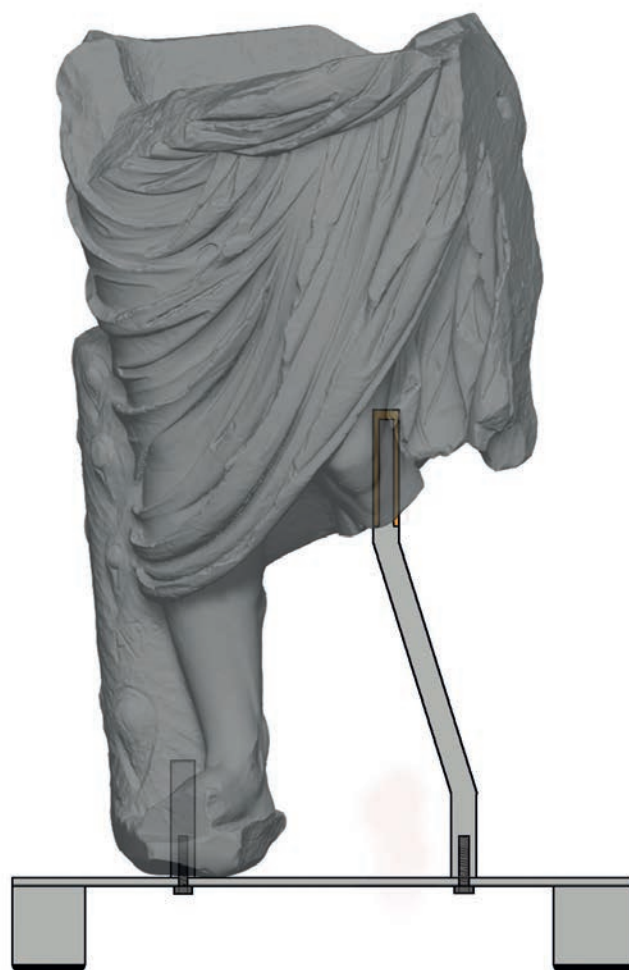
Slika 28.
Digitalni crtež metalne
konstrukcije (izradio: D.
Ordulj)

Figure 28.
Digital drawing of the metal
structure (made by D. Ordulj)

The making of the inox prosthesis and its mounting on the support was the final step which made it possible for the entire sculpture to stand independently and securely (Fig. 28).

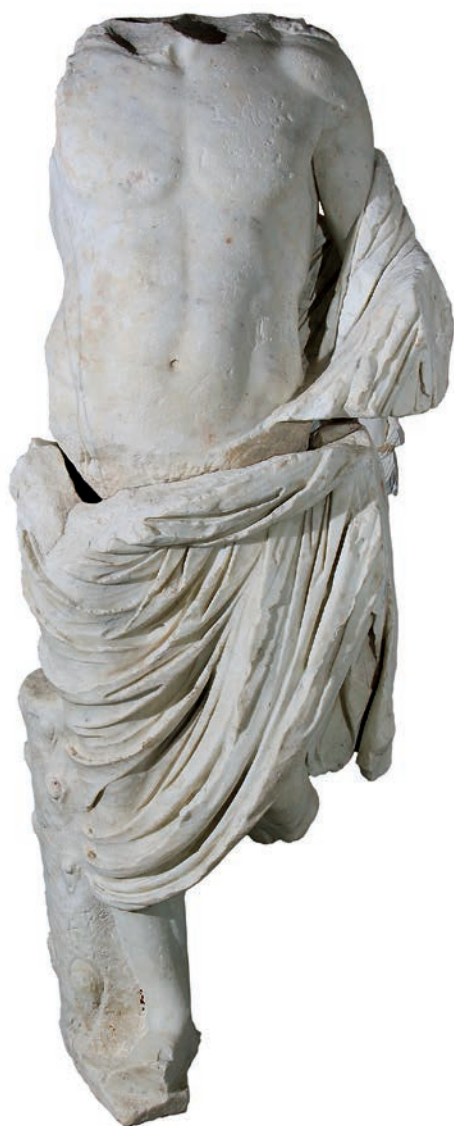
Slika 29.
Skulptura bez rekonstrukcije
(foto: T. Seser)

Figure 29.
Sculpture without reconstruction
(photograph: T. Seser)

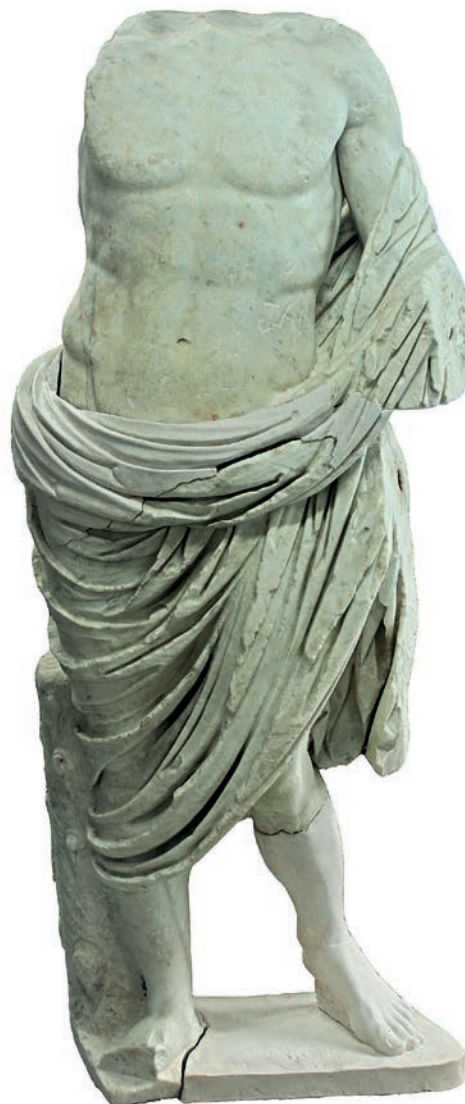
Slika 30.
Skulptura s rekonstrukcijama
(foto: D. Ordulj)

Figure 30.
Sculpture with reconstructions
(photograph: D. Ordulj)
