MATRIX REPLICA-BASED ASSESSMENT OF THE MICROSTRUCTURE OF PRIMARY STEAM PIPING ELBOWS AFTER LONG-TERM OPERATION

Preliminary Note – Prethodno priopćenje

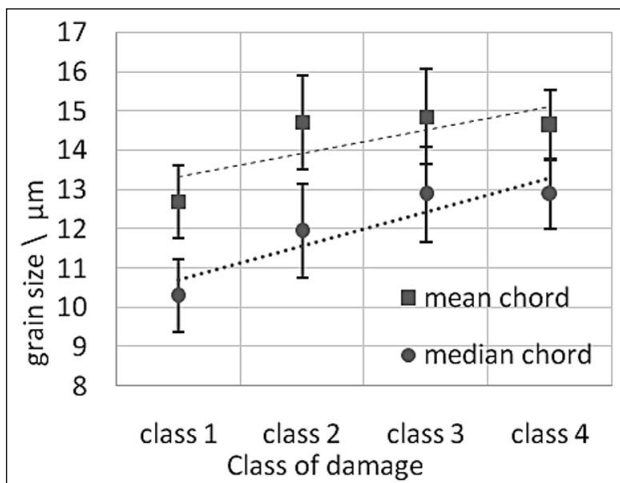
Figure 3 Microstructure grain size for 13HMF steel, represented by the mean chord and the median chord in the classes assigned by the expert

error was calculated as a half of the confidence interval for the mean. The relationship between the microstructure class assigned by the expert and the grain size represented by the mean chord length and the median chord length is shown in Figure 3. The mean chord length increases with the degree of microstructure degradation level represented by the assigned class. The largest grain size differences are between class 1 and class 2 and then decrease in subsequent classes.
