A site survey of damaged RC buildings in İzmir after the Aegean sea earthquake on October 30, 2020

Research Paper

Halit Cenan Mertol, Gokhan Tunc, Tolga Akis

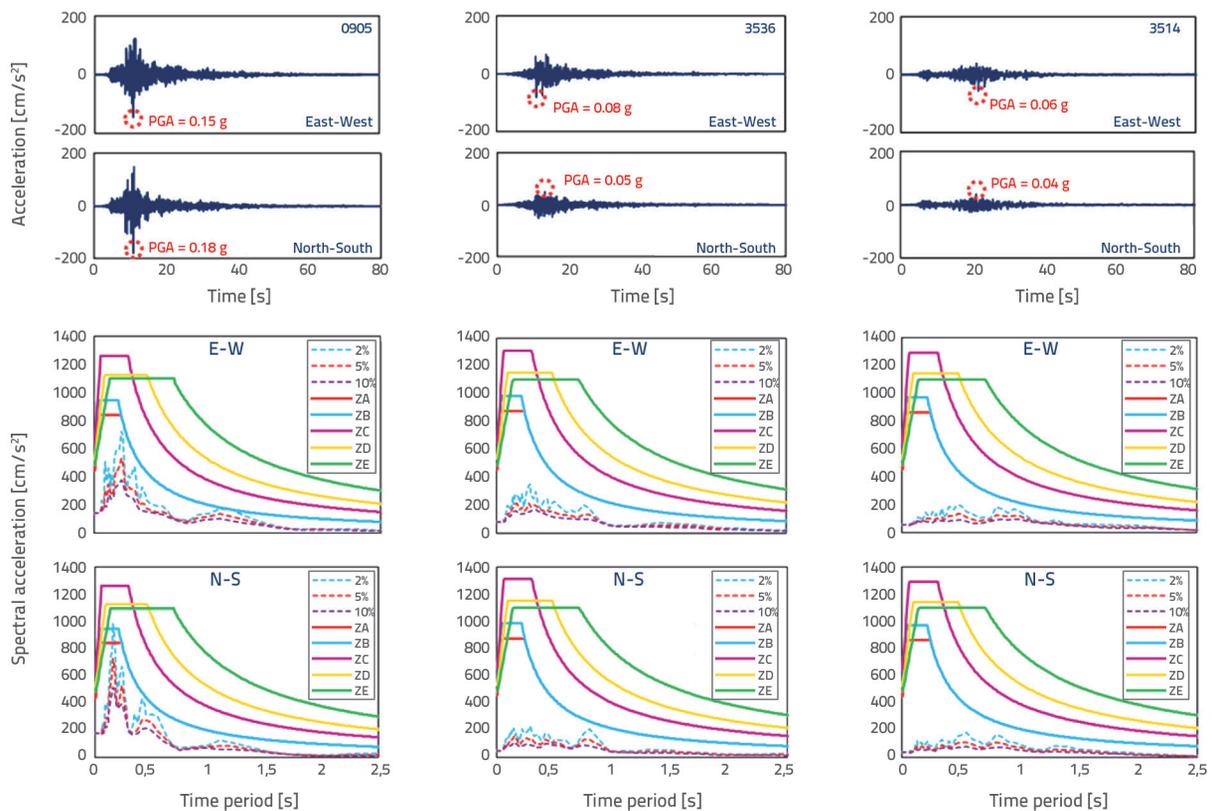
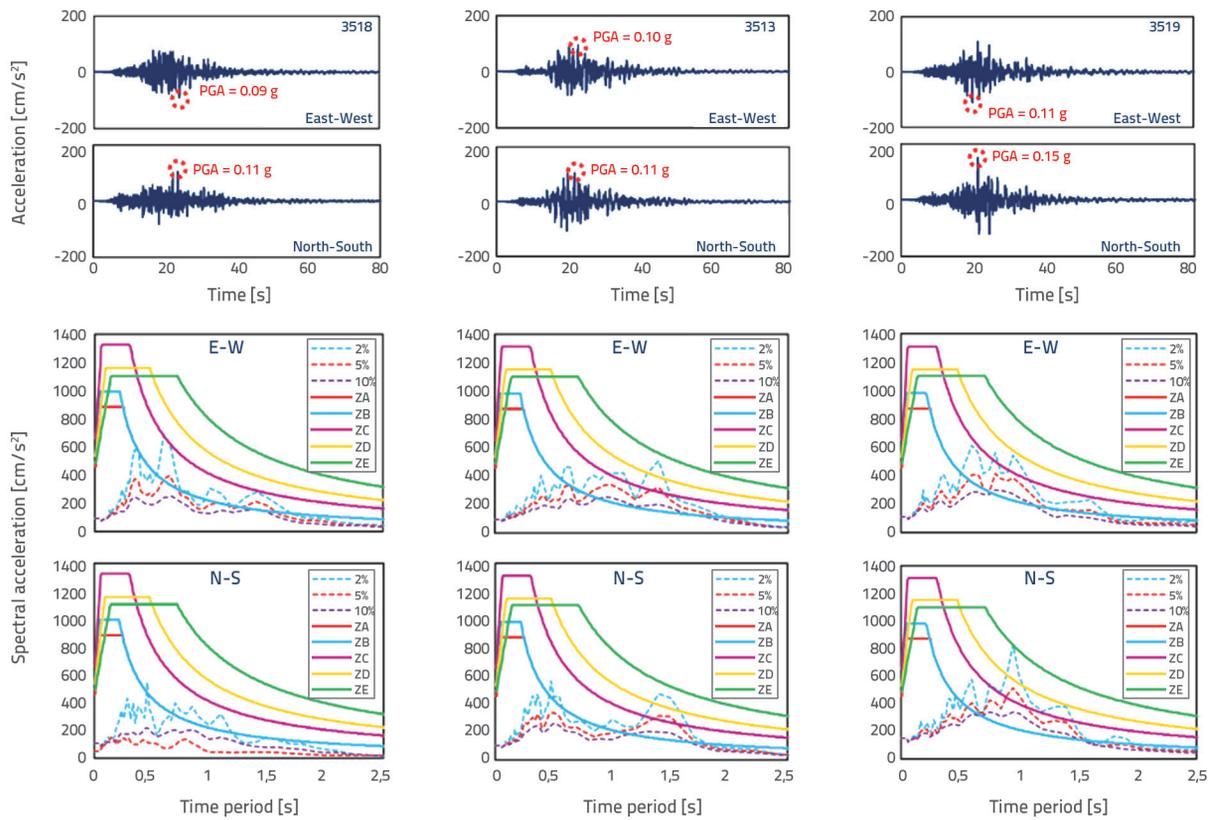
Figure 16. Peak ground and spectral acceleration values and design spectrum values for the Aegean Sea earthquake, 30 October, 2020 - Part I

The design spectrum curves of the current Turkish Building Earthquake Code (TBEC, 2018) [41] were compared with the measured spectral acceleration data, which were extracted from six stations in the north–south and east–west directions, as a function of varying damping ratios (Figure 16). TBEC (2018) [41] defined a total of six local soil classes, identified using letters from ZA through ZF, where ZA defines a hard rock soil type and ZF defines an extremely loose soil type, which requires further soil testing and site evaluation. In this study, the design spectrum curves of the first five soil classes (excluding soil type ZF) were used to evaluate the north–south and east–west peak ground acceleration components of the Aegean Sea earthquake. Based on the spectrum values, the peak ground acceleration values at stations 3536 and 3514 were much lower than the demands associated with the five soil classes. Therefore, the structural damage at these locations was moderate to minor. However, as the seismic waves travelled along stations

0905, 3518, 3513, and 3519, the corresponding periods for the peak ground accelerations shifted from 0.2 to 1.5 s. This shift exceeded the code-generated design response spectrum values, specifically at stations 3513 and 3519, for all four soil types except for type ZE. As a result of this exceedance, the degree of structural damage varied from moderate to intense in RC buildings with 8–15 floors. To further evaluate the impact of the Aegean Sea earthquake, the local soil classes of the selected stations were considered. Figure 17 shows the soil classes at these stations [42].

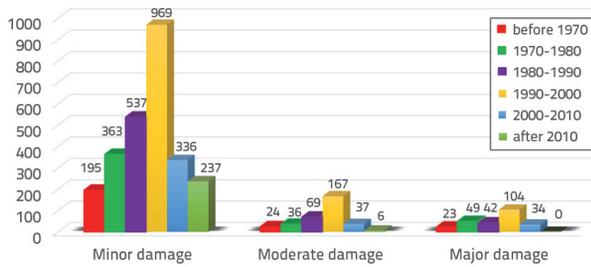
Figure 19. Distribution of damage in İzmir's RC buildings by numbers (adapted from [14])

The distribution of the damage levels of the RC buildings in İzmir is also plotted in Figure 19 as a function of their construction years. As the data indicates, most of the moderate-to-major damage was observed in buildings constructed between 1990 and 2000. Beyond 2010, the damage level shifted towards minor-level damage.

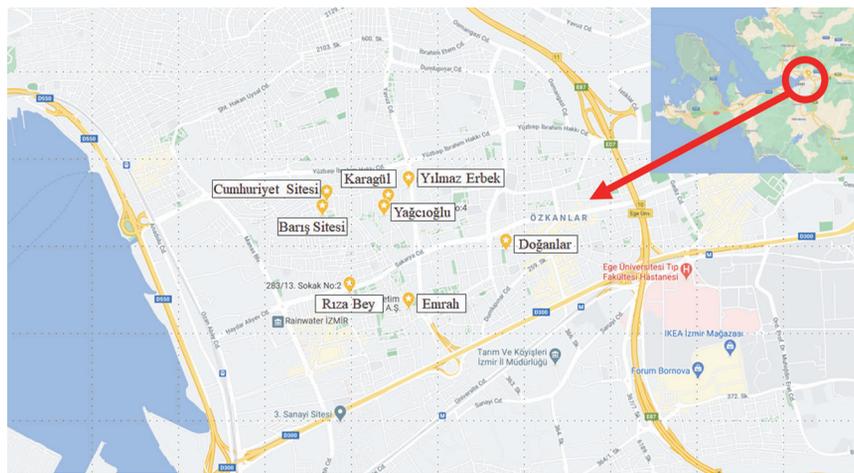
Figure 20. Locations of collapsed buildings in the Bayraklı District

As stated in Section 1, the earthquake caused the sudden collapse of 11 RC buildings. Out of these 11 RC buildings, four of them (Rıza Bey, Doğanlar, Emrah, and Block B of Yağcıoğlu Apartment Complex) completely collapsed, and seven of them (Yılmaz Erbek and Karagül Apartments, three blocks in the Barış Apartment Complex and two blocks in the Cumhuriyet Apartment Complex) partially collapsed in the Bayraklı District during the earthquake. All the collapsed buildings had structural framing systems consisting of RC columns and beams. These frames were infilled with brick masonry at all story levels except for the ground story. Most had shops on the ground story which may have produced a weak story at the ground-floor level. General information related to the collapsed buildings is presented in Table 5. The locations of these buildings are shown in Figure 20.
