CUT STABILIZATION ON THE HIGHWAY E-763 MADE IN ROCK MASS WITH UNFAVORABLY ORIENTED DISCONTINUITIES

Miodrag Pisarević^{1*}, Dragana Slavković², Vladimir Filipović³

¹Institute of Transportation CIP d.o.o. Nemanjina 6/IV, 11000 Belgrade, Serbia

Abstract: During the construction of the highway "Miloš Veliki" E-763 through Serbia, in addition to many challenges, it was necessary to stabilize the cut at the section km 81+250 to km 81+650. The cut was supposed to be constructed in the soft layered rocks of the Ljiški flysch complex, made of sandstone, marl stone and shales. The orientation of the rupture assembly of the rock mass as well as the spatial position of the slope led to a series of instabilities on the left side of the cut, while at the same time they had a positive effect on the stability of the right side. All occurrences of instability were accompanied by a dip direction of bedding, which on the left side of the cut had a dominant negative impact on the strength of the rock mass. For the purposes of geotechnical modeling and determination of remedial measures, the parameters of the rock mass were obtained using classifications of the rock mass, while the parameters of roc

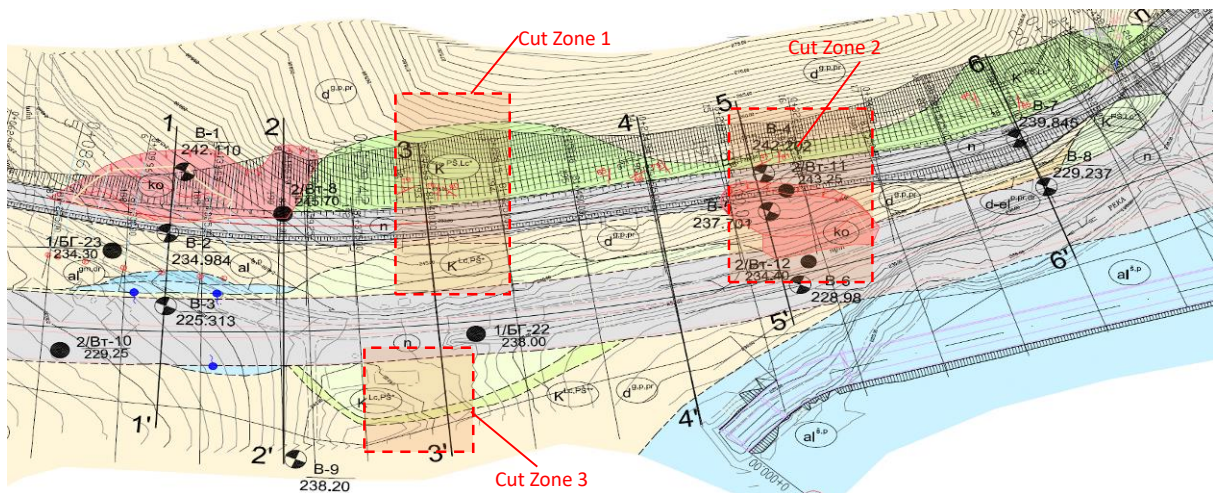
Figure 7. Engineering-geological map with the location of the performed investigation boreholes

A total of 15 investigation boreholes were done for the purpose of defining the geological structure of this section. Soil and rock mass samples were taken for laboratory testing. The position of the investigation boreholes is shown on the engineering geological map (Figure 7).

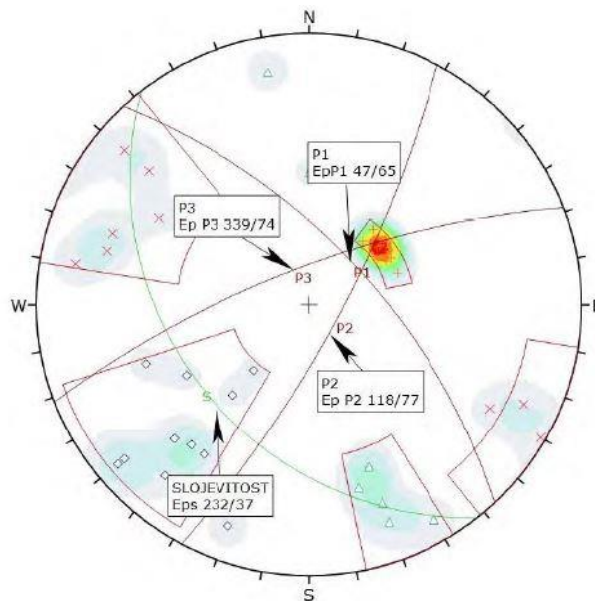
Figure 8. Contour diagram of joint sets and bedding

The main rupture assemblage of Cretaceous flysch consists of three main joints sets with dip elements P1: 47/65, P2: 118/77 and P3: 339/74, as well as beddings with dip elements S 232 /37 (**Figure 8**). Joints sets are at a medium to long spacing (from 0.2 to 2.0 m). According to the joint roughness classification (Barton & Choubey, 1977), joints have a JRC value of 3 to 6, which places them in the group of flat rough joints. Bedding is of medium to large length (from 3 to over 15 m) so that they form a continuous rupture complex. This continuity of bedding has a dominant negative effect on the shear strength in the direction where the beddings are oriented negatively, towards the excavation, so that they represent the main direction of planar sliding of the blocks, along which larger-scale movements can occur.

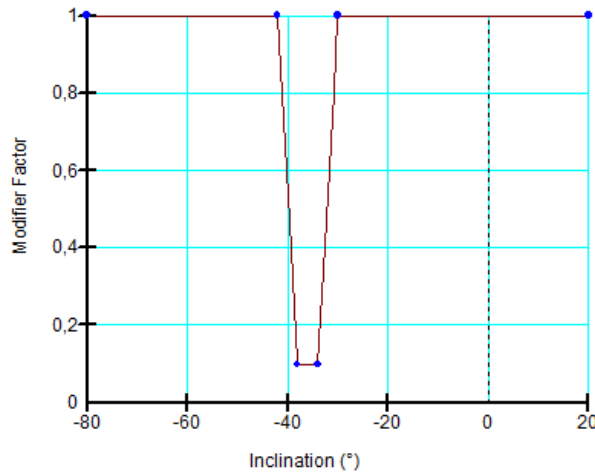
Figure 12. The anisotropic function used for geostatic calculations, which simulated a sudden drop in shear strength in the bedding directions of the 34-38°

This paper describes in detail the applied remedial measures for the stabilization of the cut on three characteristic sections, while on other parts of the cut, similar or slightly modified solutions were applied. An anisotropic soil model was used for slope stability calculations, with the application of remedial measures (**Figure 12**), to include the anisotropy of rock mass strength in the calculations. The strength of the rock mass in the bedding dip is represented by low shear strength (shear strength along the discontinuity), while the strength in other directions is significantly higher (shear strength of the rock mass).

- Construction of a cut above the regional road at an inclination of 34-38°, which corresponds to the bedding inclination, with covering with a double-twisted wire mesh.
- Construction of the slope between the regional road and the highway in a dual slope of 1:1.5 and 2:1 with the application of passive self-drilling IBO anchors (Ø32mm) 2 m long (on the flatter part of the slope) and 8.0 m (on the steeper part of the slope), at a pattern of 3x3m (on the flatter part of the slope) and 2x2 m (on the steeper part of the slope), construction of drainage channels, installation of subhorizontal tubular drains (Ø50mm) 6 m long, protection of the face of the slope from weathering, covering the face

of the slope with a road network with the installation of geocomposite, and protection of the face of the slope from surface erosion by hydro-seeding (on the flatter part of the slope), while the steep part is protected by a facing RC wall.
