António Arêde, Esmeralda Paupério, Xavier Romão

Lessons from the 2020 earthquakes in Croatia to improve the seismic performance of cultural heritage structures

António Arêde
Esmeralda Paupério
Xavier Romão
CONSTRUCT-LESE
(Laboratory of Earthquake and Structural Engineering)
Faculty of Engineering
University of Porto
PT – 4200-465 Porto, Rua Dr. Roberto Frias s/n

UDK: 72.025.1(497.5)"2020":550.34
72.025.4(497.5)"202":624
Review paper / Pregledni članak
Received / Primljeno: 11. 8. 2022.

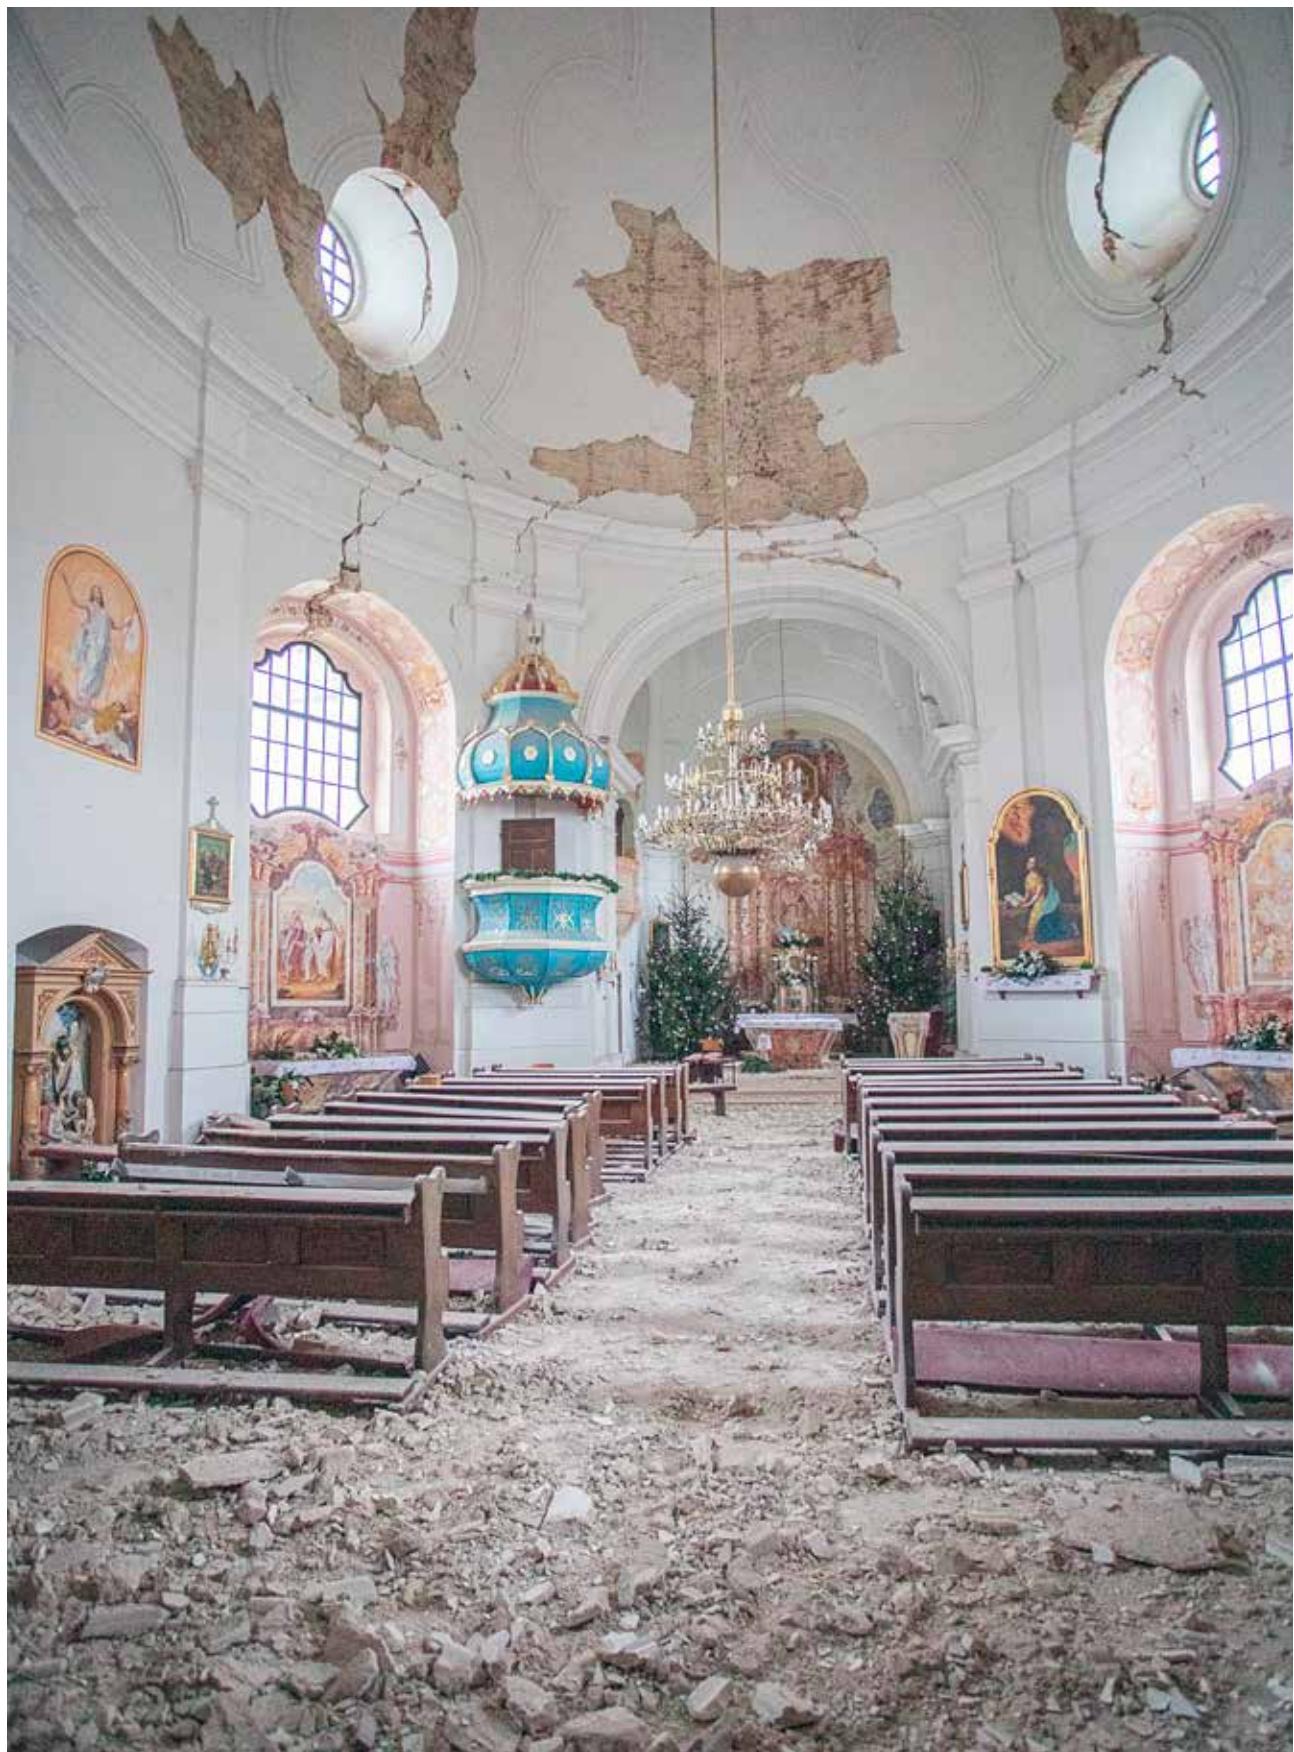
Interior of the Church of St. Mary Magdalene in Sela following the Petrinja earthquake, view towards the sanctuary (photo: Stjepan Vego, Sisak Diocese, December 2020)

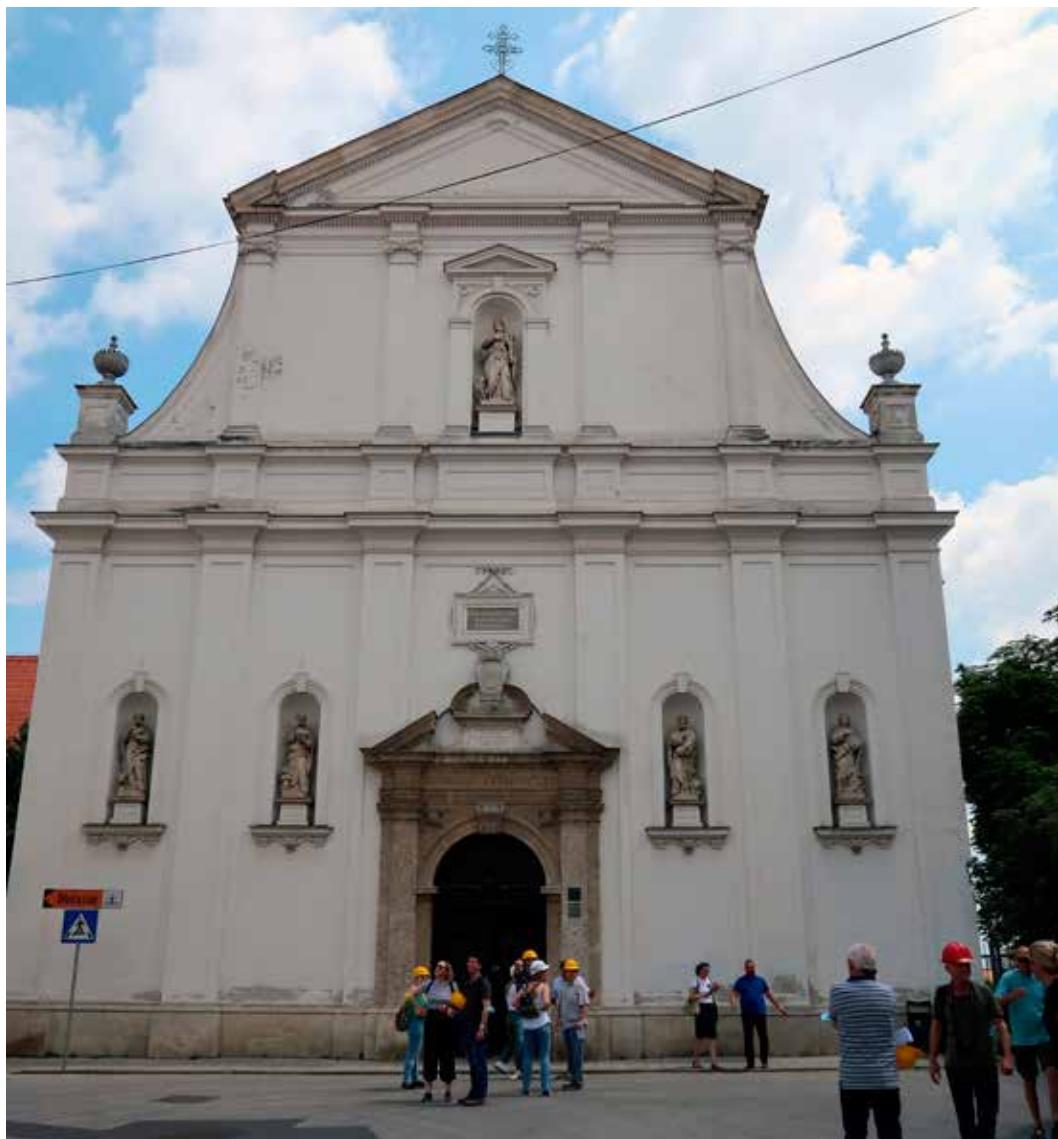
4 Main façade of the Church of St. Catherine of Alexandria in Zagreb (photo: X. Romão, July 2021)

The damage to the church that could be observed from the outside was not very expressive. The main façade did not present relevant damage while the lateral load-bearing walls exhibited light vertical cracking. The observation of the anchoring points of the tie rods from the outside of the church showed that none of the tie rods along the lateral walls of the nave exhibited signs of anchorage crushing. This means that the structure was able to accommodate the displacements imposed by the earthquake along the transversal direction (Fig. 6). However, the only tie rod visible from the outside along the alignment of the triumphal arch showed signs of anchorage crushing at the anchoring point located on the left lateral wall (Fig. 7). Finally, the observation of the roof from the exterior allowed concluding that it should be in a good condition since no evidence of bulging or missing tiles was seen.

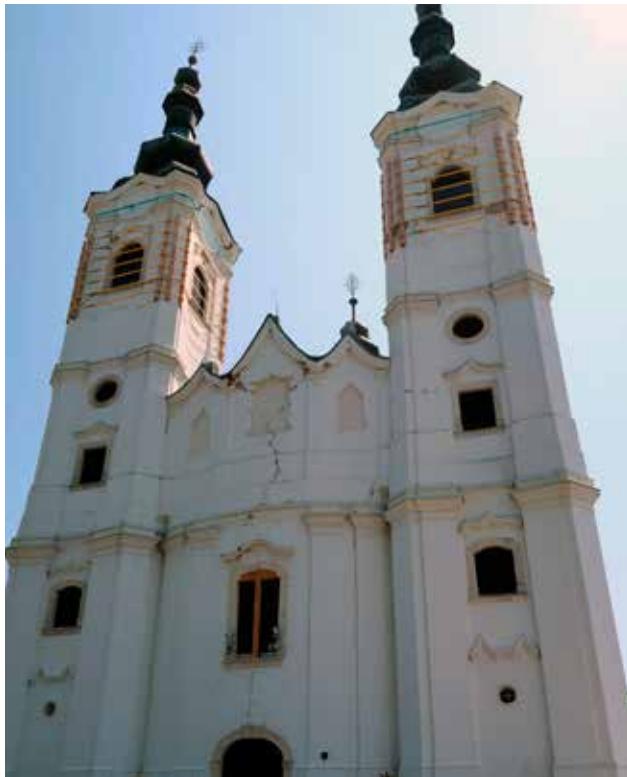
13 Sela, main façade of the Church of St. Mary Magdalene (photo: X. Romão, July 2021)

Tijekom izvida na terenu uočene su pukotine na pročelju i bočnim zidovima središnjeg broda, posebice u zonama otvora koji su trenutačno poduprti iznutra i izvana (sl. 15-18). U unutrašnjosti te zone odgovaraju bočnim kapelama nadsvodenima lukovima na kojima su utvrđena teška oštećenja i dijelovi zidnog oslika koji su otpali (sl. 19). Iako pukotina svoda središnjeg broda nije pretjera- no velika, konstrukcija je poduprta u zoni kupole koja je, prema lokalno dobivenim informacijama, imala pukotine u zoni tambura (sl. 20).

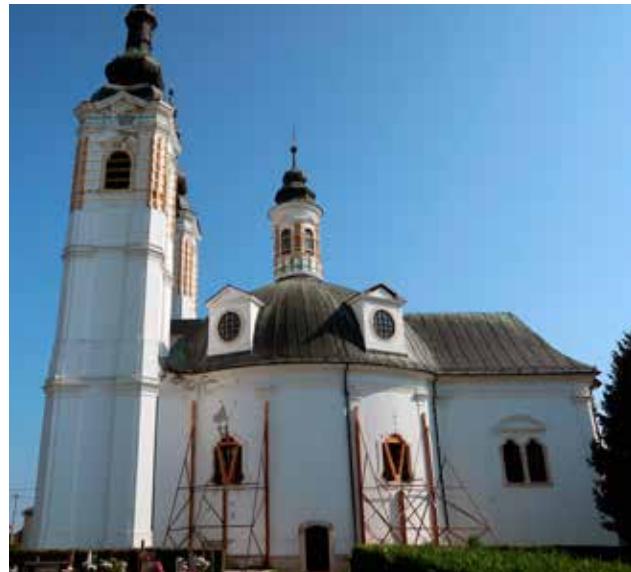
14 Lateral elevation view of the nave, showing the dome and the skylight windows (photo: X. Romão, July 2021)

Uočeno je i otvaranje spojeva između zona umetanja prozorskih kućica kupole i njima pripadajućih zidova (sl. 21). Činilo se da na svodu i u zoni prozorskih kućica kupole postoji blaga deformacija. Uz to, utvrđena su relevantna puknuća i nedostajući dijelovi završnih slojeva zidova i svoda središnjeg broda, kao i u zoni kora koja se nalazi između dva zvonika, a nose ju plitki lukovi (sl. 22, 23). Na tornjevima su uočene pukotine omeđene na njihovoj gornjoj razini (sl. 24). Zbog predostrožnosti, kupola je također osigurana izvana. Iako su pukotine primijećene i u glavnoj kapeli, ona nije znatno oštećena (sl. 25).

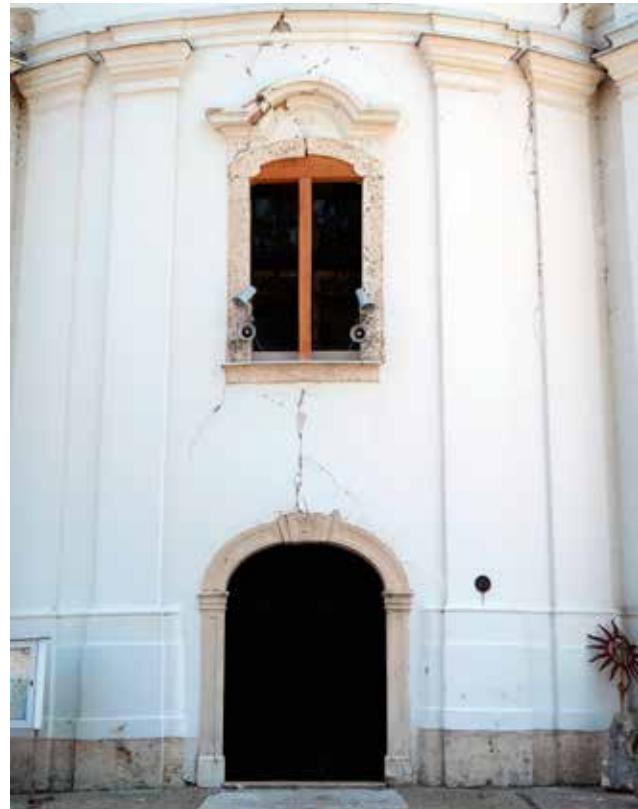
16 Detail of the main entrance (photo: X. Romão, July 2021)
Detalj glavnog ulaza (foto: X. Romão, srpanj 2021.)

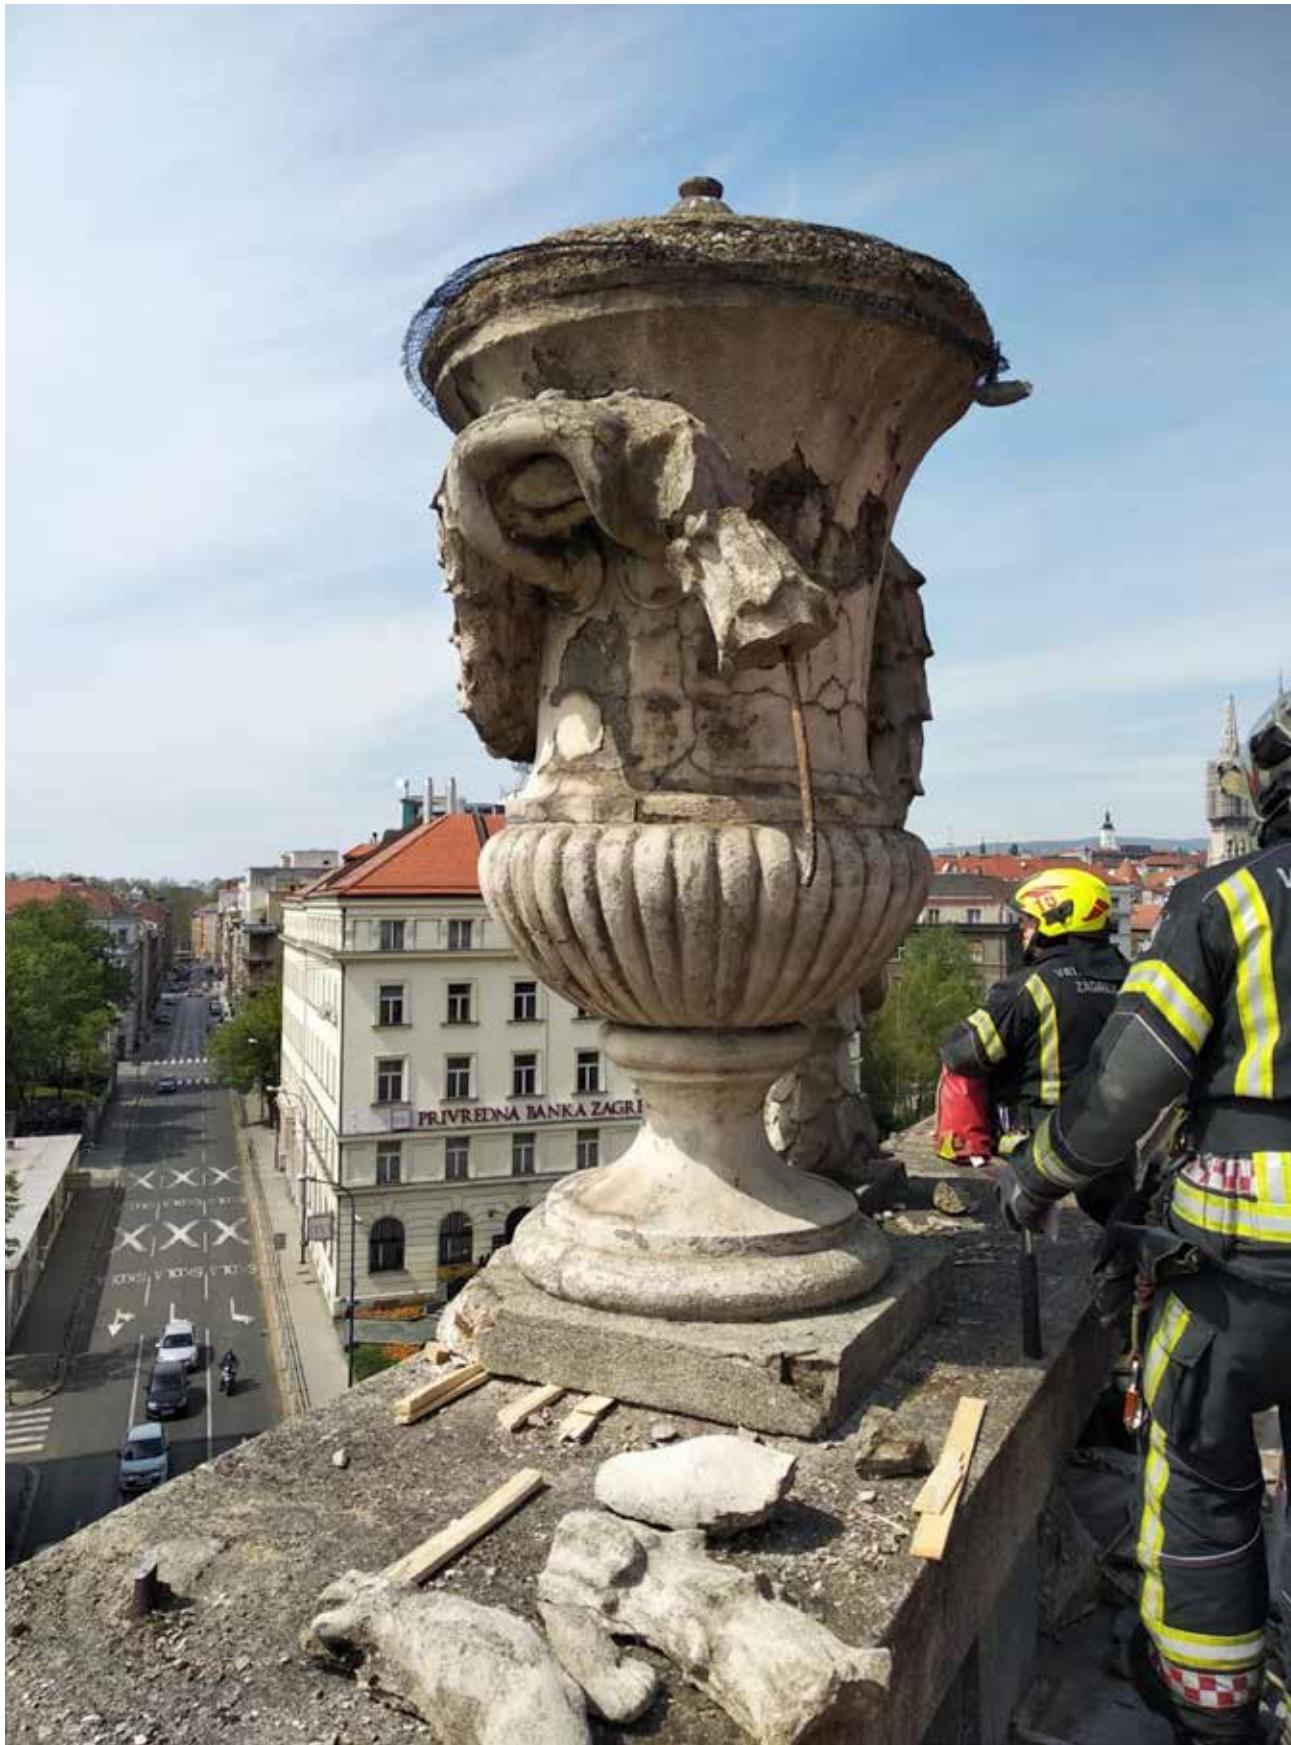
The fire department in cooperation with the City Institute before removing the decorative vase from the roof of the building at Račkoga 9 (City Institute for the Conservation of Cultural and Natural Heritage photo archive, 2020)
