Post-earthquake structural assessment of the Parish house in Sela

The 2020 earthquakes in Croatia highlighted the vulnerability of historical unreinforced masonry buildings. The Parish house next to St. Mary Magdalene church in Sela is one of the cultural heritage buildings that suffered significant damage. As these buildings hold important tangible and intangible values for the local population, their seismic assessment and subsequent retrofitting that respects the value of their historical components is crucial for the recovery of the areas affected by the earthquakes. This paper contributes to this topic by performing structural assessment both for in-plane and out-of-plane mechanisms. Analyses comprise both state-of-art numerical simulations for the in-plane behaviour and hand calculations used for both the verification of in-plane behaviour and the assessment of the out-of-plane behaviour. The paper concludes by proposing retrofitting ideas on a conceptual level.

Keywords: unreinforced masonry, post-earthquake assessment, pushover analysis, equivalent frame models, retrofitting

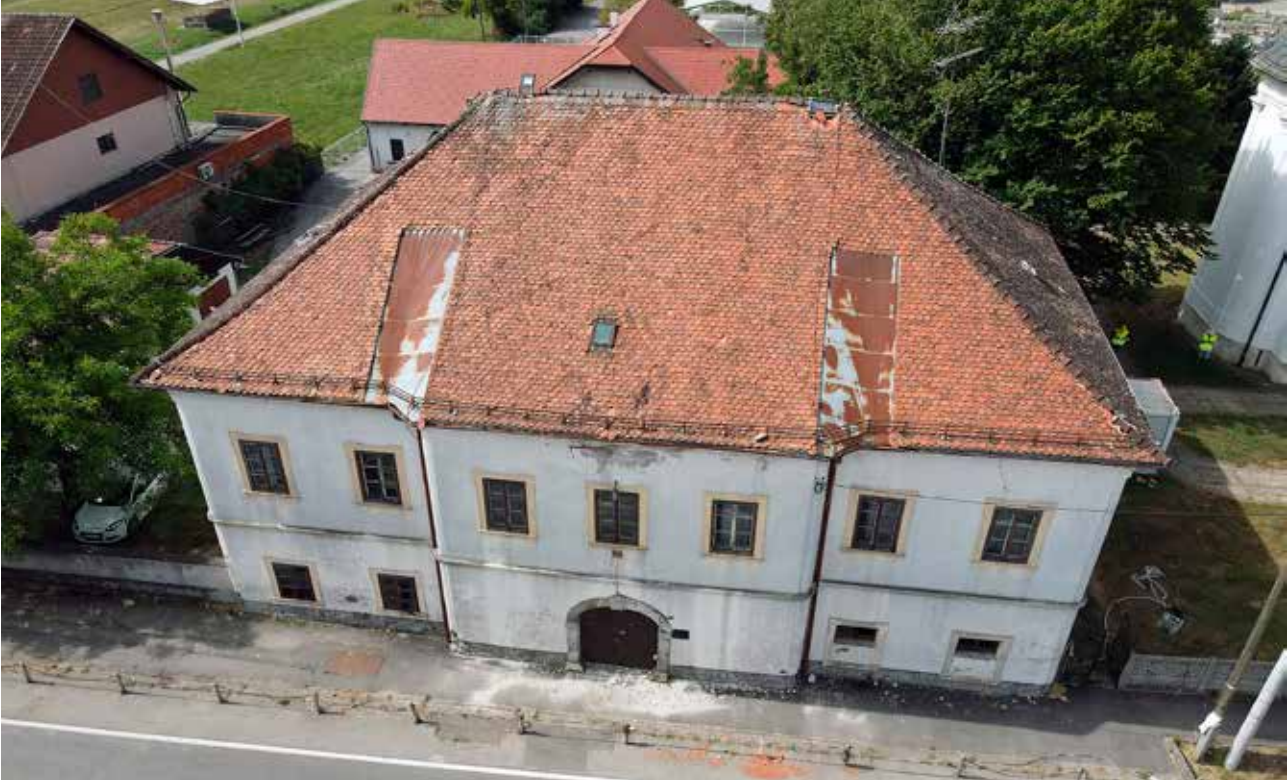
1 Parish house in Sela (photo: Thibaud Maillard, 2023)
 Župni dvor u Selima (foto: Thibaud Maillard, 2023.)

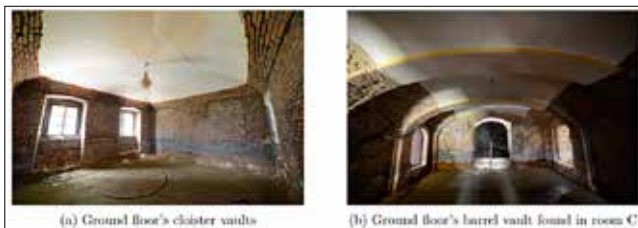
5 Cloister and barrel vaults found on the ground floor (photo: Thibaud Maillard, 2023)

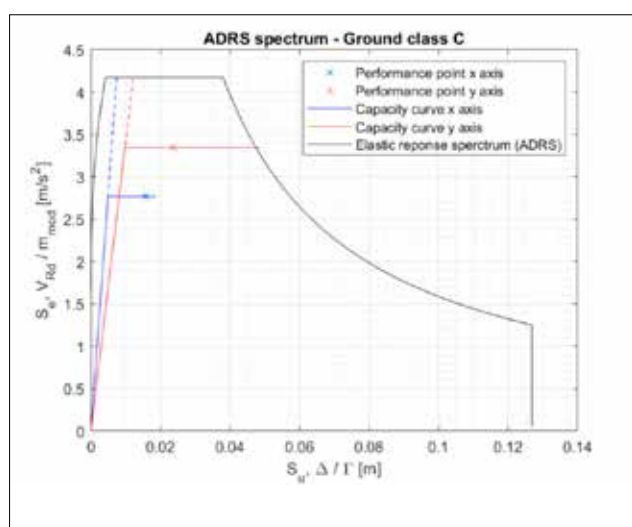
11 Capacity curves for longitudinal (x axis) and transversal (y axis) directions for the whole building and performance points (chart: Thibaud Maillard, 2023)

The calculation of the displacement demand showed that for both directions the parish house should be able to resist the seismic event. The compliance factors for the x and y directions are, respectively, $\alpha_x = 1.18$ and $\alpha_y = 2.07$. The transversal direction has a higher compliance factor, which can be explained by the fact the dominant failure in this direction is flexural and thus, the structure has a higher displacement capacity, as shown in Table 4. The results can be illustrated in an ADRS format graph (Fig. 11). The dashed lines are the prolongations of the elastic part of the capacity curves and its intersection with the response spectrum shows that the period of the SDOF is indeed on the plateau and thus the equal displacement rule could not be applied. The performance points are indicated with crosses.

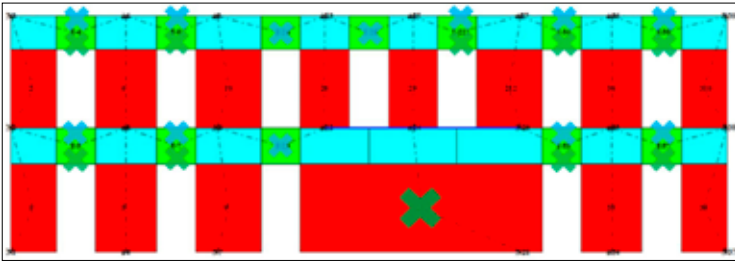
Kako bismo istražili scenarij fleksibilnih dijafragmi, proveli smo metodu postupnog guranja svakog zida kao samostalnog elementa. Prigodom provedbe metode postupnog guranja samo na jednom zidu nisu uzeti u obzir utjecaji stropova. Rezultati analize za zid južnog pročelja prikazani su slikovnim prilogom 14. Križići u plavoj boji označavaju elemente kod kojih dolazi do loma savijanjem, a u zelenoj boji elemente s posmičnim lomom. Usporedba je pokazala da je takva analiza dobro predviđjela lom nadvoja, tj. da je on nalik ponašanju u stvarnosti, barem za neizbačene dijelove pročelja. Kao što je gore navedeno, pukotine izbačenog dijela vjerojatno odgovaraju mehanizmu izvan ravnine.

14 Prediction given by Tremuri for the south facade. Blue crosses indicate elements that have failed in flexure, green crosses indicate elements that have failed in shear. (drawing: Thibaud Maillard, 2023)
