# Examination of the Causes for Premature Failure of Mating Surfaces in Smart Injector Actuators

Dejan JANKOVIC\*, Mileta RISTIVOJEVIC, Zoran STAMENIC, Zarko MISKOVIC, Aleksandar DIMIC

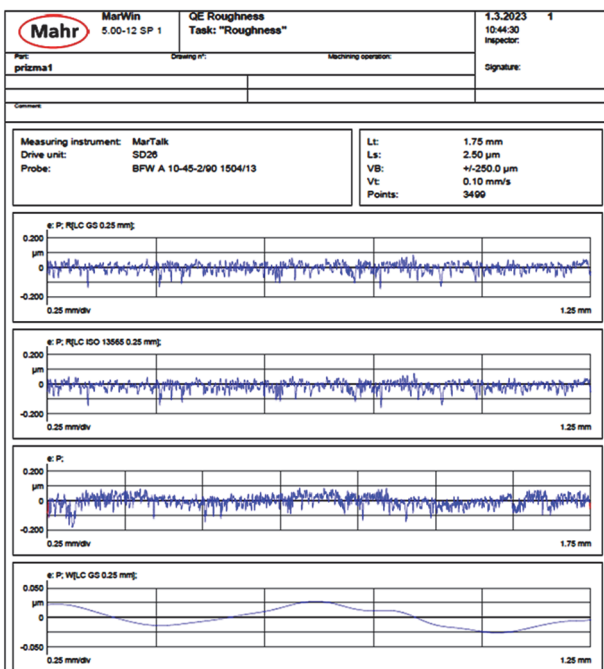
Figure 5 Graphic of micro roughness

The DLC coating roughness directly depends on the ion impingement energy, whose value below 50 eV produces a rough surface, whereas if the threshold is increased, the roughness shall sharply decline [5]. The most common DLC coating roughness value does not exceed 0.3 µm, whilst in our case,  $R_{max}$  is 0.234 µm, as shown in Fig. 5 and Fig. 6.

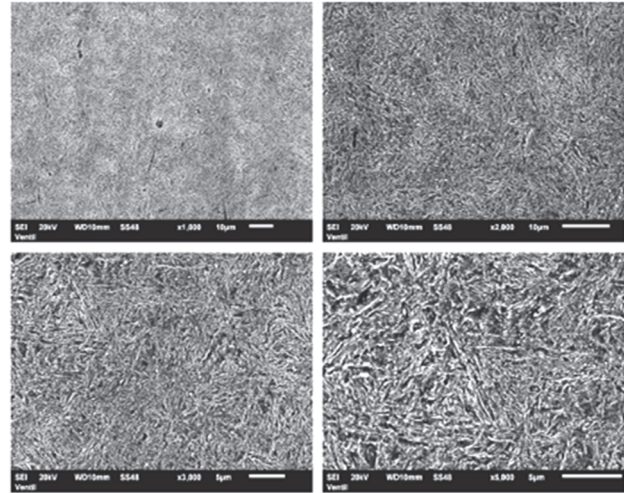
Figure 9 Actuator material microstructure

Tempered martensite, as used in the manufacture of the actuator and the intermediate plate is characterized by its needle-shaped features, which can be inferred from the microstructure analyzed by SEM, and shown in different sizes in Fig. 9.

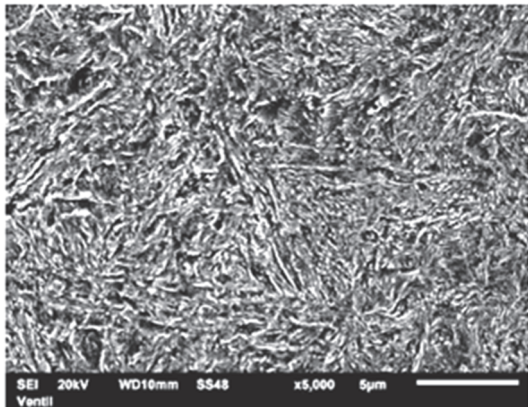
Figure 14 Base material microstructure

and/or it is linked to the operational conditions. Base material has martensite uniform structure throughout the entire surface.

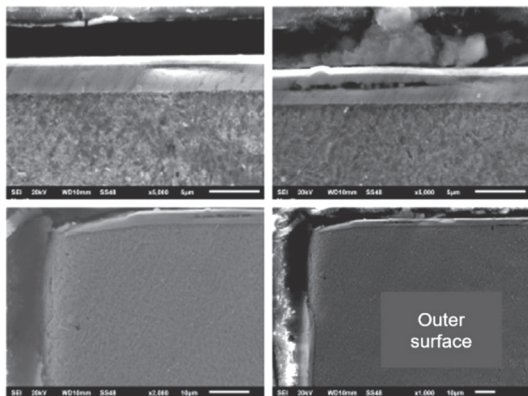
Figure 15 SEM photomicrographs without dimension values

Damage to the coating indicates inadequately coated pins. Under operating conditions, rapid damage to mating surfaces occurs due to abrasion and erosion caused by

small particles of the detached coating. In further use, this damage causes performance reduction in actuators and smart injectors.
