Transformer fleet condition assessment using advanced analytics

practically allocated for repair, refurbishment, or replacement. This article provides a case study for a fleet of eight (8) transformers that were above 50 years of age.

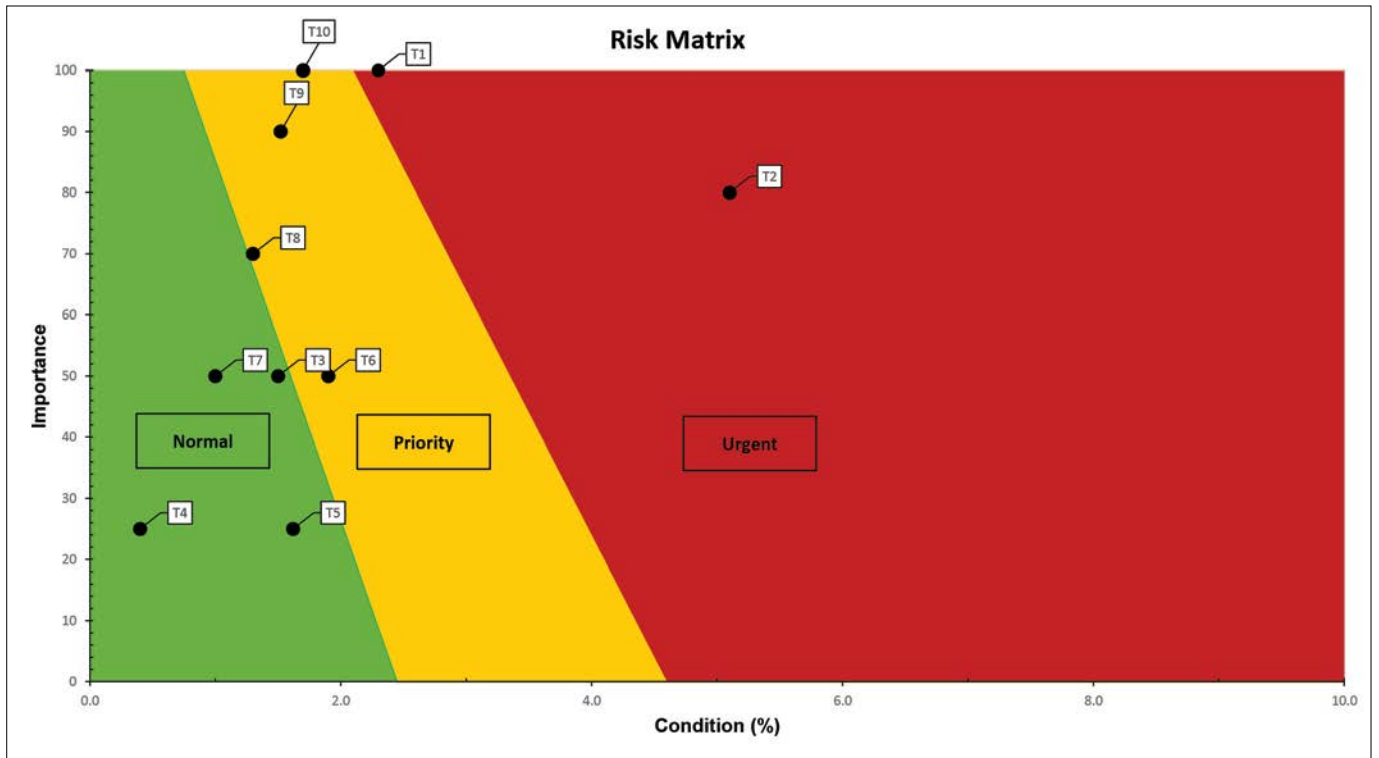
Figure 1. Risk management approach to identify transformer risk of failure.

This approach to fleet risk screening involves a combination of the risk of failure assessment and the relative importance of a transformer to the utility system. Each transformer in the fleet is assigned a risk of failure and relative importance and displayed on the risk management plot, as shown in Figure 1. Those that fall in the Red Zone are transformers with a

combination of high risk of failure and/or higher importance for the system. These are classified as Urgent or those requiring immediate action. The next transformers are those in the Yellow or Priority zone. Action would normally be taken on these transformers as soon as the Urgent transformers have been taken care of. The transformers in the Normal category would typically not require anything other than normal basic maintenance unless circumstances move either the risk of failure or importance to a higher value (into the Yellow or Red Zone).
