# Improving Welding Quality on Zacns 98 m<sup>3</sup> Wagon Underframe

**Abstract:** The Zacns 98 m<sup>3</sup> wagon is a wagon with a tank intended for the transportation of dangerous goods in a liquid state. Accidents caused by faulty production can have serious consequences for material goods and human health. It is therefore necessary to pay particular attention to the quality of the production process. The wagon itself consists of two parts: the tank and the underframe. These and other components are joined together using welding technology. The quality of the weld seams on the underframe, in particular the weld seams that belong to weld seam quality class CP B1 or CP B2 according to the HRN EN ISO 15085-3 standard, is the focus of the quality assurance system. Non-destructive surface and volume tests must be carried out on such weld seams and the results, which indicate problems in the welding process, must be closely monitored. This article presents welding and quality control systems for CP B1 and CP B2 performance class welds. In addition to the technologies of welding and quality control, the authors intend to show the quality level over a longer period and propose meas

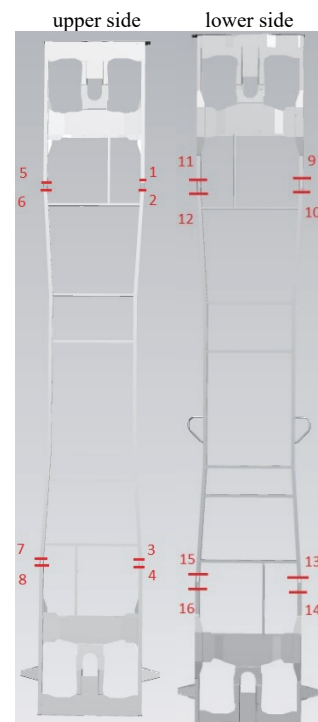
Figure 8 Location of the examined welds on the underframe

The test scope of 100% was carried out with the intention of obtaining an objective picture of the welding quality on the DP-1. Fig. 8 shows the exact position and marking technique of the weld seams on the top and bottom of the underframe.
