**ASSESSMENT OF A HISTORIC MASONRY BUILDING:
A CASE STUDY OF THE 1ST GYMNASIUM**

ORIGINAL SCIENTIFIC PAPER
[https://doi.org/10.31522/p.34-1\(71\).1](https://doi.org/10.31522/p.34-1(71).1)
UDC 727:699.841 (439.55 Sarajevo)

ASSESSMENT OF A HISTORIC MASONRY BUILDING: A CASE STUDY OF THE 1ST GYMNASIUM

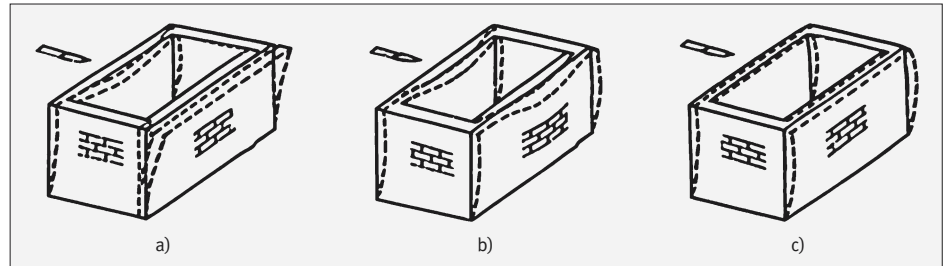
FIG. 1 INFLUENCE OF CONNECTION AND STIFFNESS OF FLOOR ON THE "BOX" MODEL:

Figure 1 shows the influence of the connection between the floors and walls and the stiffness of the floors on the seismic action of the structure. The variants shown illustrate different seismic response scenarios depending on the degree of interconnection of structural elements.

Fig. 1a illustrates a structure with a flexible floor without a rigid connection between orthogonal walls. In such a case, each wall acts as a separate element, without the possibility of working together with other load-bearing walls. This configuration significantly weakens the resistance to horizontal forces. As the walls are not mutually supported, this increases the risk of a local or global collapse during seismic loading. Fig. 1b shows a construction in which the walls are connected by

A) FLEXIBLE FLOOR WITHOUT HORIZONTAL BOND BEAMS; B) FLEXIBLE FLOOR WITH HORIZONTAL BOND BEAMS; C) RIGID FLOOR WITH HORIZONTAL BOND BEAMS (GALLONELLI, 2007: 57)

horizontal bond beams at the junction with the floor, while the floor remains flexible. This solution somewhat improves seismic resistance because horizontal bond beams connect the walls and enable their partial associated deformation. It is what reduces the possibility of complete separation of the walls during an earthquake. In this type of construction, the significant out-of-plane bending of the walls is still present, which may lead to local collapse mechanisms. The construction of the rigid floors and horizontal bond beam is illustrated in Fig. 1c. This changes the action of the structure once exposed to an earthquake. Now the structure overall demonstrates “box action,” which is more favourable. In this case, horizontal forces are efficiently transferred onto the walls with respect to their stiffness.

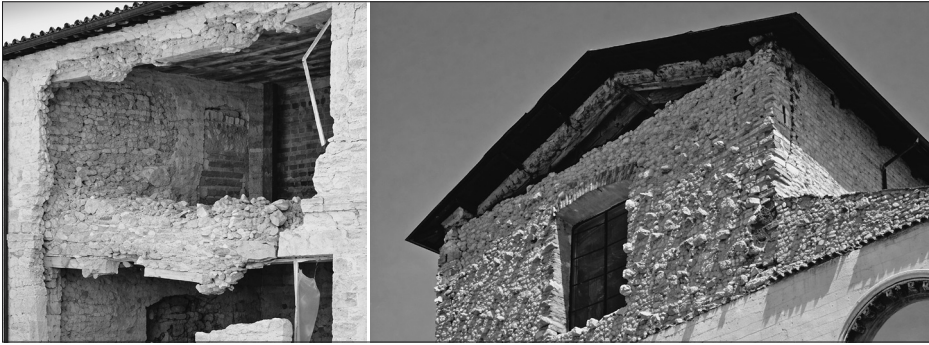
FIG. 2 INADEQUATE STRENGTHENING METHODS (BINDA AND MODENA, 2011)

strophic scenarios. An example of this was seen, after the earthquake in the Friuli region, where improper interventions on historical buildings caused the so-called *hammering effect*. In particular, the installation of reinforced concrete slabs significantly altered the dynamic response of the structure. The increased stiffness of the floor led to the concentration of seismic forces in the walls, which resulted in out-of-plane failure (see Fig. 2).

Fig. 9 illustrates the current state of the structure, indicating the creation of the additional third floor. This addition has increased the mass of the structure, and with the usage of the reinforced concrete bond beams and tie columns, this has significantly altered the dynamic action of the original URM structure. The addition of the mass and the change in the stiffness of the upper floor have had an impact on the natural frequency. If the connection of the old part of the structure and the new part is not conducted in a proper way, this could have an impact on the structure's seismic response. At the location of intervention, there is an obvious stiffness and mass discontinuity, which may lead to differential movements, cracks, and stress concentrations, as seen in similar cases in Italy (Fig. 2). The dynamic
