Materials Analysis of Parts of a Subsystem for the Tailings' Spreader Movement

Dušan ARSIĆ*, Ružica NIKOLIĆ, Aleksandra ARSIĆ, Malgorzata ULEWICZ, Nenad GUBELJAK, Dragan CVETKOVIĆ

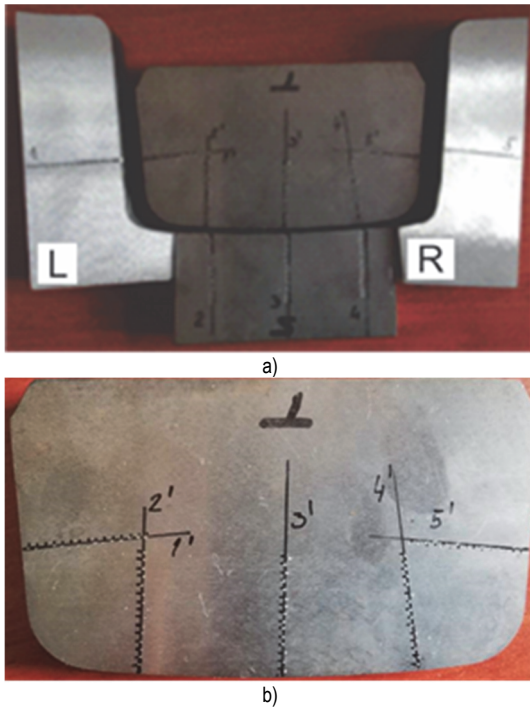
Figure 7 a) Directions of the hardness measurements in the contact zone of the wheel and the shoe link; b) Details of the hardness measurements positions (lines 1 to 5, Tab. 4)

By calculating the strength according to the mentioned formulas, a slightly higher strength is obtained than that prescribed for the tested steel. High strength in the surface zones of the track material (acted by the wheel) can lead to peeling of the material and significant damage to the track [9].

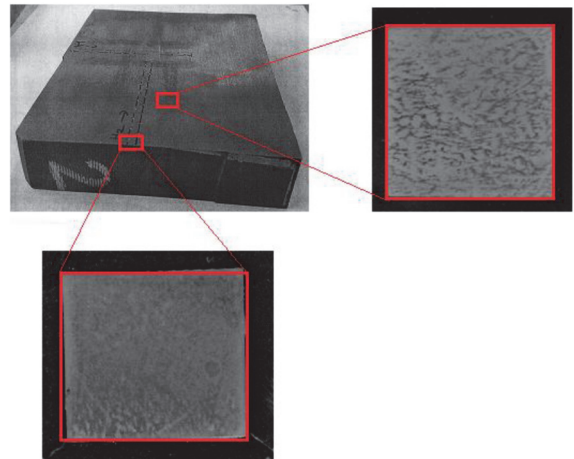
Figure 9 The tested part of the wheel and location of points at which the samples were taken

The microstructure in the surface and subsurface zone of the examined piece (at depth of 3 mm from the sample surface) consists of martensite (Fig. 10a and 10b), and the microstructure in the bulk (at depth of 10 mm from the sample surface) of martensite and bainite, Fig. 10c, which corresponds to the material class of steel forging 42CrMo4 +QT.

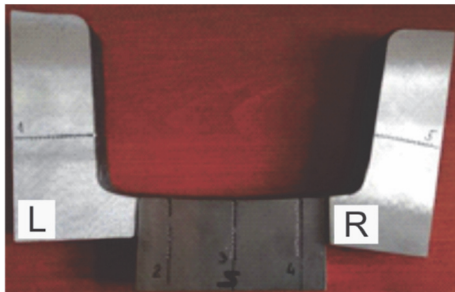
Figure 11 Directions of the hardness measurements in the contact zone of the shoe link and the wheel

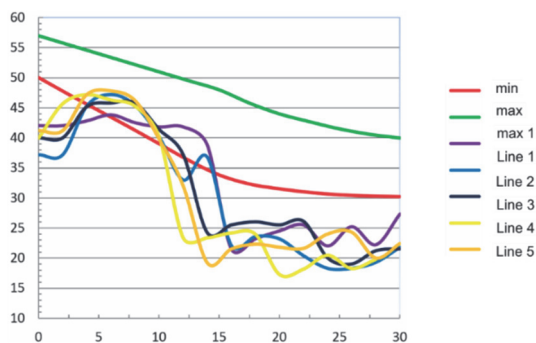
Figure 12 Hardness variation along the material's depth with minimum and maximum values

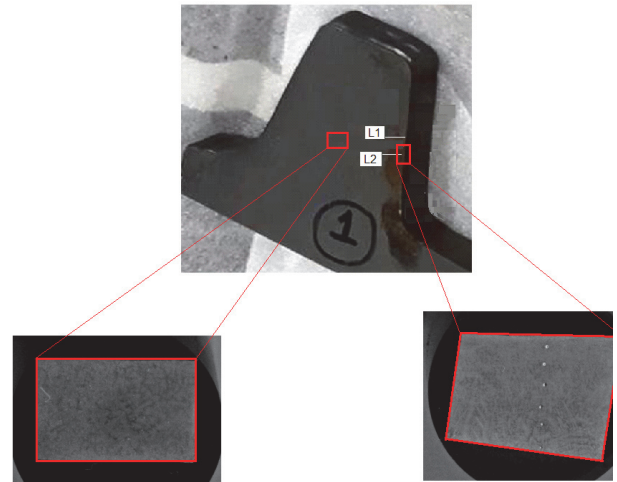
Figure 13 The tested part of the shoe link and location of points at which the samples were taken

The results of the test with a magnification of 100× are given in Fig. 14. The microstructure in the surface and subsurface zone of the tested piece, at a depth of 3 (mm) from the surface, consists of martensite (Figs. 14a and 14b), and the microstructure in the bulk of the test piece sample, at a depth of 10 mm from the surface, consists of bainite and martensite, Fig. 14c.
