ANALIZA VELIKOG KVARA U TRAFOSTANICI NA OTOKU KRETI

THE STUDY OF A MAJOR 2008 SUBSTATION INCIDENT IN THE EPS OF CRETE

Emmanuel Thalassinakis – Thales M. Papazoglou, Iraklio, Crete, Greece

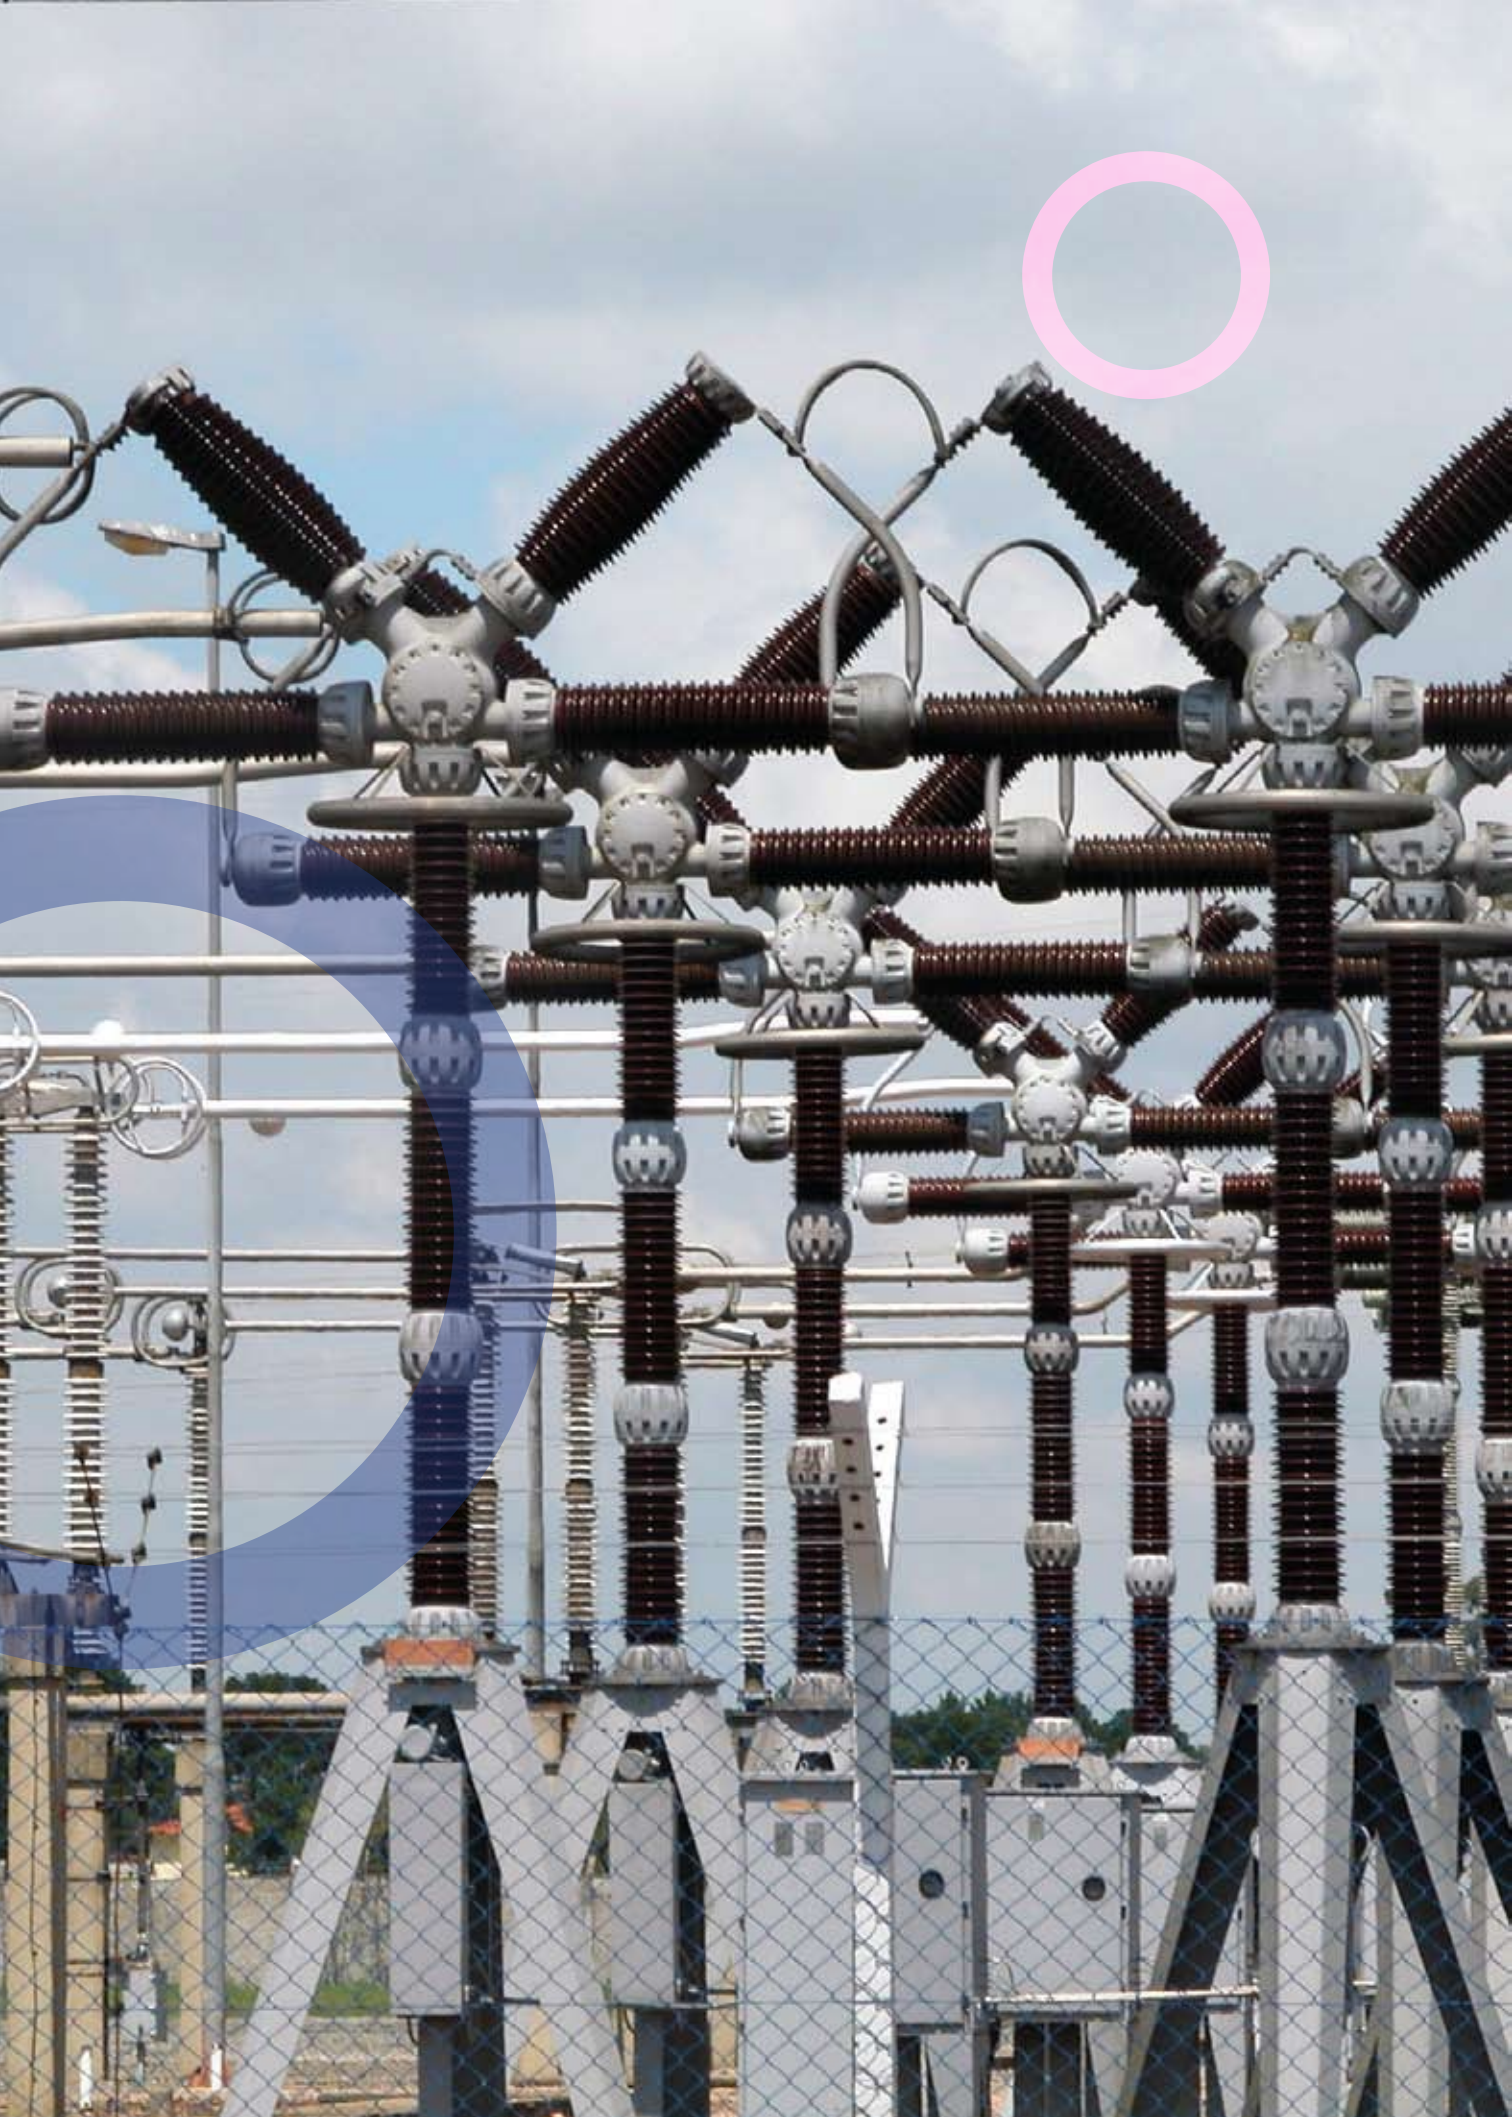
Shortly afterwards, the fault developed into a three-phase fault causing the differential transformer protection to open the circuit breaker P215 (Figure 1) on the transformer secondary side, but, it failed to open the breaker P15 (same figure) due to the destruction of the corresponding trip-circuit. In other words, the fault failed to be cleared. The fault currents have been estimated to 4 933 A. These currents were sustained for 16 continuous minutes, producing destructive heat that resulted in extensive fires in the substation installations. The end result was that Power Transformer # 1 of the substation suffered extensive damage, as had all the control and protection equipment, including one internal service transformer, three audio-frequency transformers, etc. which were destroyed.

Following this experience, it is considered a must to separate the power cables from the control and protection cables passing them through completely different channels. Moreover, back-up transformer protections are advisable. For example, there should be a back-up protection in case differential protection fails to act. So, a high-current protection should be enacted, at a slightly higher time-interval, at the HV breaker of the transformer. In addition, a restricted earth-fault protection could be necessary, which is more sensitive to single-phase faults.
