RAIL INSPECTION OF RCF DEFECTS

Key words: rail, rail defects, rolling contact fatigue, inspection

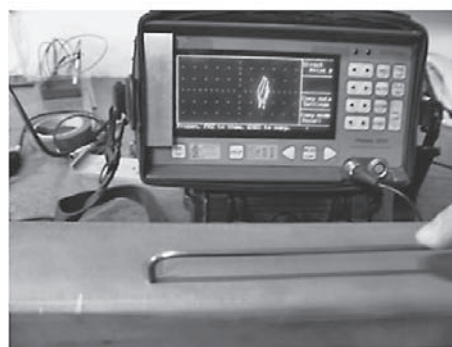
Figure 6 Rail testing using EC device Phasec 2200 (NDT Laboratory JAT in Belgrade, 2012)

α by using the EC method. Based on a long period of investigation, for calculation of HC defect depth, large range of angle values, from $15^\circ \div 30^\circ$, should be used. This is a serious disadvantage of EC inspection method, because depth of defect can only be measured indirectly [15]. The eddy current device, Phasec 2200, for manual testing (NDT Laboratory JAT in Belgrade, 2012) is shown in Figure 6. Standard sonde was used at operating frequency of 500 kHz.
