THE EFFECT OF CRACKS ON STRESS STATE IN CRANE WHEEL HARD-SURFACE UNDER CONTACT LOADING

Drakče Tanasković, Uroš Tatić, Branislav Đorđević, Simon Sedmak, Aleksandar Sedmak

Original scientific paper

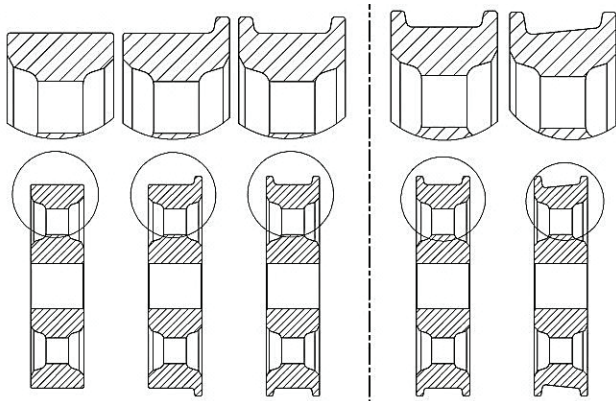
Figure 1 Left: Different geometries; Right: Different contact surfaces

Examples of the different geometries as well as contact surfaces of wheels can be seen in Fig. 1.

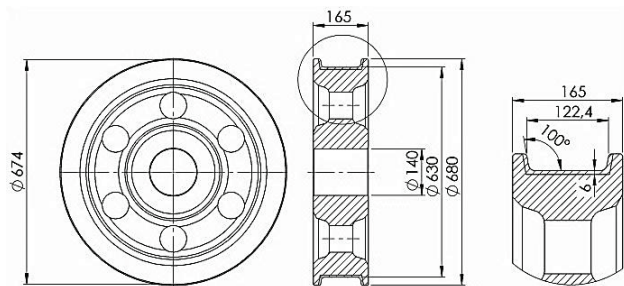
Figure 2 Geometry of the most commonly used wheel type in Steel mill facility "Železara Smederevo"

Most commonly used wheel type in Steel mill facility "Železara Smederevo" is with two rims and cylindrical contact surface, as shown in Fig. 2. Test and simulations shown in this paper were obtained on this type of wheel.

Contact surface diameter is $\varnothing 630$ mm with outer rim diameter $\varnothing 680$ mm. Rims are set under the angle of 100° . Width of the wheels is 165 mm. Wheels are made with six symmetrically spaced holes used to reduce weight. Hole for the axis has a diameter of 140 mm. Repaired welded layer with a thickness of 6mm can be seen at the contact surface area. Geometry of the rail S49 (DIN 536 part 1, TU U 14-2-1230-99) with enlarged contact area can be seen in Fig. 3[7].

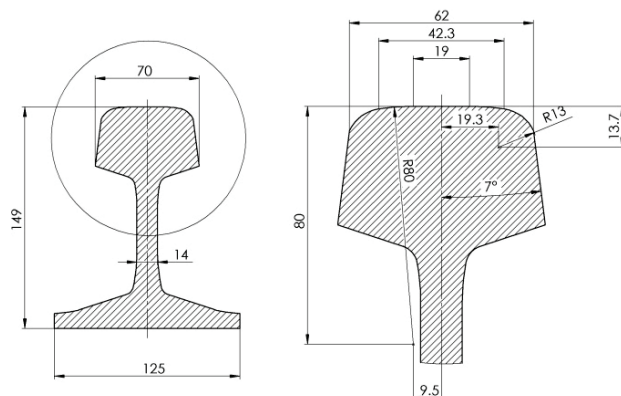
Figure 3 Geometry of the rail

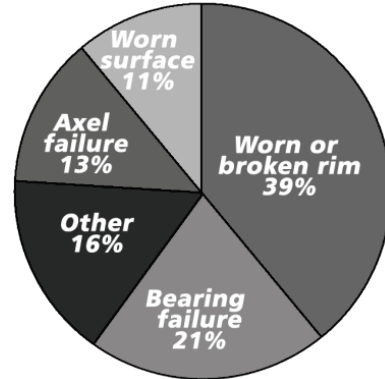
Figure 4 Failure types shown in percentage

noted. The most common reason for replacement is the wear of the rim. It is defined by the local regulations that in a case when rim thickness is reduced to 10 mm or less the wheel must be replaced immediately. Rim wear or even breakage is responsible for almost 40 % of all failures. Fig. 4 represents a diagram with all of the most common failures defined in the percentage.

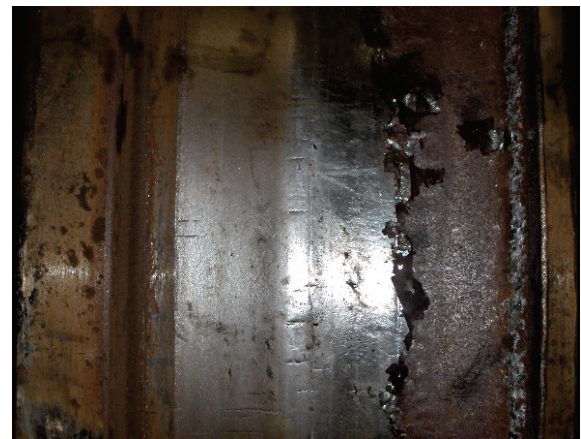
Figure 5 Contact surface and rim wear during the wheel exploitation

Examples of surface and rim wear as well as the rim breakage that has occurred during the wheel exploitation can be seen in Fig. 5 and Fig. 6.

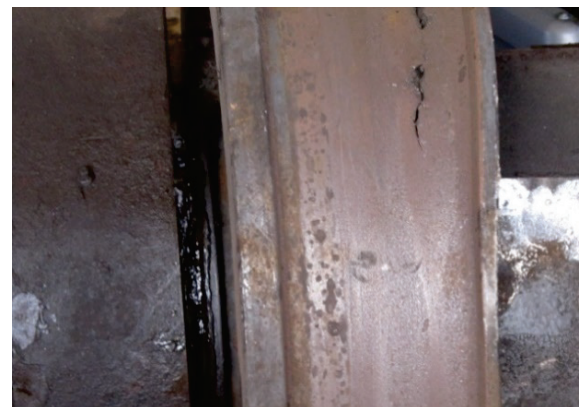
Figure 6 Rim wear and breakage during the wheel exploitation

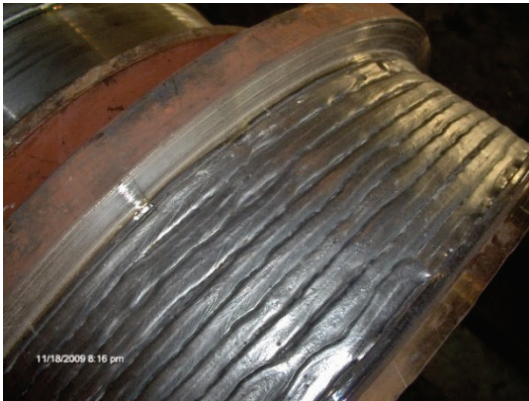
Figure 7 Repaired wheel after welding procedure

After welding, wheel was subjected to annealing. Appearance of repaired wheel after welding procedure can be seen in Fig. 7.

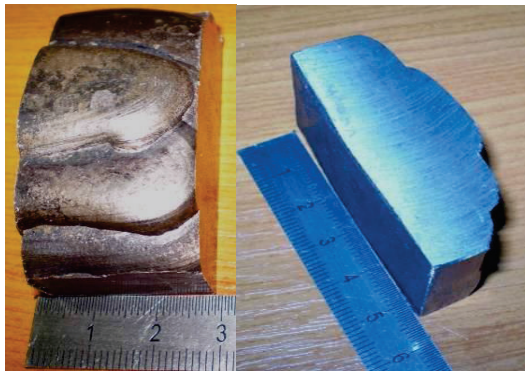
Figure 8 Macro appearance of sample

base material is a ferrite-pearlite. Macro appearance of sample can be seen in Fig. 8.

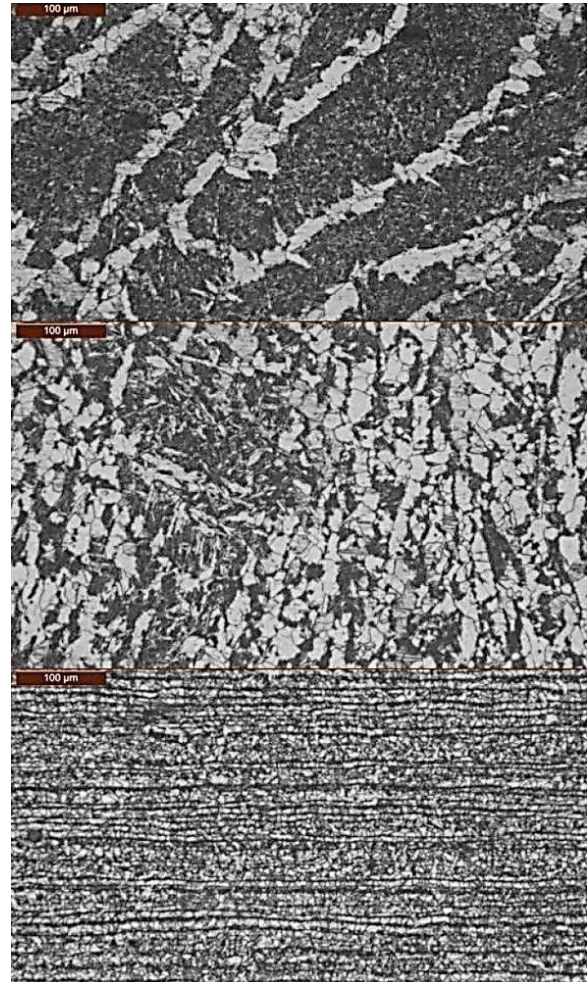
Figure 9 Microstructure of sample

Microstructure of the sample can be seen in Fig. 9. Martensite structure in both welded layers can be observed. Martensite structure has very high wear resistance. It is used to solve the problem of wear due to friction of metal on metal or general wear and tear caused by friction and impacts, [11, 13].

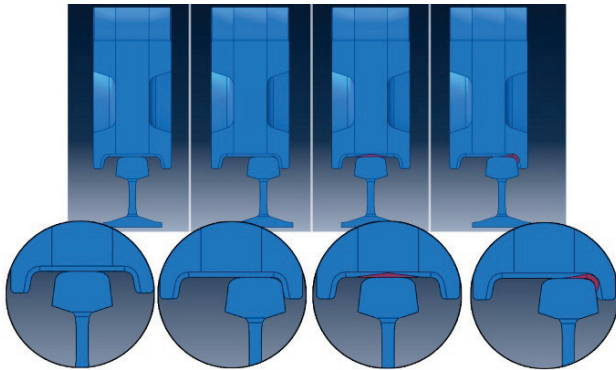
Figure 10 Different models used for simulations (left to right); symmetric loading without a crack; asymmetric loading without a crack; symmetric loading with a crack; asymmetric loading with a crack.

In order to evaluate stress strain distribution caused by the contact, four separate models were developed. First model was made with assumption that a contact was ideal, i.e. that the wheel and the rail were symmetrical, Fig. 10. This model was denoted as symmetric loading without a crack.

rail, there is no initial contact between top of the rail and wheel i.e. gap is present between top surfaces of the wheel and rail. This model was denoted as asymmetric loading without a crack and can be seen in Fig. 10.

Third model used for evaluation was positioned as a symmetric loading but with a symmetrically positioned crack in the contact area. This model was denoted as symmetric loading with a crack and can be seen in Fig. 10.

The fourth model developed was based on asymmetric loading with an asymmetrically positioned crack in the transition area between the wheel rim and contact surface. This model was denoted as asymmetric loading with a crack and can be seen in Fig. 10.

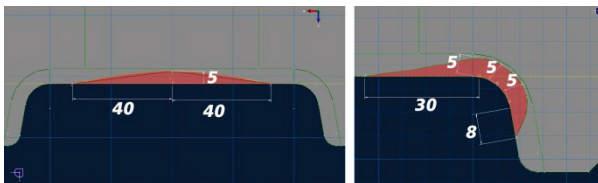
Figure 11 Sketches used to define cracks geometry

Detailed dimensions and sketches of predefined cracks on models with symmetric loading and asymmetric loading with a crack can be seen in Fig. 11.

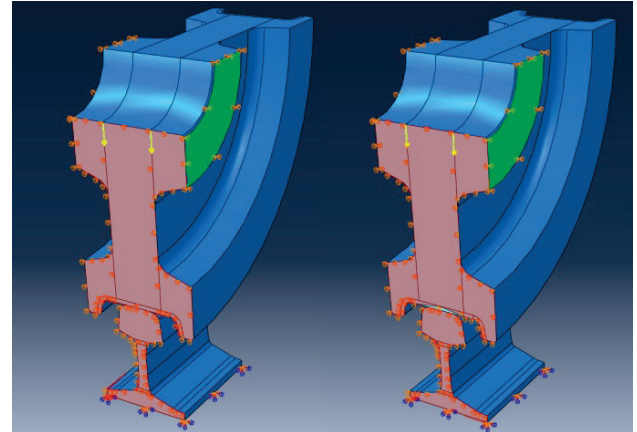
Figure 12 Left: Loads and boundary conditions for symmetric loading without a crack; Right: Loads and boundary conditions for symmetric loading with a crack

Loadings and boundary conditions that were applied to all models can be seen in Fig. 12. Support on a bottom side of the rail was used to restrict the position of the whole assembly and to simulate working conditions. Additional restriction to lateral movement and rotation was added on to side surfaces of axis opening (green area). Displacement restriction in the axial direction of the rail was also introduced (red area). Please note that although boundary conditions and loads were the same for all models, with only difference in the mutual position of the wheel and rail and geometry of the crack, in Fig. 12

only symmetric loading without a crack and symmetric loading with a crack is shown. In the case of all models with a crack, crack area displacement was not restricted in the axial direction.

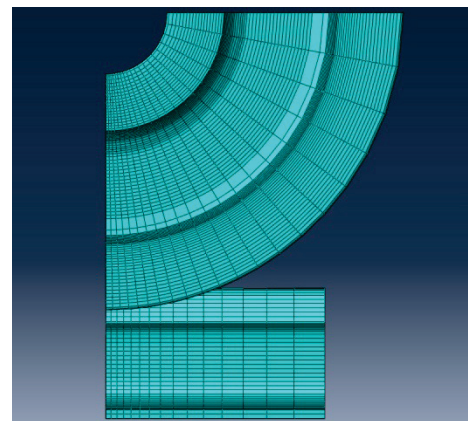
Figure 13 The finite element mesh

All models were meshed with the use of C3D8R elements, 8-node linear elements with reduced integration. Element size was reduced towards the contact area in both wheel and rail in order to ensure adequate results. Example of the mesh is shown in Fig. 13.
