# IMPACT RESISTANCE OF GYPSUM BOARD SUBJECTED TO LOW VELOCITY IMPACT

Original scientific paper

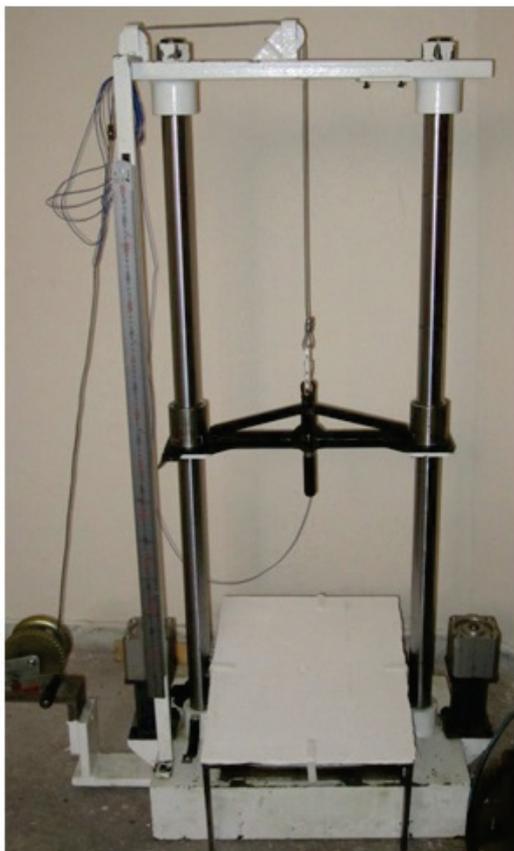
Figure 1 Drop weight test device

In this study, a special drop weight test device developed in Engineering and Architecture Faculty in Selcuk University is used (Fig. 1). The device is 1.4 m high. Striker which has semi spherical tip geometry has 6.350 kg mass and is able to fall freely from 1.0 m. There is a locking mechanism in order to release the mass from a desired distance. Thus, tests in various impacts energies and velocities can be performed.

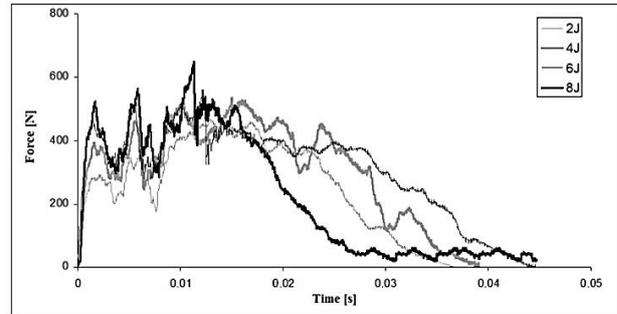
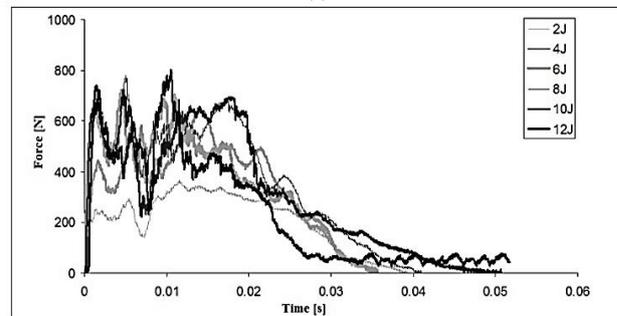
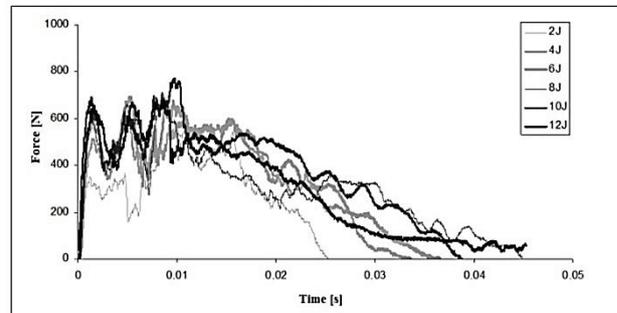
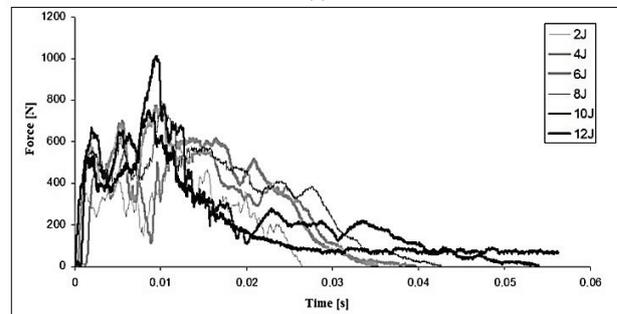
Figure 2 Contact force and time histories for a) gypsum board, b) gypsum+mesh, c) gypsum+wallpaper and d) gypsum+mesh+wallpaper samples for various impact velocities

Contact force-time variations can be seen in Fig. 2 for a) gypsum b) gypsum+mesh c) gypsum+wallpaper d)

gypsum+mesh+wallpaper test samples. In all figures, the force reaches a maximum value by rapidly increasing and then it goes to zero for the impact occurred with rebound and stuck. In the samples where the puncture occurred, the force does not go to zero, force-time curve moved parallel to the horizontal axis with the effect of friction. A lot of oscillations are observed in the increasing part of force-time curves in all graphs. These oscillations indicate the damages occurred in the sample.

In plain gypsum board samples, rebound occurred for 2 and 4 J impact energy levels, stuck occurred for 6 J and puncture occurred for 8 J impact energy levels so the tests for 10 and 12 J were not carried out for them. When the impact energy is increased in these samples, the biggest contact force also increased. In gypsum+mesh samples, rebound occurred for 2, 4 and 6 J impact energy levels, stuck occurred for 8 and 10 J and puncture occurred for 12 J impact energy levels. The highest contact force shows increment until 8 J impact energy where the stuck occurred and decrement is observed in 10 and 12 J impact energy levels. In gypsum+wallpaper samples, rebound occurred for 2, 4 and 6 J impact energy levels, stuck occurred for 8 and 10 J and puncture occurred for 12 J impact energy levels. The highest stuck force showed increment until 10 J impact energy level where the stuck occurred from gypsum+mesh samples and fell down again at 12 J impact energy level. In gypsum+mesh+wallpaper samples, rebound occurred for 2, 4, 6 and 8 J impact energy levels, stuck occurred for 10 J and puncture occurred for 12 J impact energy levels. The highest stuck force showed increment until 10 J impact energy level where the stuck occurred and fell down at 12 J impact energy level.

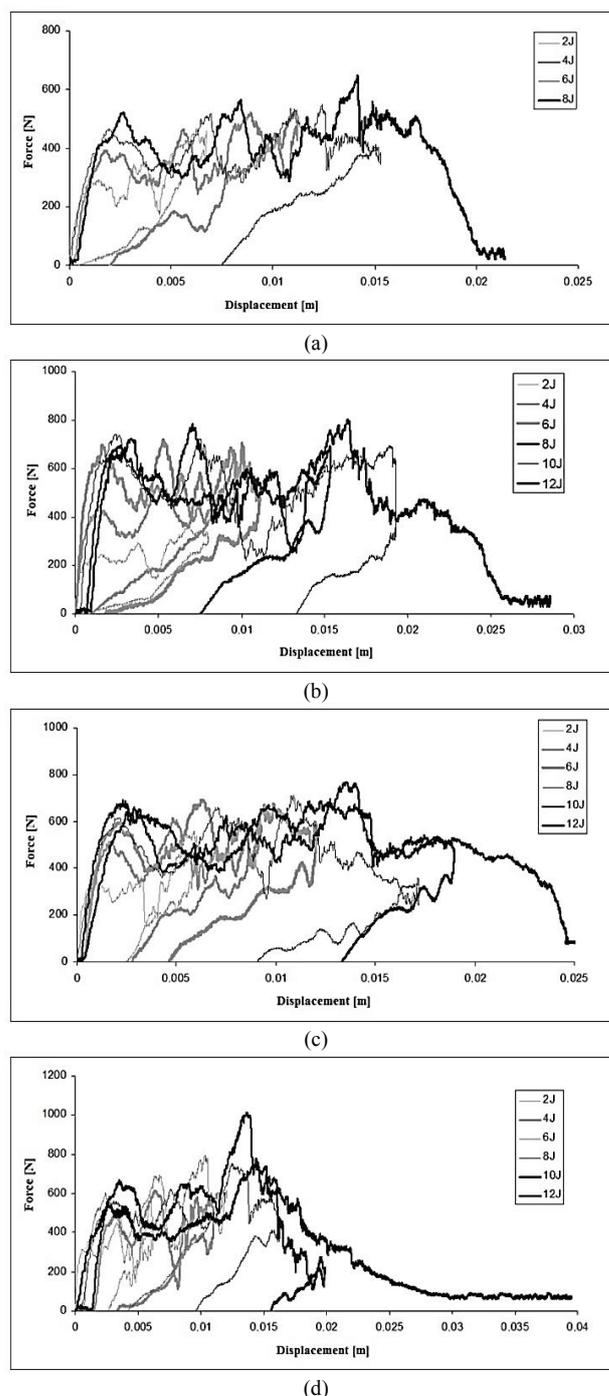
**Figure 3** Contact force and displacement histories for a) gypsum board, b) gypsum+ mesh, c) gypsum+wallpaper and d) gypsum+mesh+wallpaper samples for various impact velocities

Force-displacement changes in gypsum plate, gypsum+mesh, gypsum+wallpaper and gypsum+mesh+wallpaper samples can be seen in Fig. 3.

Force-displacement graphs obtained from various impact energy levels from gypsum plate samples are seen in Figure 3a. The curves obtained for 2 and 4 J impact energies are a closed type curve because the rebound occurs in those energy levels. While the curve obtained in 6 J impact energy level, it is in the transition region to the open type curve. This energy level is the one where the striker tip stuck to the sample. Since 8 J impact energy is the energy level where the perforation occurs, the obtained curve is open type.

A lot of oscillation is observed in force-displacement changes obtained for all samples in this study. The oscillation amount is lower in force-displacement graphs obtained from the studies where impact behaviors of layered composite materials are investigated. High amount of oscillation in the graphs obtained from gypsum board and doped gypsum board samples is related with impact damage mechanism occurring in the samples. Collapse and crush amount in the region where the striker contacts with the samples during impact are a lot more comparing to the layered composite materials. Since the resistance shown by gypsum material against crushing and compaction is weak, too much oscillation occurs in force-displacement curves.

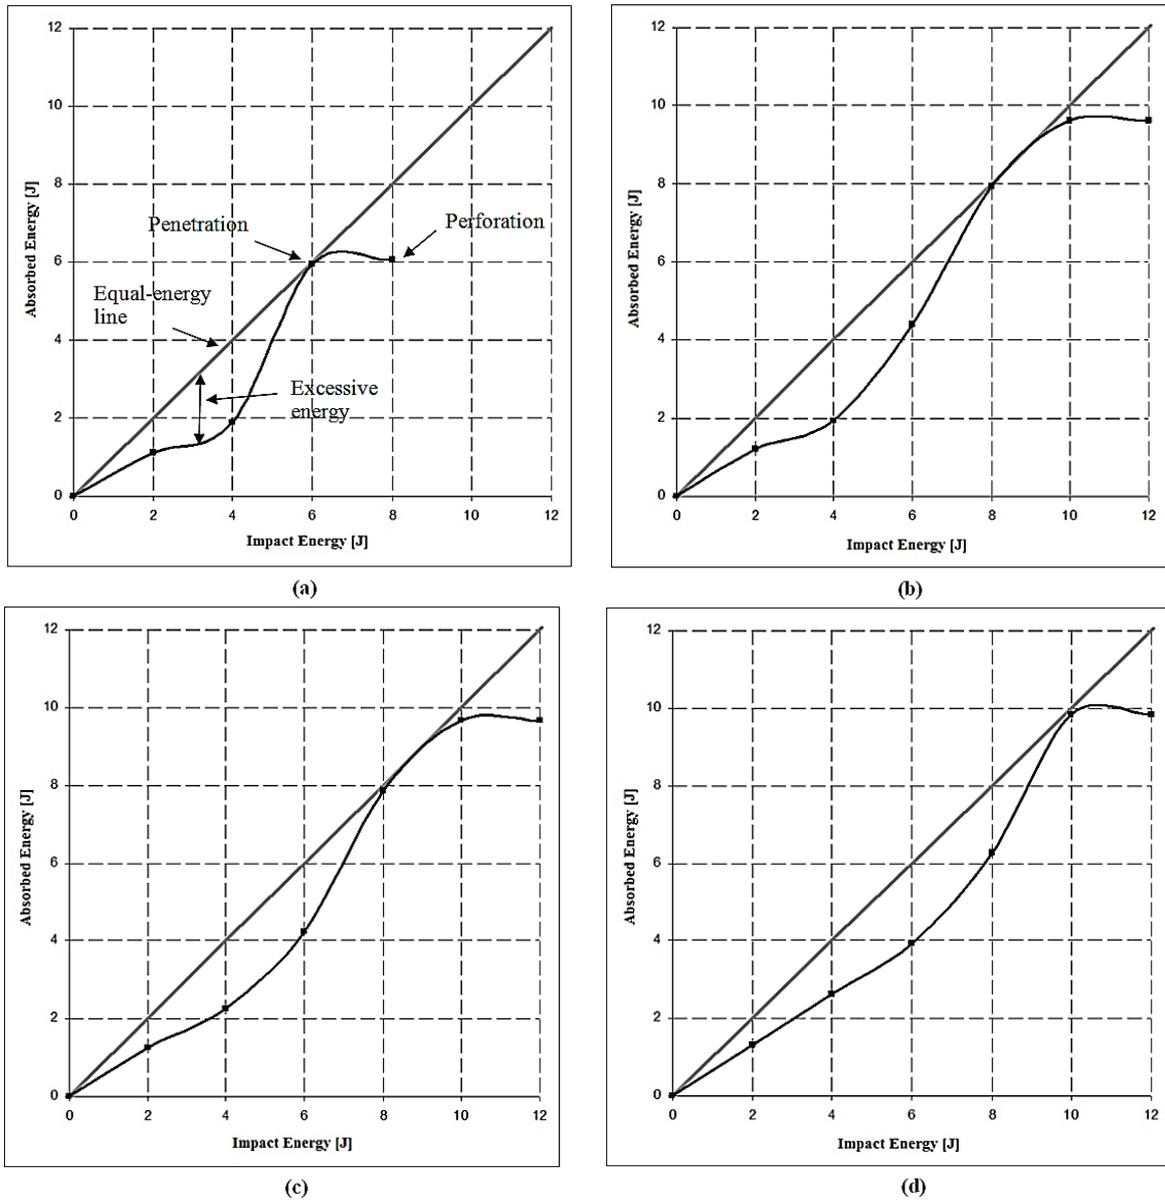
Figure 4 Energy profile variations for a) gypsum board, b) gypsum+mesh, c) gypsum+wallpaper and d) gypsum+mesh+wallpaper samples for various impact velocities

The correlation between impact energy and absorbed energy can be found using Energy profile method (EPM) (Liua et al. [22]). Energy profile variations are seen in Fig. 4 for gypsum board, gypsum+ mesh, gypsum+wallpaper and gypsum+mesh+wallpaper samples for various impact velocities.

Energy profile diagram belonging to gypsum board is given in Fig. 4a. High amount of energy and rebound were seen to have occurred in 2 J and 4 J impact energy levels. This excessive energy is used in rebound at striker tip. While the impact energy and absorbed energy is almost equal in 6 J impact level, stuck occurred in the

sample. A puncture occurred in the samples in 8 J impact energy. The energy absorbed by the sample remains constant after the puncturing limit. No matter how much the impact energy in striker tip increases, damages will not occur in the samples.

From the test, it is observed that the highest puncture limit is in gypsum+mesh+wallpaper sample and the perforation thresholds are increased by 62.4 % comparing to gypsum board.

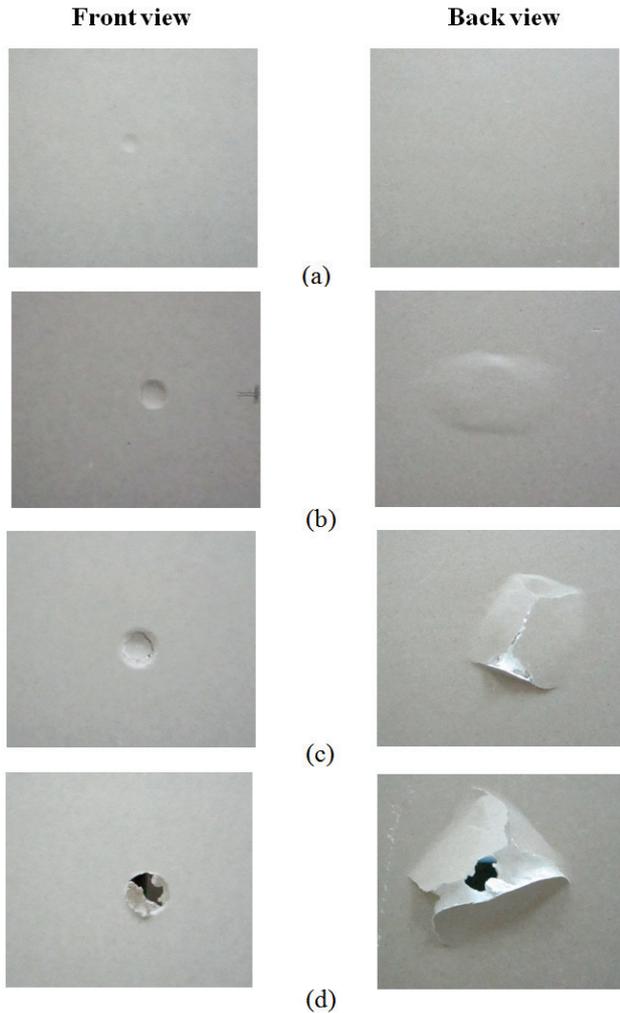
**Figure 5** Front and back damaged zones of Gypsum board for (a) 2 J, (b) 4 J, (c) 6 J, (d) 8 J impact energy levels

Macro scale impact damages occurred in composite gypsum boards. After the impact made in test samples, high resolution pictures of the front and back side of the damaged regions were taken. Front and back damaged regions for gypsum board, gypsum board+mesh, gypsum+wallpaper and gypsum+mesh+wallpaper samples subjected to low velocity impact, are seen in Figs. 5, 6, 7, 8, respectively.

In the tests performed for 2 J, 4 J impact energies on gypsum plate samples, bouncing occurred on gypsum plate. Stabbing occurred on gypsum plates in the test performed at 6 J impact energy. Puncture occurred on the gypsum plate in the test made at 8 J impact energy. While penetration region of the striker is seen on the front side of the sample in Fig. 5a, no damage is observed at the back side. Penetration zone formed in front side of the sample is seen in Fig. 5b. It is seen that swelling type damage occurred at the back surface of the sample and it is almost 8 times bigger than the one in front of the area. In 6 J impact energy, stuck is observed in the front side of the sample in Fig. 5c, but at the back side, impact trace

area occurred in the front side by striker impact tip causes again 8 times more damages. This damage is in the shape of splitting. Stuck is observed in the front side of the sample in Fig. 5d. Gypsum plate is punctured in 8 J impact energy and opening occurred at the back side as well as a cracking.

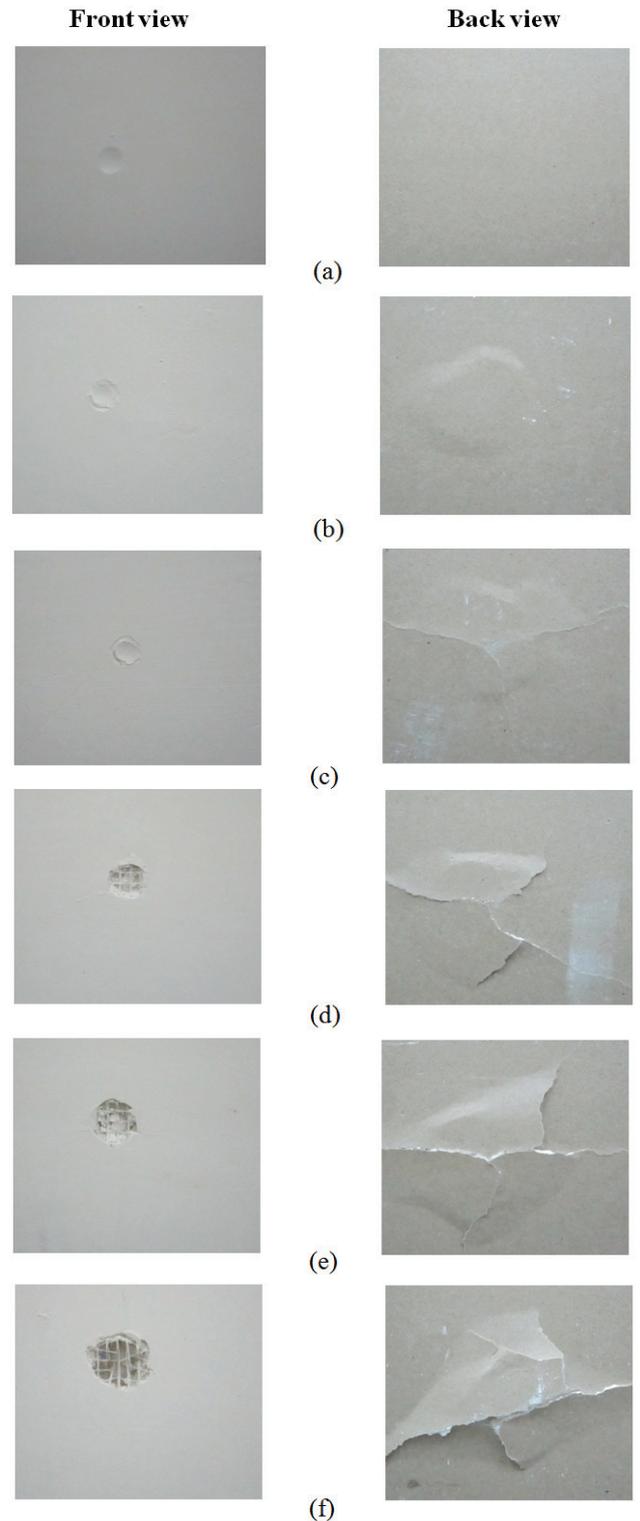
**Figure 6** Front and back damaged zones of Gypsum board+mesh for (a) 2 J, (b) 4 J, (c) 6 J, (d) 8 J (e) 10 J, (f) 12 J impact energy levels

Rebound occurred on gypsum plates in the test performed at 2 J, 4 J, 6 J impact energies in gypsum+mesh samples. Stabbing is observed on gypsum plate in the test performed at 8 and 10 J impact energies. Puncture occurred on gypsum plate in the test made at 12 J impact energy. While penetration area of striker can be seen in Figure 6.a. in the front surface of the sample, no damage is observed at the back side. While striker penetration damage is observed in the front face of the samples in Fig. 6b÷6c, approximately 8 times bigger damage that the impact trace created by the impact tip on the front side is observed at the back side. While stuck on the front side of the sample is observed in Fig. 6d÷6e,

explosion is seen at the back side of the samples. An opening is formed together with the explosion at the back side of the gypsum plate in 10 J impact energy. In 12 J impact energy, it is seen in Fig. 6f that the sample is punctured and opened by exploding.

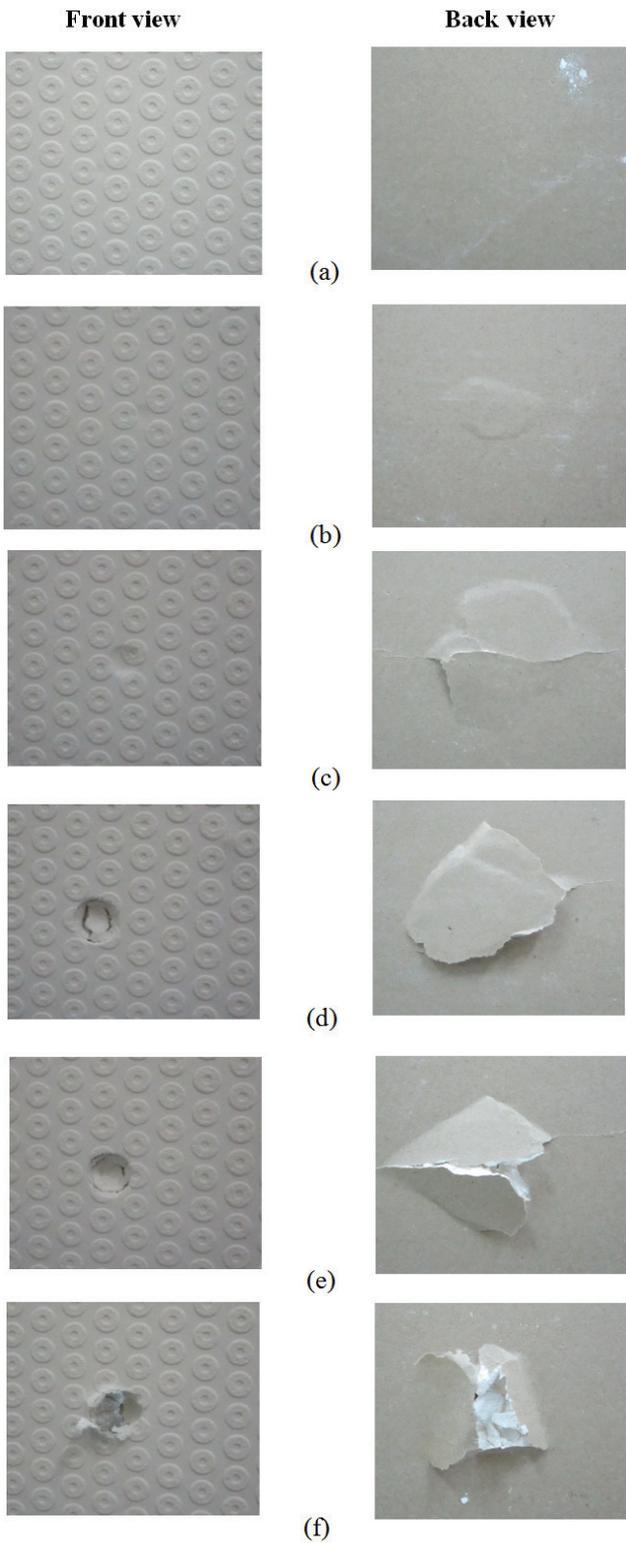
**Figure 7** Front and back damaged zones of Gypsum board+wallpaper for (a) 2 J, (b) 4 J, (c) 6 J, (d) 8 J (e) 10 J, (f) 12 J impact energy levels

Front and back side pictures belonging to the impact damages occurring in gypsum+wallpaper samples are given in Fig. 7 and gypsum+mesh+wallpaper samples are given in Fig. 8.

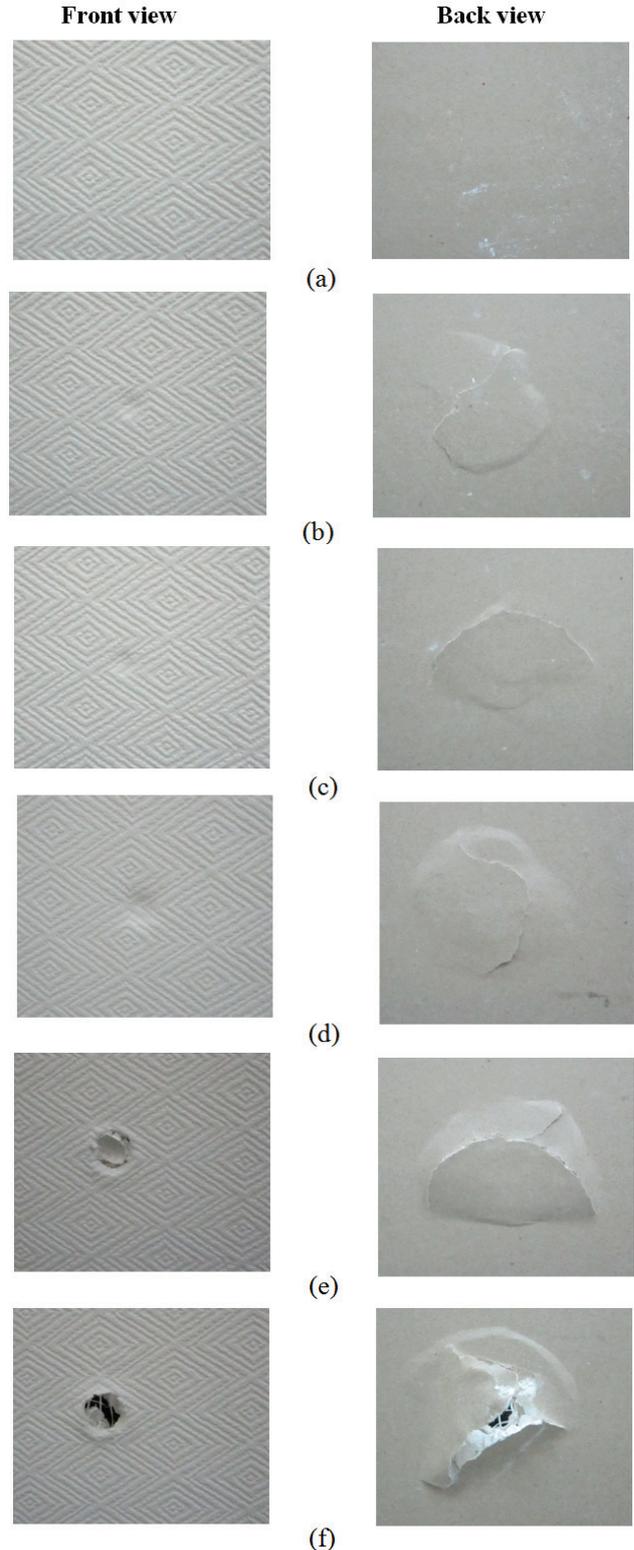
**Figure 8** Front and back damaged zones of Gypsum board+mesh+wallpaper for (a) 2 J, (b) 4 J, (c) 6 J, (d) 8 J (e) 10 J, (f) 12 J impact energy levels
