Fretting Wear in Selected Elements of Rail Vehicles

Śławomir KOWALSKI

Keywords: forced-in joint; fretting wear; operation; rail vehicles; tribology; wheel set

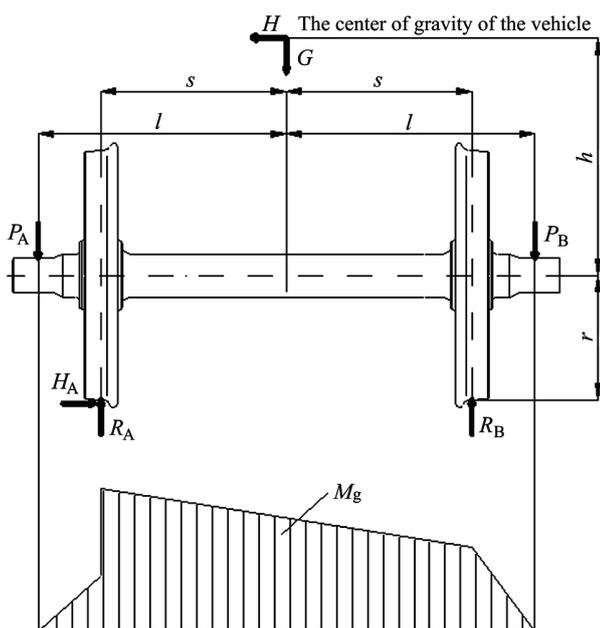
Figure 1 Forces acting on the wheel set during operation

The wheel set is subjected to vertical loads from the weight of a rail vehicle (P_A and P_B), to lateral forces at the contact surface of the wheel edge and rail head (H_A), such forces coming into being as a result of the hunting oscillation of the vehicle, and to dynamic forces at the contact surface of the wheel and the rail. As a consequence of those loads, a bending moment (M_g) occurs, whose diagram is presented in Fig. 1. The maximum value of the bending moment will occur at the axle seat in the plane of operation of reactions R_A and R_B , that is in the area of the connection of the axle with the wheel. Hence, it may be stated that the axle operates in rotational bending conditions, which will, during wheel set rolling, cause the occurrence of oscillation between the axle and wheel.

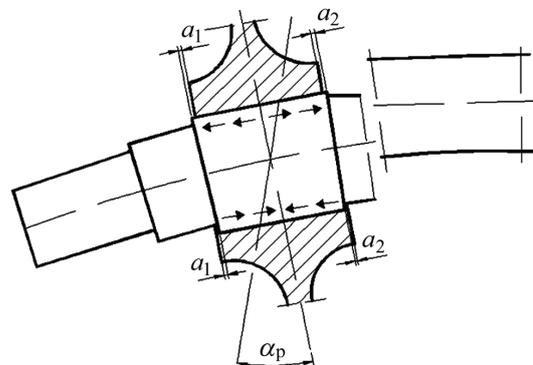
The wheel set axle is subjected to deformation shown in Fig. 2 under the influence of the external loads described above. Tensile stresses occur in the upper axle layers, and compressive stresses in the lower layers.

Figure 2 Deformation of the wheel set axle [1]

That kind of axle deformation would be insignificant if the wheel axle length were subjected to similar deformation. For the deformation of the axle seat and wheel hub to occur at the same time, the unit friction forces at the joint contact surface must be greater than or equal to normal stresses in the axle seat [1].

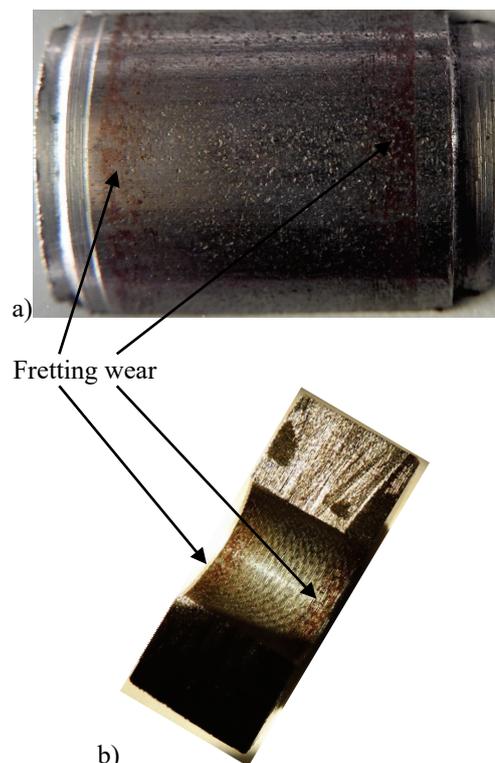
The macrographic image of fretting wear occurring at the surface of the shaft and sleeve is presented in Fig. 4.

Figure 4 The image of fretting wear at the surface of the shaft (a) and sleeve (b)

Badania Macroscopic examinations reveal fretting wear occurring on either side of the axle seat, at the distance of approximately 2 mm. Wear occurs at the entire axle seat surface circumference in the form of a ring which is 2-3 mm wide. Operation tests of real wheel sets also demonstrate a similar nature of wear. In that case, wear comprises the area from the hub front deeper into the joint, and the ring width is approximately 30 mm [1].

The occurrence of fretting wear, observed close to the edges of the axle seat, is related to the assembly process and to the wear development mechanism.

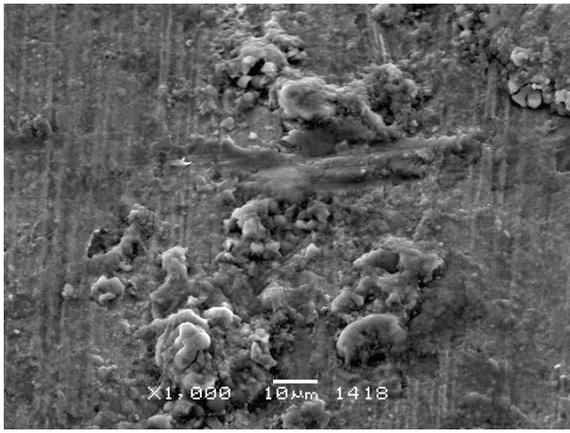
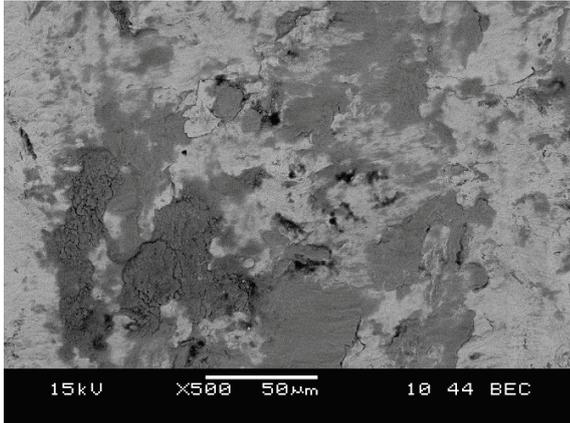
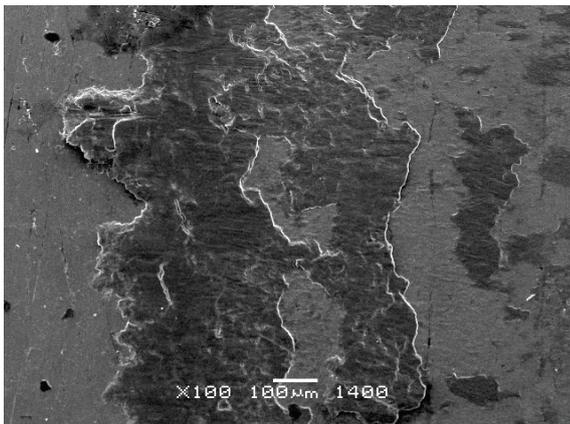
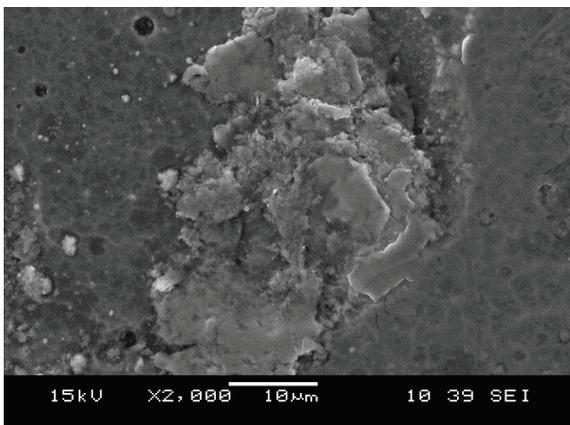
The presented scanning images demonstrated the occurrence of material build-ups, their source being adhesion, which is one of the components of fretting wear. Considerable surface abrasion and micro pits may also be observed, which are most probably the result of micromachining processes.

Figure 5 The sample images of fretting wear

Products coming into being during assembly, which are called the third body, and following from the shearing of the micro irregularities of the sleeve and shaft top surfaces, separate both of these surfaces, owing to which their direct contact does not occur during model cyclical bending. In the case of occurrence of oscillatory tangential displacement, the third body will fulfil the function of an agent taking over the relative displacement of the surfaces of both elements. Such a situation will take place in the central part of the joint. Close to joint edges, as a result of the cyclic relative slips of the mating surfaces, the removal of wear products will take place, owing to which the direct contact between the surfaces will occur [1]. The places of wear were observed under a scanning microscope, and the sample results presented in Fig. 5.

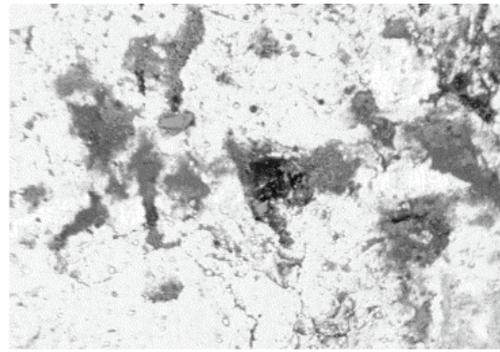
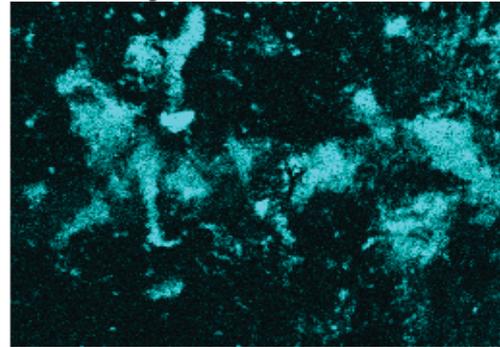
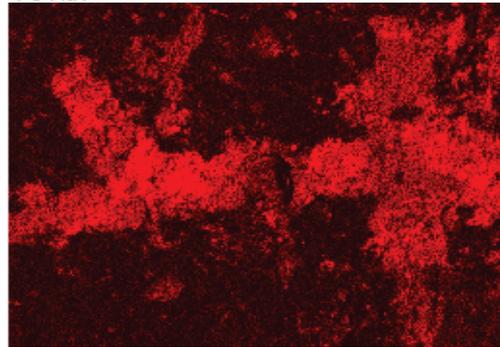
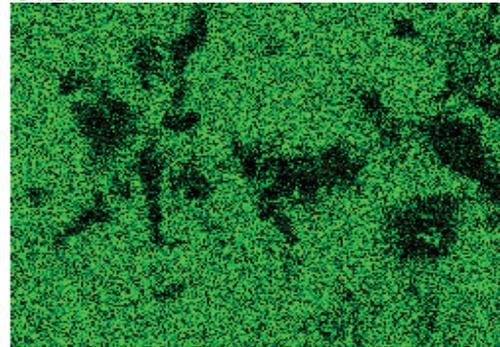
Figure 6 Chemical element distribution maps for the shaft surface in the fretting wear zone

The presented element distribution maps depict the oxidation of 80% of the surface being examined. Visible nickel is the effect of sample preparation for the analysis.

The wear traces observed at macroscopic images are brown, which is typical of the atmospheric corrosion of iron. This is evidence of a gap, which comes into being between the surface of the shaft and sleeve as a result of sample deflection, thus enabling the contact of the damaged area with oxygen, and the oxidation of plastically deformed micro build-ups. That phenomenon is confirmed by the EDS analysis conducted at the shaft surface. The results of the analysis are presented in Fig. 6 as an element distribution maps.

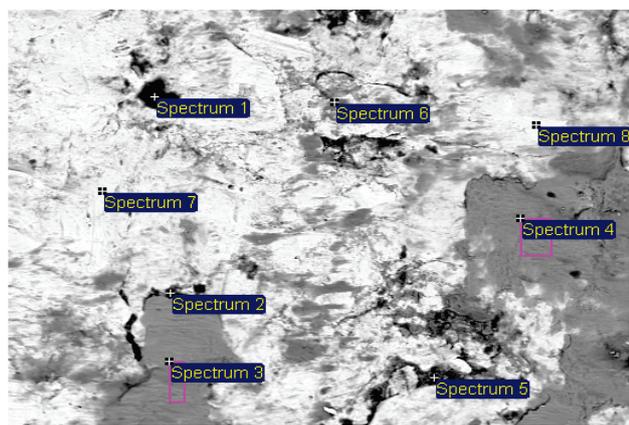
The results of the EDS microanalysis of the chemical composition of wear products in the place of fretting wear are presented in Fig. 7. That analysis also confirms the occurrence of material build-ups, which became oxidised.

Figure 7 The microanalysis of chemical composition at the shaft surface in the place of fretting wear (all results in weight %)

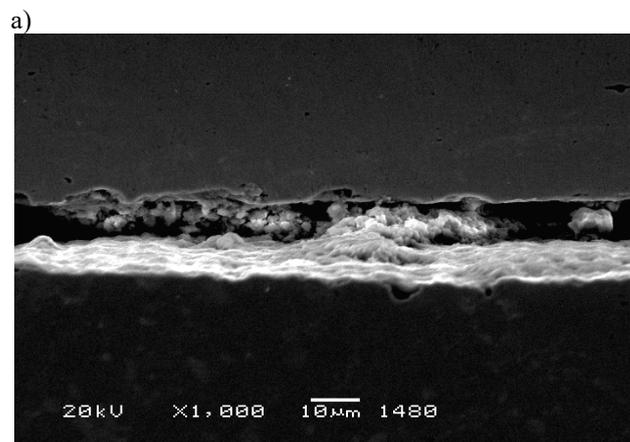
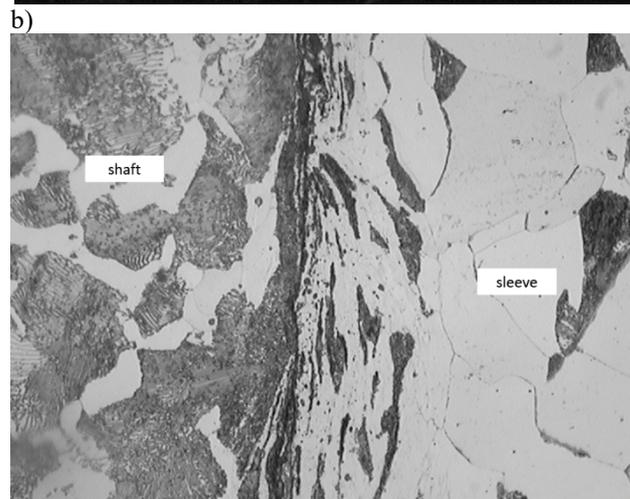
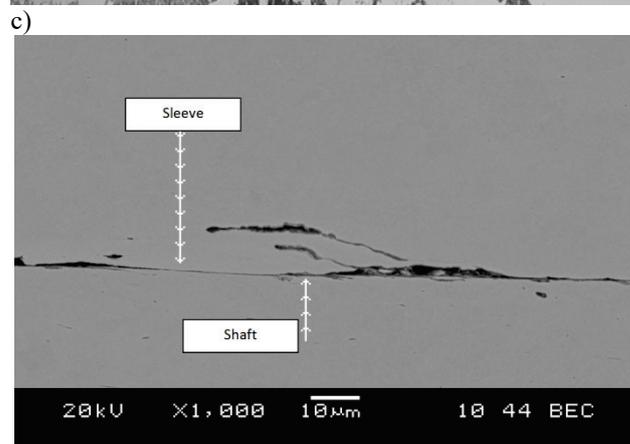
Laboratory observations also covered the examinations of the shaft top layer and the sleeve at the contact surface of the connected elements. The objective of those examinations was the assessment of the actual contour of the contact surface of both connected elements with its deformation and damage. Sample results of those observations are shown in Fig. 8. Images vary depending on the fragment of the analysed joint. In the central part of the joint, the direct contact between the shaft and sleeve surfaces prevails. Towards the edges of the joint, a gap filled with the third body, which came into being as a result of the shearing of micro irregularities during forcing, is observed (Fig. 8a). The plastic deformation of the sleeve top layer is observed in places (Fig. 8b).

The micro cracks of the sleeve top layer were found in places, as shown in Fig. 8c. Those cracks run deeper into the material each time at 20°. During operation, they may pose a hazard and contribute to the faster development of fatigue wear.

Figure 8 Sample images of the joint contact surface of the connected elements: a, c) unetched samples, b) a sample etched with nital, 1000× magnification

The examination results mentioned above indicate that the contact surface between the shaft and sleeve is very complex. The ultimate shape of that surface will be influenced by many factors, including the roughness of the top layer of the connected elements, tolerance, the presence of a lubricating medium etc.
