SPECIFIC ENGINEERING GEOLOGICAL AND GEOTECNICAL PROBLEMS OF DAM CONSTRUCTIONS IN KARST TERRAINS

Abstract: The paper first presents a general overview of the problem of dam construction - the formation of reservoirs in karst terrains, followed by the overview of the karst terrains specificities, specificities of engineering geological problems, and the relevant influence factors of the karst process and its forms on dam construction in karst. The construction of dams in karst terrains is a special problem that requires additional conditions in relation to the conditions in other terrains, which is why special care is needed during engineering geological research, as well as construction and operation. There are numerous, complex, diverse and specific engineering geological problems in karst terrains, almost always somewhat different, at each new location, which must be taken into account when constructing dams. Typical examples of the engineering geological risk of constructing dams in karst terrains, from foreign and domestic practices, are presented at the end of this paper, including both, remediation works that have given positive solutions, and cases where extensive and long-t

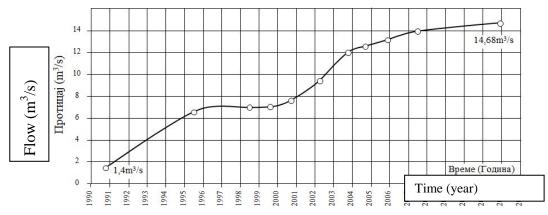
Figure 1. The combined flow at the springs in Drina riverbed under the dam (Institute for Water Resources "Jaroslav Černi" Belgrade and "Stucky Ltd.").

In spite of the conducted repair works, the outflow of water at the springs downstream of the dam did not stop, but increased from initial 1.4m³/s (1990) to 14.68m³/s (December 2012), Fig. 1.

Over a period of five years (1991-1996), the capacity of the springs increased from $1.4m^3$ /s (which accounts for 0.41% of the average Drina flow of $342m^3$ /s on the dam profile) to $6.5m^3$ /s (1.90% of the average flow of Drina on the dam profile).

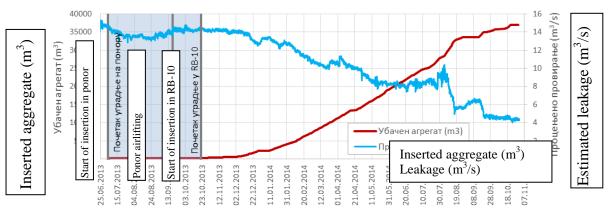
As the available financial resources were spent, it was decided to suspend the works and carry out conservation of boreholes, in order to make it possible to resume the repair works at a later stage. The performed repair works, which are presented in a nutshell, achieved a significant success in reducing the leakage (from about 14.68m³/s to about $4.5m^3$ /s), as evident in Fig. 2.
