**Goran Vizentin**

University of Rijeka, Faculty of Maritime Studies, Marine Engineering Department,  
Studentska 2, Rijeka, Croatia

## **Prolonged Real Marine Environment Exposure of Composite Marine Structures**

### **Abstract**

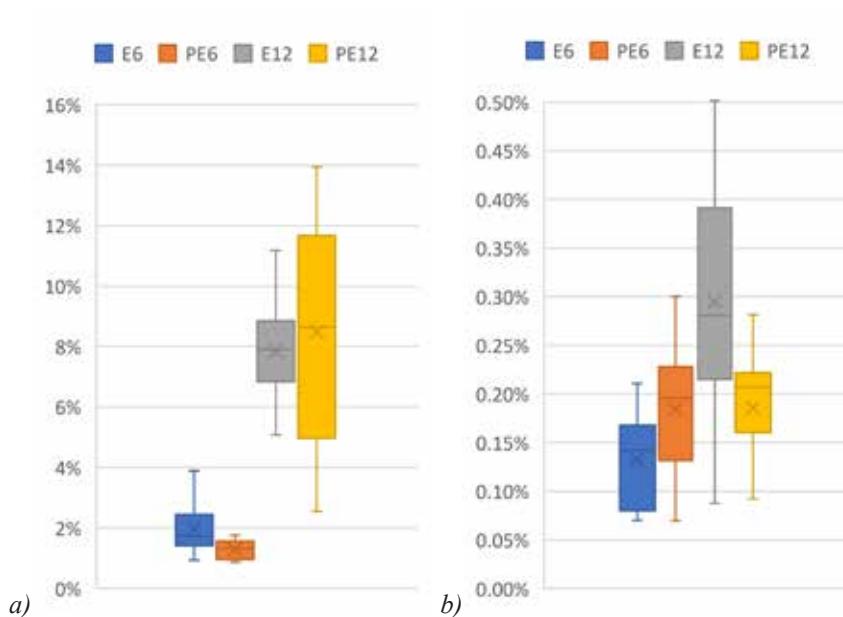
The average aggregate mass gain due to the coupled algae/marine organisms' growth and water absorption and only water absorption for the two matrix resins is given in Figure 1, where the denotations E and PE stand for epoxy and polyester resin respectively, while the numbers 6 and 12 indicate the period of submersion in months.

Figure 1: Mass gain due (a) bio growth and water absorption; (b) only water absorption.
