POVIJESNA ISTRAŽIVANJA I ZAHVATI NA MALOM RIMSKOM KAZALIŠTU U PULI

PAST INVESTIGATION AND INTERVENTION AT THE SMALL ROMAN THEATRE SITE IN PULA

Đeni Gobić-Bravar
Arheološki muzej Istre, Pula, Hrvatska
geni.gobic.bravar@gmail.com

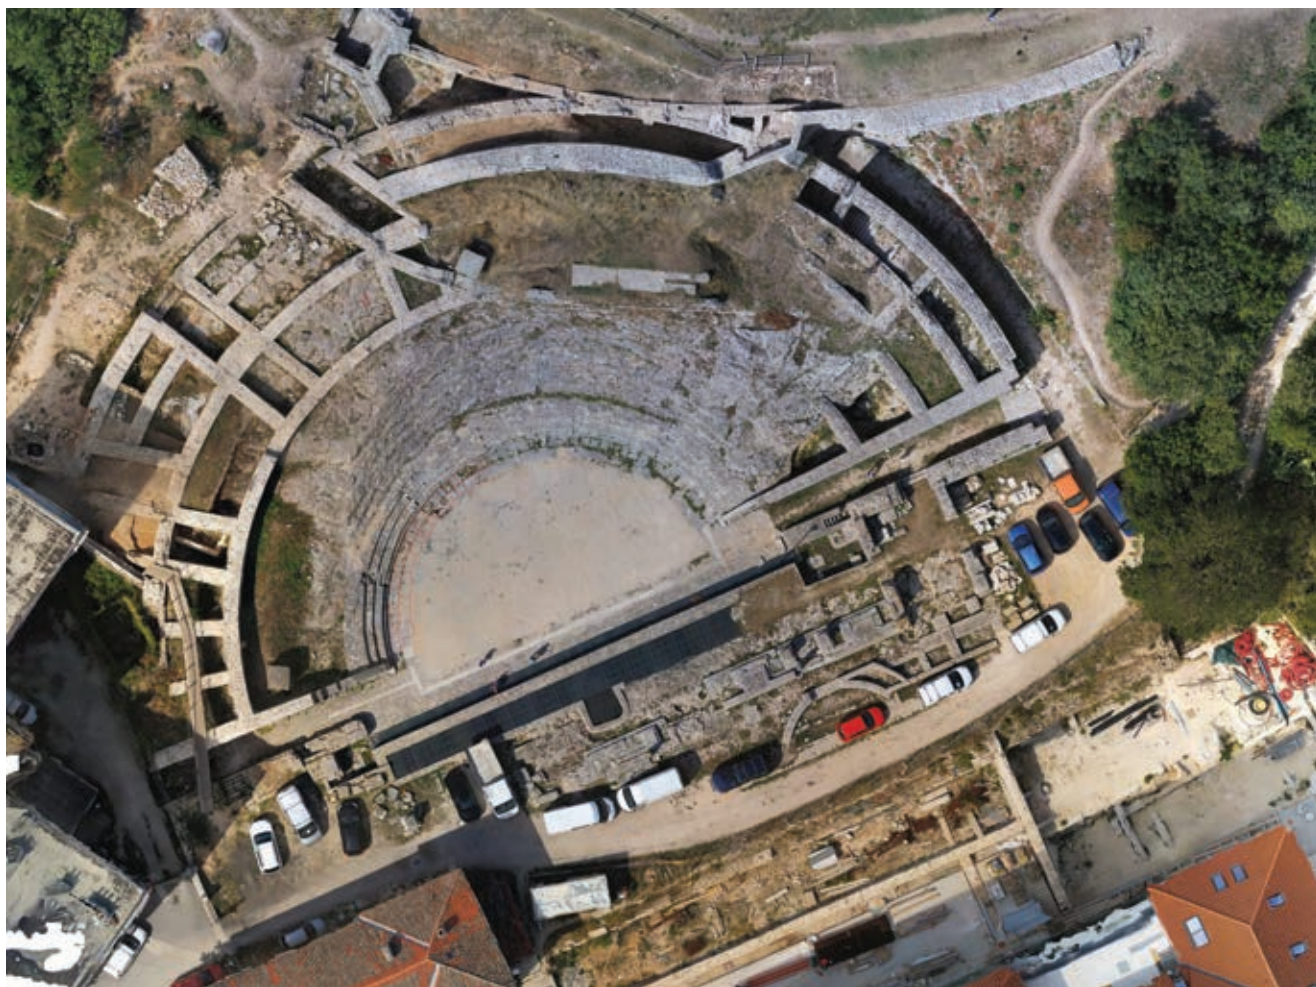
Sl. 1 Pogled na malo rimsko kazalište 2020. godine (Ortofoto AGG d.o.o.).
Fig. 1 The Small Roman Theatre in 2020 (Orthophoto AGG d.o.o.).

Orkestra je promjera oko 83 m, a prostire se polukružno zapadno od scene. Razina orkestre 1,1 m je niža od razine pozornice. Prostor orkestre, kao i prilazni hodnici, bio je popločan velikim pravilnim pločama od kamena vapnenca, od kojih su danas ostala djelomično sačuvana samo dva reda prema stubištu. Unutarnji red ujedno prekriva i kanal za odvodnju oborinskih voda. Iznad unutarnjeg reda kamenih ploča izdizao se, na 1,15 m od prve stube gledališta, kameni zid širine 0,6 m koji je dijelio gledalište od centralnog dijela orkestre (Matijašić 1994, 129-145; Mlakar 1981, 91-107).

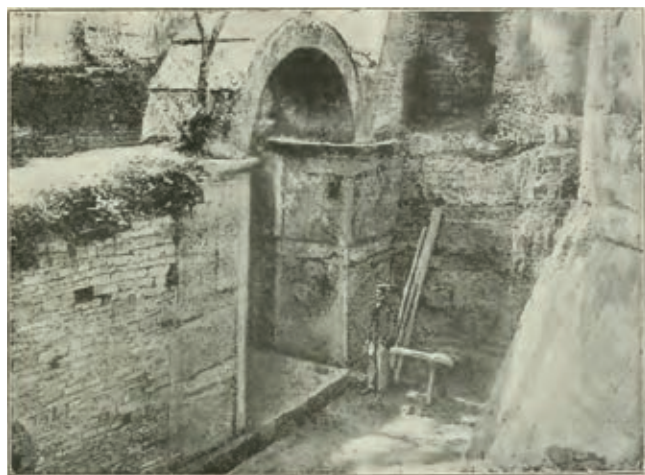
Sl. 2 Fotografija ulaznih vrata na gledalište iz 1904. godine (Gnirs 1904).
Fig. 2 The gate leading to the auditorium in 1904 (Gnirs 1904).

O samim “vratima prema kaštelu” Gnirs je pisao 1904. godine, još uvijek ne sluteći da se radi o monumentalnom ulazu u kazalište, povezujući ih s Dvojnim vratima. Piše tada Gnirs: “Put koji vodi od Dvojnih vrata prema Kaštelu završava kamenim zidom visine oko 5 m.

Lijevom stranom ovog puta proteže se kameni zid koji djelomično drži zemlju s druge strane, a djelomično skriva stubište koje se nastavlja na kamena vrata. Ova se monumentalna vrata nastavljaju na zid. Veliki kubični blokovi iz kamena vapnenca, međusobno povezani, tvore pilastre koji završavaju gredom u korinjskom stilu. Luk izveden iz 7 velikih blokova podiže se iznad grede. Iza vrata nalazi se prostor koji naliči sobi gotovo kvadratnog tlocrta, još uvijek okružen antičkim zidovima velike visine. Unutarnji blokovi vrata sadrže i kubične otvore za umetanje greda za zatvaranje vrata, koji su vjerojatno kasnije izrađeni. Pod unutar vrata i pod ceste bili su popločani velikim blokovima od vapnenca, neki su još *in situ*. Iz kubičnog prostora stepenice vode na gornji plato kojim se prilazi kapitoliju. No, prije ovih stuba prolazi se ispod drugih vrata, čiji je luk također sačuvan. Izgrađen je od kamena; počeci luka su izrađeni od istarskog kamena.”

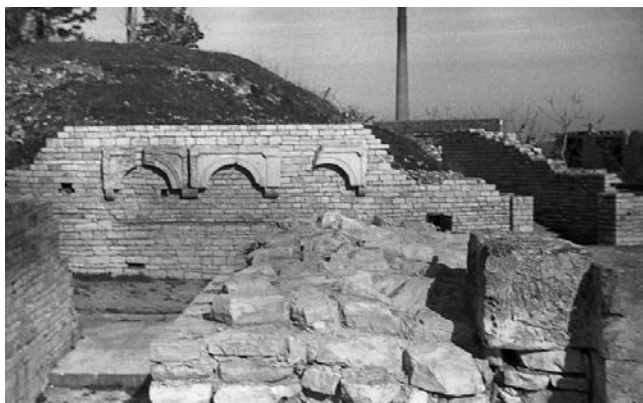
Sl. 7 “Pogled na krunu vanjskog zida desnoga paradosa (načinjena ljeti 1949.) i lukove balkonske lože, rađene 1933. i uzidane u VI/VII mj. 1939. lijevo od prolaza - cliva.” (fotografija: nepoznati autor, Dokumentacijski odjel AMI). Fig. 7 “View of the top of the outer wall of the right side parodos [aditus maximus] (shot taken in 1949) and the arches of the balcony loggia, done in 1933 and walled up in June/July of 1939 left of the passage/incline.” (photo by: anonymous, AMI documentation department).

Sredinom 1939. godine ograđen je prostor kazališta sa strane prema Kaštelu te duž ruba parcele prema sjeveru. Ograđivanje je bilo nužno, ne samo radi sigurnosti samoga muzeja, već i zato što je istraženo područje, predugo zapostavljeno, bilo često prostor dječjih igara, a ona su prljala i razbijala kamenje. Dio sredstava usmjeren je i na zahvate na arheološkim ostacima – tada je djelomično rekonstruiran rubni zid koji je vodio prema sjevernom monumentalnom ulazu. Čišćenjem zemlje

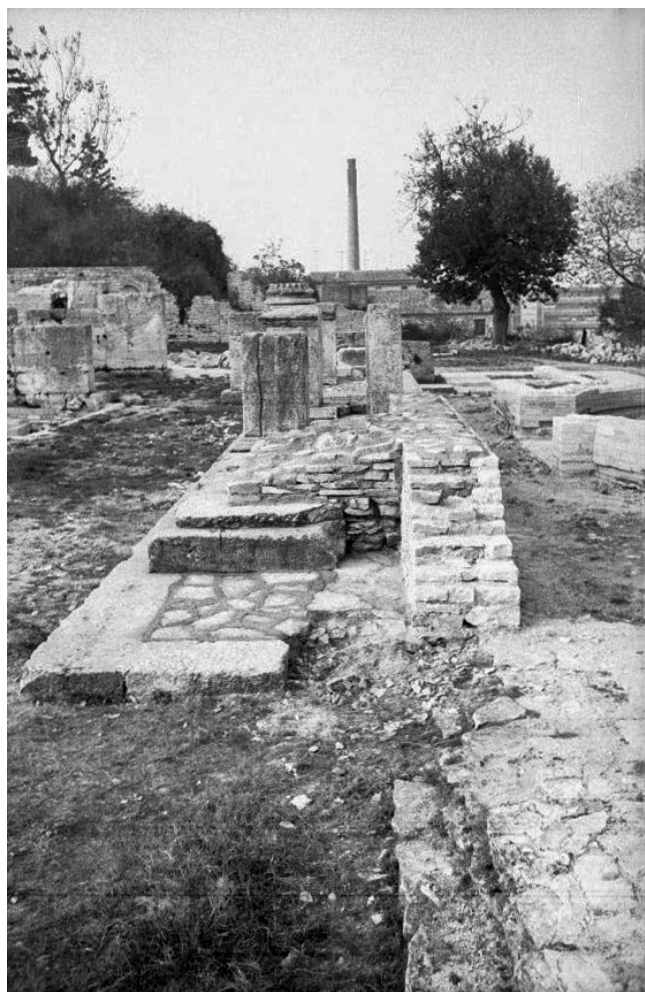
Sl. 8 Pogled na scenu s profilacijom, bazom i stupom položenim na bazu 1971. godine (fotografija: B. Marušić, Dokumentacijski odjel AMI).
Fig. 8 View of the scaenae with a moulding, base, and a column set on the base in 1971 (photo by: B. Marušić, AMI documentation department).

Mirabella Roberti navodi iste godine da je po pronađenom ulomku gornje profilacije pilastra, koji je bio izgubljen, ali je naknadno opet otkriven te vraćen na originalnu poziciju, izrađena šablona po kojoj je trebalo izraditi stiliziranu repliku profilirane baze na kojoj su stajali stupovi scene (Mirabella Roberti 1940, 249–251). Usporedbom fotografija iz 1912. godine zaključeno je da se radi o jedinom profiliranom i reljefno ukrašenom arhitektonskom elementu koji je bio pričvršćen iznad posljednje baze scenskog prostora prema sjeveru. Očigledno je u nekom trenutku ovaj profilirani element uklonjen s pozicije te je 1939. pronađen i vraćen. Međutim, Mirabella Roberti je pogrešno interpretirao element. Ne radi se o profiliranom završnom dijelu baze stupa, već o dijelu grede, vjerojatno scenske dekoracije. Temeljem ove profilacije izrađena je profilirana ploča u dva dijela, koja je postavljena na sljedeću postojeću bazu stupova *in situ*. Ona je vidljiva na fotografijama iz 70-ih godina prošlog stoljeća, ali je kasnije uklonjena i položena na tlo u jednom od sporednih prostora na sjevernom dijelu scenske zgrade. Nema zapisa o uklanjanju ove ploče, kao ni baze stupa i ulomka kapitela koji su na njoj stajali; stoga nemamo dokumentiran razlog ni period

In the same year Mirabella Roberti notes that a template has been produced—based on a discovered fragment of the upper moulding of a pilaster, which had been lost but was re-discovered and restored to its original position—based upon which a stylised replica of the moulded base on which the *scaenae* columns stood should be produced (Mirabella Roberti 1940, 249–251). Based on a comparison of photographs made in 1912 it has been concluded that this was the only moulded and relief decorated architectural element that was set above the last of the bases of the *scaenae* to the north. This moulded element was evidently at some point removed from its position and was found and restored to that position in 1939. Mirabella Roberti had, however, erroneously interpreted this element. This was not the moulded terminal part of a column base, rather it was part of a beam, likely from the *scaenae* decoration. Based on this moulding a two-part moulded piece was produced and placed on the next existing *in situ* column base. It is evident on photographs made in the 1970s, but was later removed and set on the ground in one of the side rooms at the north end of the *scaenae*. There is no record of the removal of this piece, nor of the column base and the fragment of a capital that stood atop it; thus, we have no documented reason or period in which this intervention was performed. One may, however, posit that the column base and capital fragment were removed in order to avoid vandalism, which occurred frequently at the theatre site, while the moulded reconstructed piece may have been removed because it was determined that the created form and moulding profile did not correspond to the decoration above the base (the plinth) but rather to moulding that would have stood at higher parts of the *scaenae frons*. A 1971 photograph (Fig. 8) shows the base with the moulded piece, and we see that a base and part of a capital are also present, while there is no capital fragment on a photograph from 1974 (Fig. 9). From the existing photographs we cannot determine the time at which the moulded replica piece was removed.

u kojem je obavljen ovaj zahvat. Međutim, moguće je pretpostaviti da su baza stupa i ulomak kapitela uklonjeni da ne bi bili oštećeni vandalizmima koji su bili česti na kazalištu, dok je profilirana rekonstruirana ploča možda uklonjena jer je utvrđeno da izrađeni oblik i profil ne odgovaraju dekoraciji iznad baze (plinta) već profilaciji koja je trebala stajati u višim dijelovima scenske fasade. Fotografija iz 1971. godine prikazuje bazu s pločom, prisutni su baza i dio kapitela, a na onoj iz 1974. godine ulomak kapitela je uklonjen. Iz postojećih fotografija nije moguće definirati u kojem je trenutku uklonjena profilirana replika.

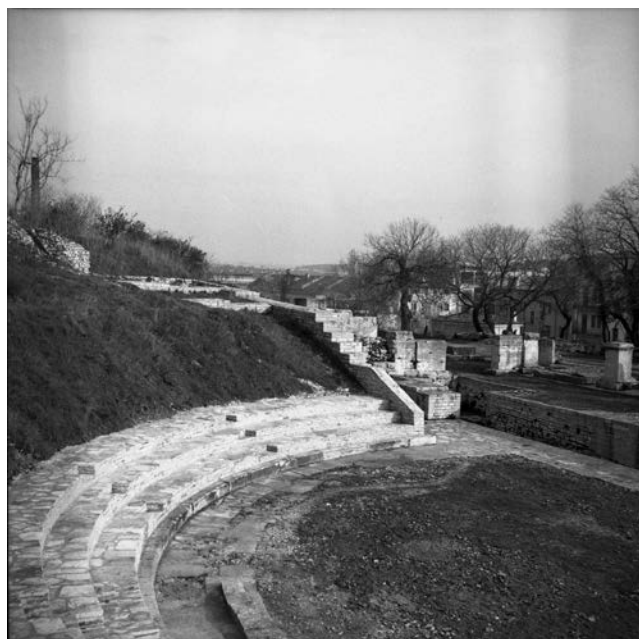
Sl. 9 Pogled na dio scene i orkestre, baza i stup uklonjeni su s profilacije, 1974. godine (fotografija: Š. Mlakar, Dokumentacijski odjel AMI).
Fig. 9 View of a part of the scaenae and orchestra; the base and column have been removed from the moulding, 1974 (photo by: Š. Mlakar, AMI documentation department).

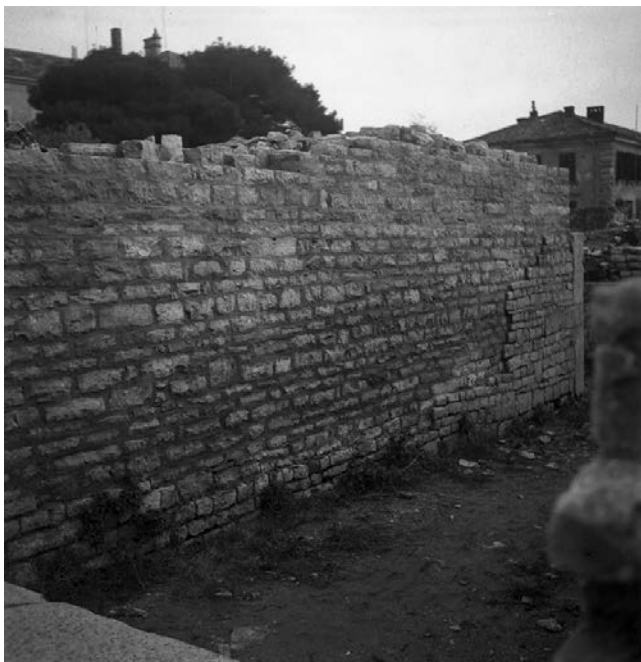
Sl. 10 “U prvoj polovini 1949. restaurirana vanjska stijena desnog paradosa.” (fotografija: nepoznati autor, Dokumentacijski odjel AMI).

Fig. 10 “The outer wall of the right side parodos [aditus maximus], restored in the first half of 1949.” (photo by: anonymous, AMI documentation department).

Based on only a few photographic negatives from 1949 we learn that a minor “restoration” was performed of the *scaenae* walls toward the north access to the orchestra.

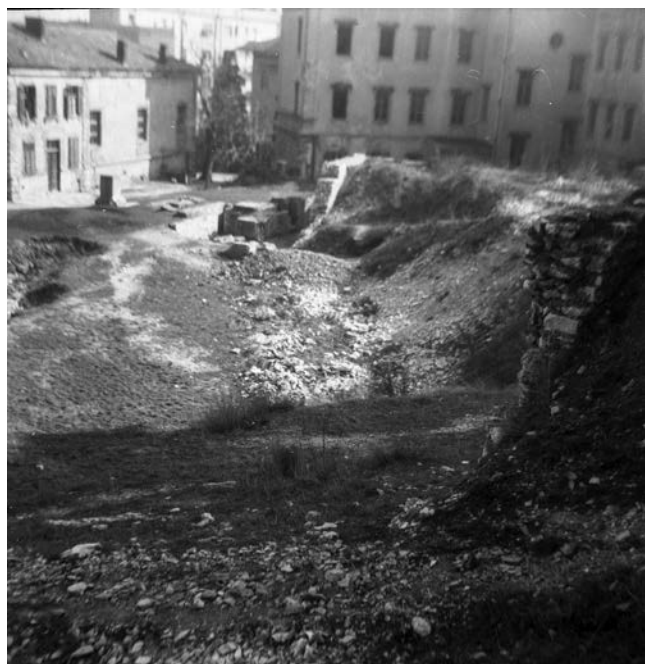
Sl. 12 Pogled na zatrpani prostor orkestre i gledališta 1968. godine (fotografija: B. Marušić, Dokumentacijski odjel AMI).

Fig. 12 View of the filled orchestra and auditorium area in 1968 (photo by: B. Marušić, AMI documentation department).

Za 1968. godinu ne postoje pisani tragovi, već samo nekoliko fotonegativa koji prikazuju prostore gledališta i djelomično orkestre potpuno prekrivene zemljom.

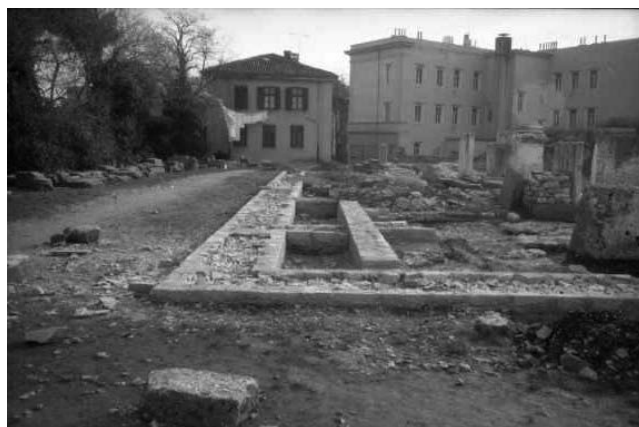
Sl. 13 Pogled na scenu nakon djelomično izvršenih zahvata 1969. godine (fotografija: B. Marušić, Dokumentacijski odjel AMI).

Fig. 13 View of the scaenae in the course of the interventions of 1969 (photo by: B. Marušić, AMI documentation department).

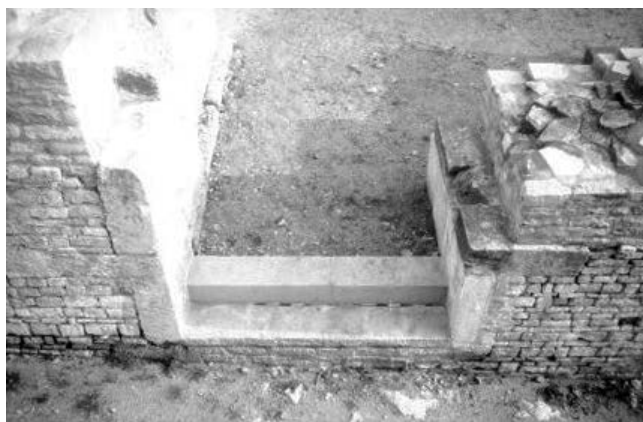
Sl. 14 Ulaz u sjeverni prostor glavne scenske zgrade s hodnika - poslije rekonstrukcije 1970. godine (fotografija: B. Marušić, Dokumentacijski odjel AMI).

Fig. 14 Entrance to the north part of the *scaenae* from a corridor following the reconstruction of 1970 (photo by: B. Marušić, AMI documentation department).

Sljedeće godine nastavljena je rekonstrukcija kruništa zidova scenske zgrade, ali i drugi veći zahvati. Tako temeljem fotonegativa saznajemo da su u dva sjeverna prilaza scenskom prostoru iz sjevernog hodnika ugrađene nove kamene stepenice. Uz sjevernije stepenice postojao je *in situ* ortostat za koji se smatralo da je loše očuvan te je demontiran i zamijenjen novim. Također, obavljene su opsežne

The following year saw continuing work on the reconstruction of the tops of the wall of the *scaenae*, and other large scale interventions. From the photographic negatives we see that new stone steps were installed at the two north access points to the *scaenae* area from the north corridor. Next to the steps further to the north there was an orthostate *in situ* deemed to be in a poor state of preservation; it was taken down and replaced with a new one. There was also comprehensive reconstruction work on the wall around the north room from which stage devices were controlled. Work on the reconstruction of the east walls of the *scaenae* were completed with stone and mortar integrations built into the heads of walls.

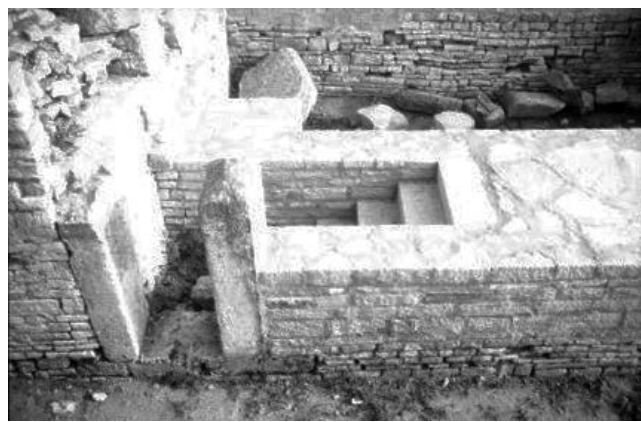
Sl. 15 Ulaz na sjeverni paraskenij s rekonstruiranim stepenicama 1970. godine (fotografija: B. Marušić, Dokumentacijski odjel AMI).

Fig. 15 Entrance to the north paraskenion with reconstructed steps in 1970 (photo by: B. Marušić, AMI documentation department).

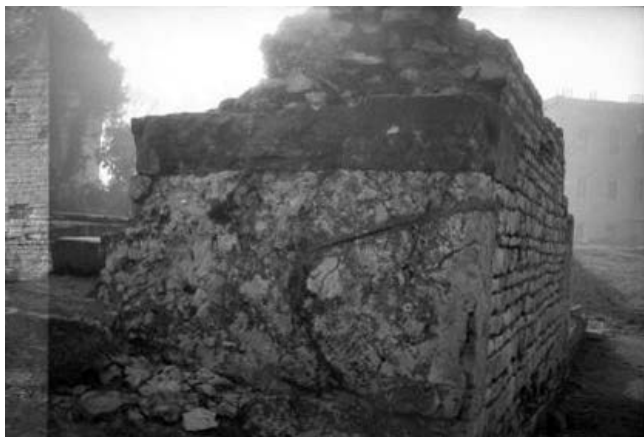
Sl. 16 Originalni ortostat prije zamjene 1970. godine (fotografija: B. Marušić, Dokumentacijski odjel AMI).

Fig. 16 The original orthostate prior to its replacement in 1970 (photo by: B. Marušić, AMI documentation department).

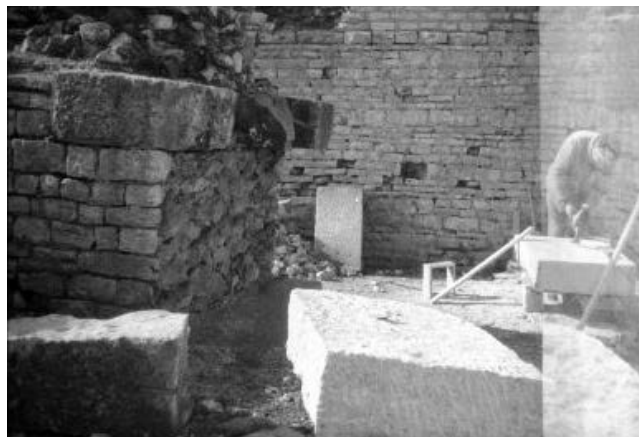
Sl. 17 Priprema za zamjenu ortostata 1970. godine (fotografija: B. Marušić, Dokumentacijski odjel AMI).

Fig. 17 Preparations for the replacement of the orthostate in 1970 (photo by: B. Marušić, AMI documentation department).

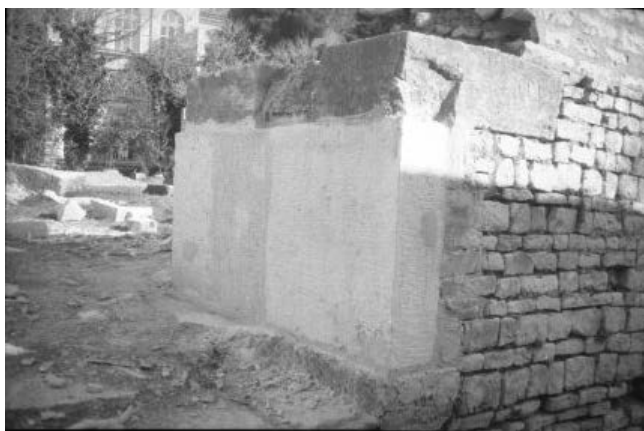
Sl. 18 Novopostavljeni ortostat 1970. godine (fotografija: B. Marušić, Dokumentacijski odjel AMI).

Fig. 18 The newly installed orthostate in 1970 (photo by: B. Marušić, AMI documentation department).

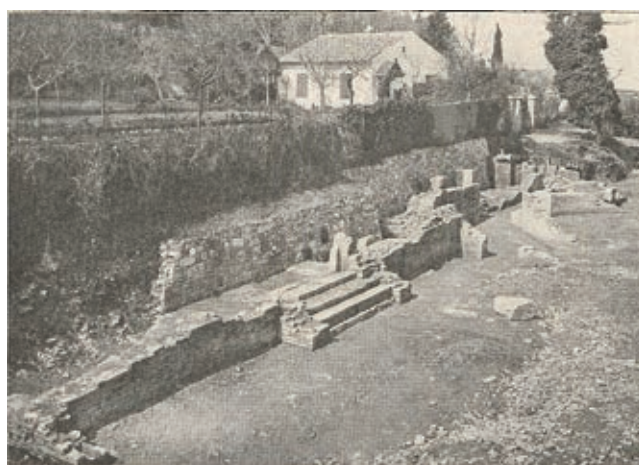
Sl. 19 Pogled na lokalitet tijekom istraživanja 1911. godine s vidljivim ostacima zidova (Gnirs 1912).

Fig. 19 The site in the course of investigative work in 1911 with visible remains of walls (Gnirs 1912).

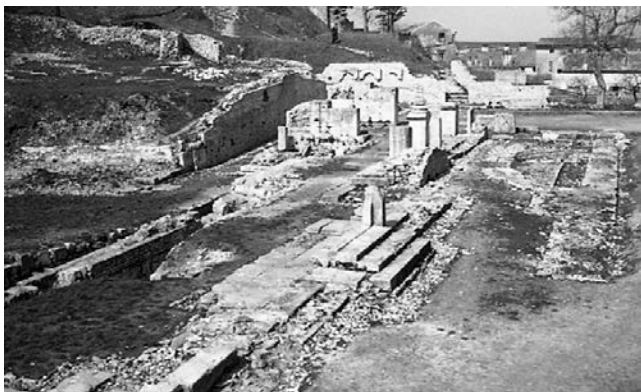
Sl. 20 Pogled na scenu s potpuno nedostajućim zidovima struktura prije zahvata 70-ih godina (fotografija: V. Karlič, Dokumentacijski odjel AMI).
Fig. 20 View of the scaenae with entirely absent walls of the structure prior to the interventions of the 1970s (photo by: V. Karlič, AMI documentation department).

bez godine snimanja, ali sudeći po njegovom niskom inventarnom broju trebalo bi se raditi o poslijeratnoj fotografiji prije početka zahvata 70-ih godina, na kojem se vidi jedna veća dionica zida, koja je kasnije uništena.

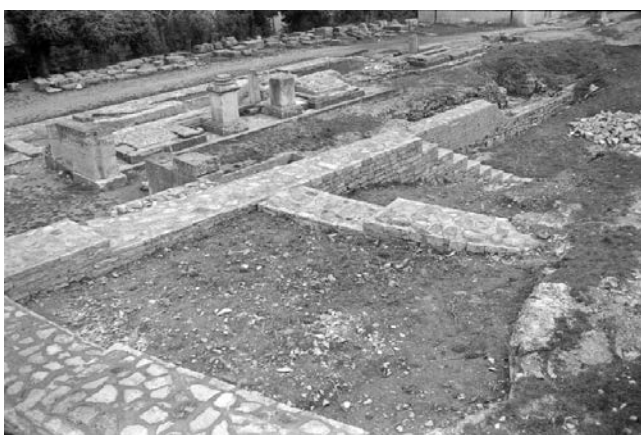
Sl. 21 Pogled na strukturu, snimljeno s krova muzeja (fotografija: Lj. Horvat, Dokumentacijski odjel AMI).
Fig. 21 View of the structure from the museum roof (photo by: Lj. Horvat, AMI documentation department).

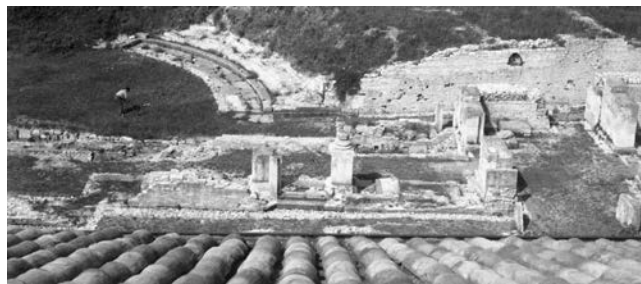
Sl. 22 Pogled na konzervirani sjeverni ugao gledališta 1972. godine (fotografija: B. Manušić, Dokumentacijski odjel AMI).
Fig. 22 The conserved north corner of the auditorium in 1972 (photo by: B. Manušić, AMI documentation department).

Godine 1972. zahvati su fokusirani na sjeverni ugao gledališta. Tada su oslobođeni, s unutrašnje strane, zid uz sjeverni prilazni hodnik orkestri, sjeverni završni zid gledališta te dionice radijalnih unutarnjih zidova. Isti su zidovi očišćeni te rekonstruirani kamenim ulomcima i cementnim mortom. Krajem iste godine prešlo se na prostor hiposcene i kanala s kamenim blokovima za zastor te je započeto njihovo čišćenje i priprema za konzervaciju, što je nastavljeno iduće dvije godine. Tada je obavljena i konzervacija podnice orkestre, koja

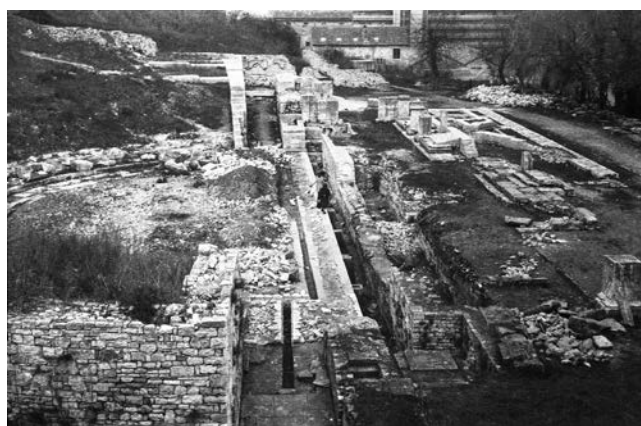
Sl. 23 Pogled na zahvate završnog zida scene prema orkestri te kanala i odvodnog kanala orkestre (fotografija: V. Karlič, Dokumentacijski odjel AMI).
Fig. 23 View of the interventions to the wall of the scaenae bordering the orchestra, and the canal and drainage canal at the orchestra (photo by: V. Karlič, AMI documentation department).

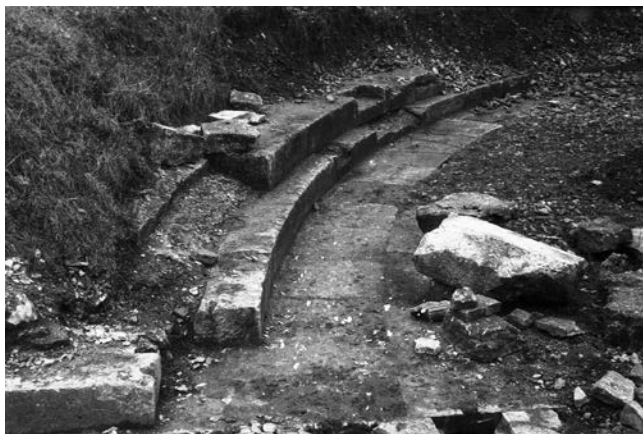
Sl. 24 Ostaci originalnih stepenica gledališta prije zahvata rekonstrukcije (fotografija: V. Karlić, Dokumentacijski odjel AMI).

Fig. 24 The remains of the original stepped auditorium rows prior to the reconstruction intervention (photo by: V. Karlić, AMI documentation department).

1974 saw integration work on walls along the access corridor towards the orchestra, and the reconstruction in stone of the missing first three rows of the auditorium.

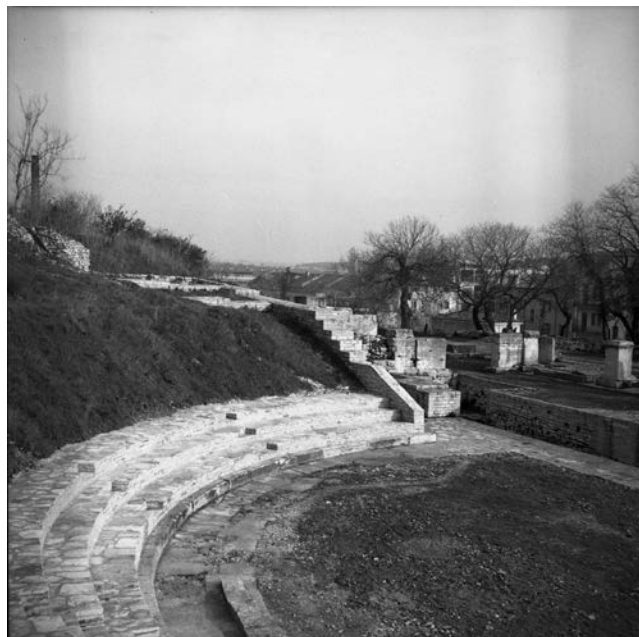
Sl. 25 Pogled na sjeverni dio kazališta nakon zahvata 70-ih godina. Zanimljiv je detalj u donjem lijevom uglu fotografije gdje je još uvijek vidljiv ostatak kamene ograde in situ, koja je dijelila gledalište od orkestre (fotografija: Š. Mlakar, Dokumentacijski odjel AMI).

Fig. 25 View of the north part of the theatre following the interventions of the 1970s. An interesting detail in the lower left corner of the photograph is the still visible in situ remains of the stone barrier that separated the auditorium from the orchestra (photo by: Š. Mlakar, AMI documentation department).
