PRIMJENA 3D TEHNOLOGIJE PRI IZRADI DETALJNE DOKUMENTACIJE STAROHRVATSKOG BRODA *CONDURA CROATICA*

THE USE OF 3D TECHNOLOGY IN THE CREATION OF DETAILED DOCUMENTATION OF THE EARLY CROATIAN SHIP *CONDURA CROATICA*

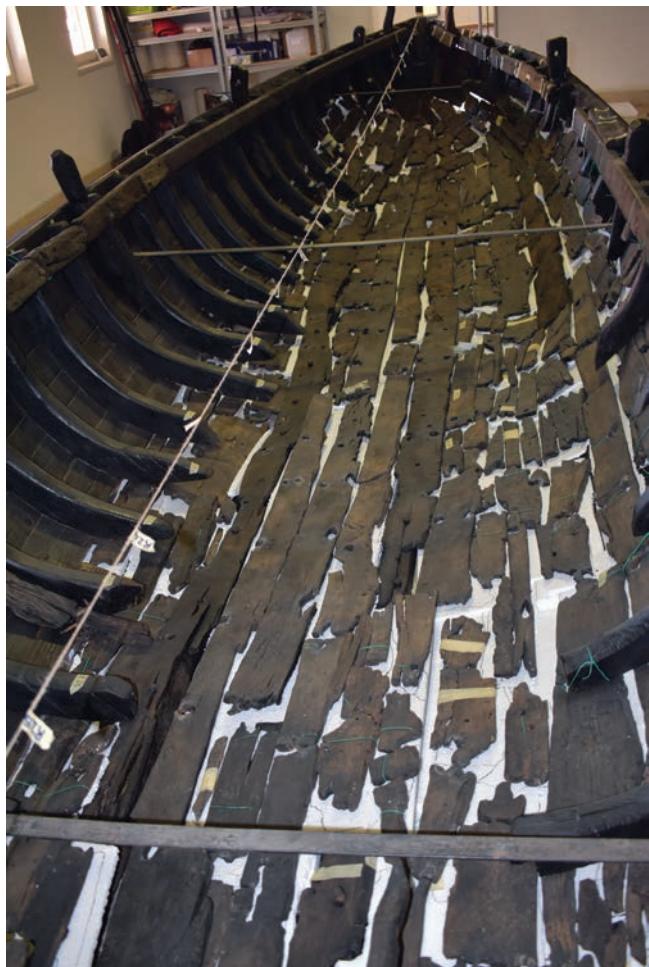
Slika 2. Fragmentirana oplata rekonstruiranog broda, AMZd, inv. br. MNS2530, pogled od krme prema pramcu

Figure 2. Fragmented planking of the reconstructed ship, AMZd, inv. no. MNS2530, a view from the stern towards the bow

During the conservation-restoration process, more precisely during the cleaning phase, the ships' structures were discovered, i.e. a series of wooden elements of different shapes and dimensions that comprised the ships' structure (Fig. 2). Namely, due to the use of a large amount of wood surface protection agent during the previous conservation and restoration of the ships, the aforementioned elements were not visible. Although all discovered elements were drafted, documented and sketched during the new conservation-restoration procedure, for safety reasons it was decided that ships should be digitally documented, and their current state should be permanently archived.

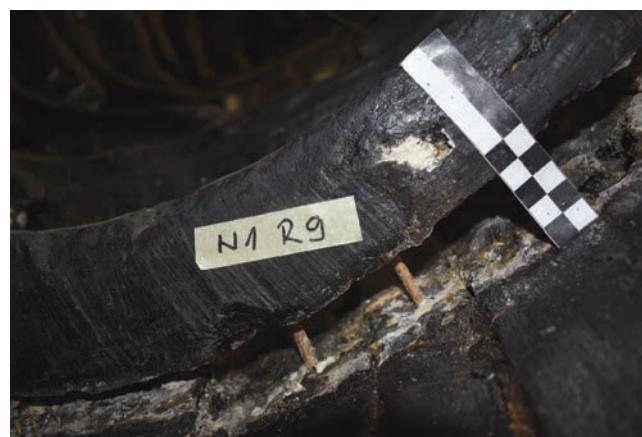
Slika 3. Praznina između oplate i rebra 9 rekonstruiranog broda, AMZd, inv. br. MNS2530

Figure 3. The gap between the planking and frame no. 9 of the reconstructed ship, AMZd, inv. no. MNS2530

During the conservation-restoration process, between the planking and the most of the frames, a gap filling mixture was observed, which varies in thickness to a maximum of five centimetres (Fig. 3). It is assumed that these gaps were caused by the metal bases, i.e. the metal cradles in which the ships were displayed, which did not match the dimensions and the shape of the ships. It is suspected that the cradles were constructed according to the measurements taken in 1974, during the extraction of parts of the ships from the seabed. At the time, the possibility of wooden elements expanding was most likely overlooked, which could have happened at the moment of sinking, and during the long-lasting influence of sea water on the wooden structure. Furthermore, the possibility of changes in dimension of wooden elements that can occur during the conservation-restoration process, i.e. the process of impregnation and the drying of wooden material, was also probably overlooked. These are all possible reasons that might have caused the present gap. Although the observed gap indicates the presence of irregularities in the apparently well-positioned frames, the fragmentation of the planking was the primary reason for the digital documentation of the condition of the ships.

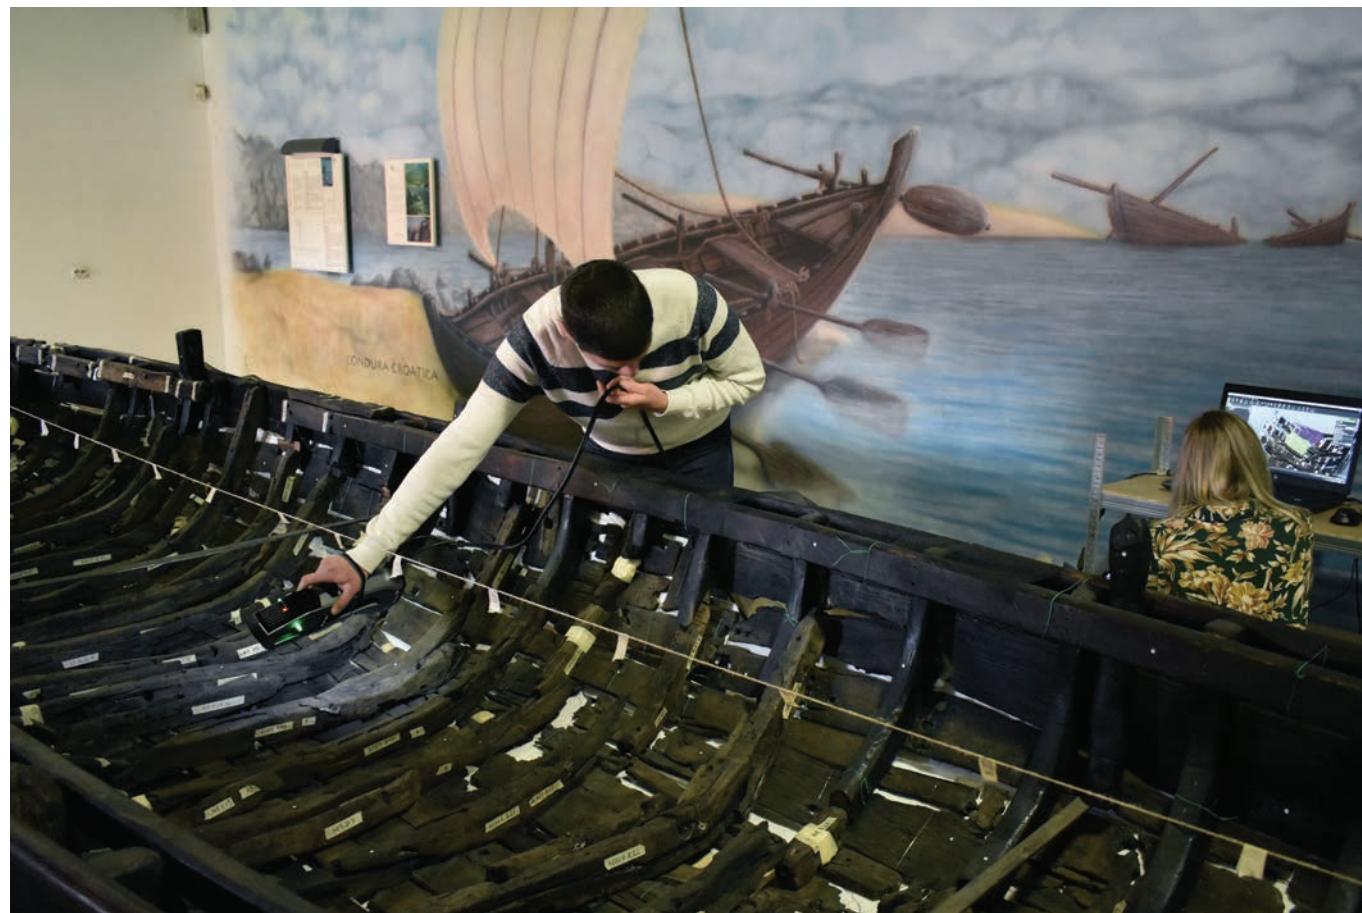
Slika 4. Postupak 3D skeniranja ručnim GO!SCAN SPARK 3D skenerom
Figure 4. 3D scanning procedure with a handheld GO!SCAN SPARK 3D scanner

The detailed scanning of parts of the ships' structures was accomplished by a handheld scanner, the GO!SCAN SPARK 3D scanner,¹⁶ without the need to touch or move the elements. The contactless data collection abolished the need to expose the wooden elements to potentially unfavourable conditions and circumstances. However, since the ships at the time of scanning were in one of the stages of the conservation-restoration process, where they were temporarily and safely protected by a net on the outer planking, the 3D scan was performed only on the inner planking. Namely, the safety net interfered with the operation of the scanner, and the data received by 3D scanning was not entirely usable for engineering. Therefore, only the internal parts of the ship structures, i.e. the elements of the ship's frames and planking, were scanned in detail, and the scanning process was successfully performed in a few hours (Fig. 4).¹⁷
