# Performance Evaluation of Coco Wood Chairs Constructed with Traditional Joints

### ORIGINAL SCIENTIFIC PAPER

**ABSTRACT** • Furniture is an engineered structure that is subjected to various loads throughout its service life. As a result, to guarantee that furniture satisfies the standards of the target market for strength and durability, it must be designed and constructed with the appropriate strength features. This study, therefore, assesses the structural and aesthetic performance of three chairs made from West African Tall Coco Wood (*Cocos nucifera*) using three traditional joints: mortise and tenon, halving, and dowel joints. With rising demand for sustainable alternatives to tropical hardwoods, coco wood represents an underutilised yet promising material in Ghana's furniture sector. The coco wood was obtained from the Abura Asebu Kwamankese District in the Central Region of Ghana. The chairs were produced at the Asuansi Technical Institute and were tested at the laboratory of the Wood Mechanic and Furniture Testing Centre (FORIG), Kumasi, according to European Standards (EN 1022 and EN 1728). The results indicate that mortise and tenon joints performed best, followed by

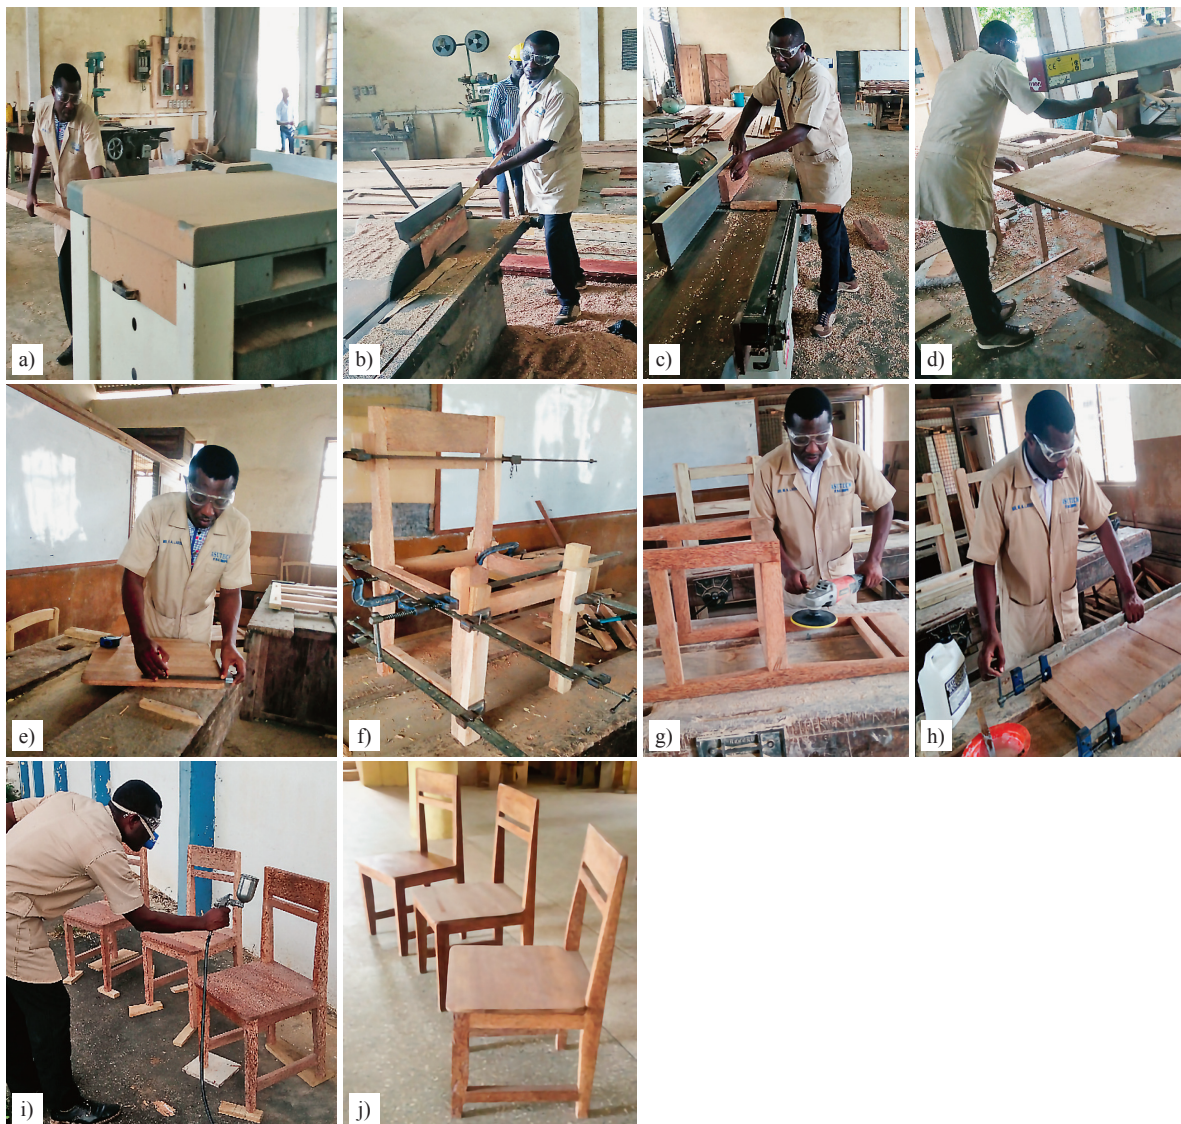
**Figure 2** Construction stages of the three coco wood chairs: a) planing, b) ripping, c) shooting, d) cross-cutting, e) marking out and joint construction, f) trial and final assembly of joints, g) sanding of the chair structure, h) lamination of the chair seat, i) application of the final coating material, j) final products

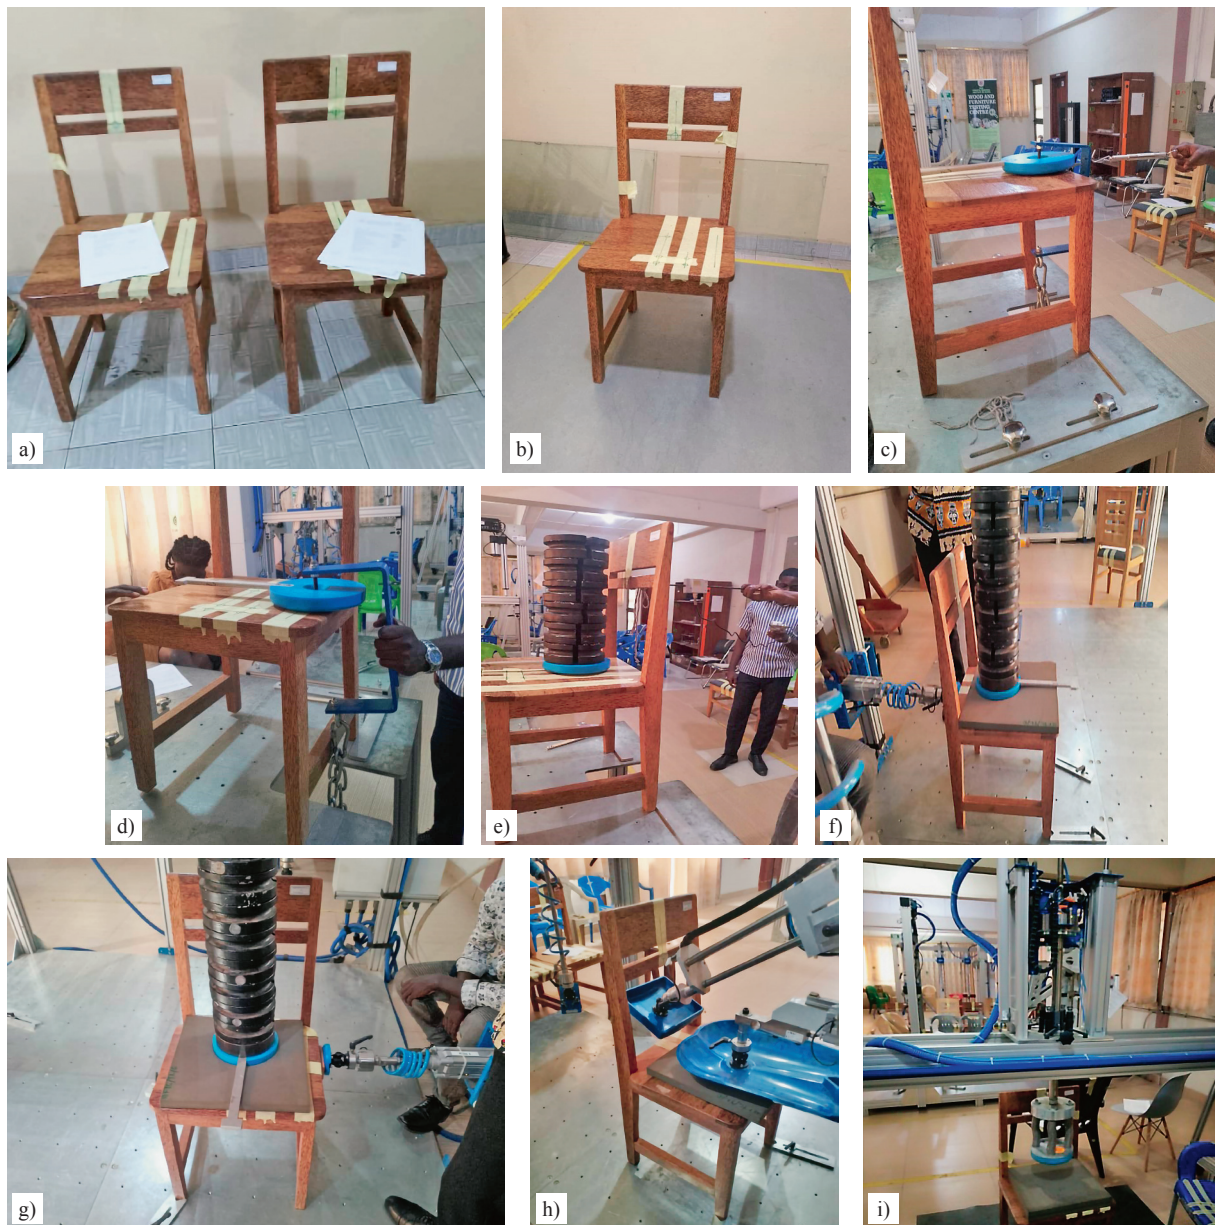
**Figure 3** Experimental testing of coco wood chairs in accordance with EN standards: a) chairs in a climate-controlled room, b) chair at the marking-out centre, c) forward stability test, d) sideways stability test, e) rearward stability test, f) seat and back static load test, g) leg forward and sideways static load test, h) combined seat and back durability test, i) seat impact test  
**Slika 3.** Ispitivanje stolica od drva kokosove palme u skladu s EN normama: a) klimatiziranje, b) označivanje, c) ispitivanje stabilnosti prema naprijed, d) ispitivanje bočne stabilnosti, e) ispitivanje stabilnosti prema natrag, f) ispitivanje statičkog opterećenja sjedala i naslona za leđa, g) ispitivanje statičkog opterećenja nogu prema naprijed i bočno, h) kombinirano ispitivanje trajnosti sjedala i naslona za leđa, i) ispitivanje sjedala udarom

During the testing procedure, the chairs were placed on a rigid, level surface, and loads were applied vertically or horizontally at specified locations on the seat, backrest, and legs using a calibrated loading system. The loading direction, support conditions, and points of load application were kept constant across all specimens to ensure repeatability. The ultimate load sustained prior to failure was recorded. In cases where no failure occurred, testing was terminated once the performance requirements specified in the relevant standards had been satisfied.

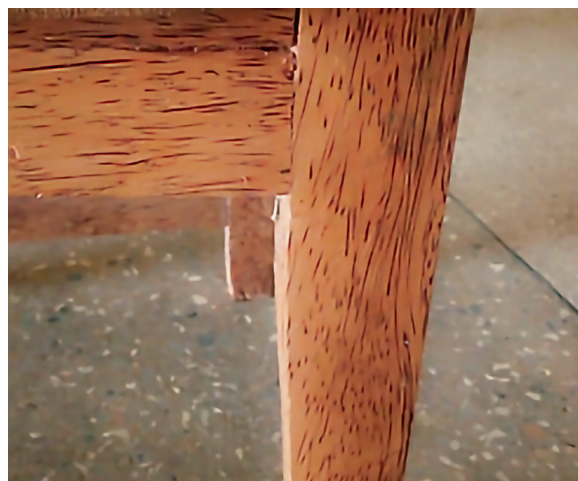
**Figure 4** Typical failure modes observed during testing  
**Slika 4.** Tipični načini loma uočeni tijekom ispitivanja

All chair configurations failed under lateral loading, indicating a limitation in sideways stability. Mortise and tenon and halving joints mainly failed due to wood splitting near the joint, while dowel joints showed occasional glue-line failure. This suggests that dowel joints are more susceptible to adhesive-related stresses under lateral loading conditions. The findings are consistent with Vlaović (2024), who recommends that future designs incorporate cross-bracing elements
