TRIBOCORROSION OF LOW CARBON STEEL C15E IN 5 % NaCl AND 5 % NaCl + SiO₂

The article represents testing results of corrosion and erosion-corrosion wear. Specimens have been made from low carbon steel C15E in four different states: delivery state and heat-treated (carburizing, boronising and carburizing + boronising). The results are shown as wear of materials (losing of surface mass in mg/(cm² · d)). Surface hardness method HV1 and micro hardness per section of specimen HV0,2 method have been used during the analyses. A comparison of testing results of wear in four different states was made. The best performances have shown samples which have been treated with duplex procedure (carburizing + boronising) as was predicted.

Key words: erosion - corrosion wear, low carbon steel, carburizing, boronising, duplex procedure

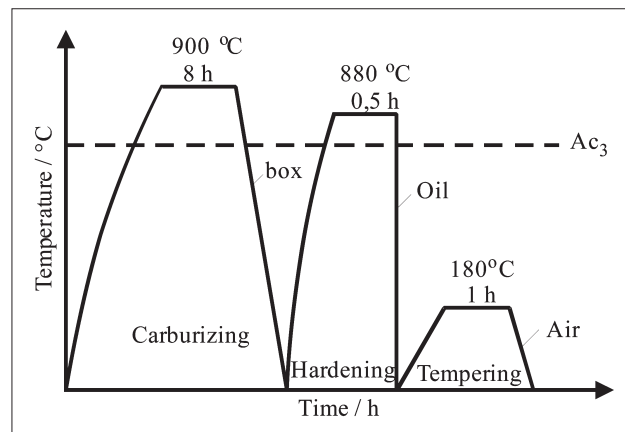
Figure 1. Schematic preview for carburizing process of low carbon steel C15E

1. Carburizing (Figure 1)
2. Boronising in Ekabor 3 (Figure 2)
3. Carburizing + boronising (duplex) treatment.

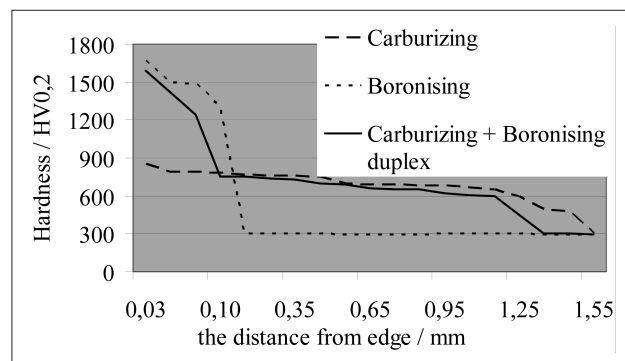
Figure 3. Diagram of average micro hardness HV 0,2 values

In practice these problems are tried to be solved through carburizing, boronising and carburizing + boronising analysis (HV₁, HV_{0,2} etc.) (Table 1, 2). The main goal is to equalise hardness near the surface and on the surface (to reduce effect of "glass" surface on soft weak substrate). Analysis of hardness (HV₁) and micro hardness (HV_{0,2}) affirms wear of diffusion coating on some specimens more than is expected and that problems have to be solved in further researching (Table 1, 2 and Figure 3).

Decrease in measured hardness values from coating surface to substrate has been shown in Table 2 and Figure 3.

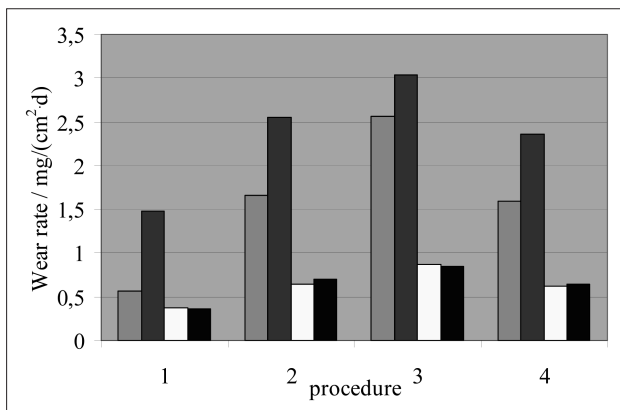
Figure 4. Preview of wear C15E in mg/(cm²·d) in salt spray for:
 1 – Delivery state
 2 – Carburizing
 3 – Boronising
 4 – Carburizing+ boronising (duplex)

Corrosion researching (Figure 4) in salt spray shows the increasing of resistance of carburized + boronised
