346-359 Vesna Lovec Miroslav Premrov Vesna Žegarac Leskovar Thermal Comfort and Indoor Air Quality after a Partially Energy-efficient Renovation of a Prefabricated Concrete Kindergarten Constructed in 1980's in Slovenia

Original Scientific Paper https://doi.org/10.31522/p.28.2(60).10 UDK 72.025.4:725.573 (497.4) "19/20" Toplinska udobnost i unutarnja kvaliteta zraka nakon djelomične energetske obnove prefabriciranog betonskog dječjeg vrtića izgrađenog 1980-ih u Sloveniji

# Thermal Comfort and Indoor Air Quality after a Partially Energy-efficient Renovation of a Prefabricated Concrete Kindergarten Constructed in 1980's in Slovenia

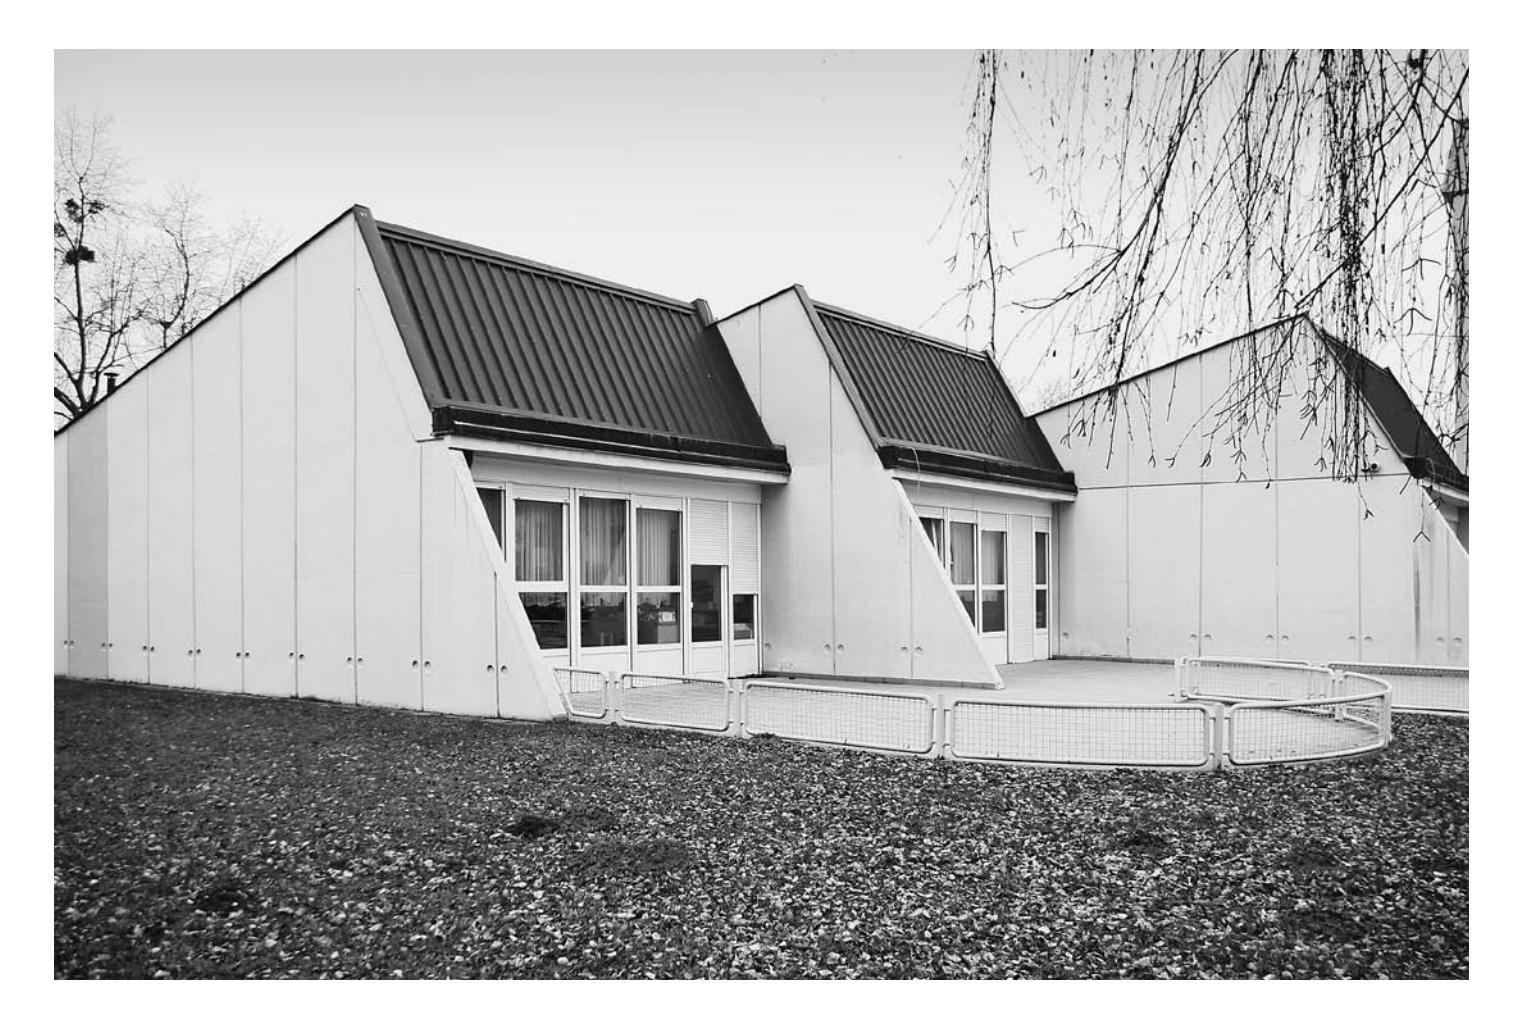
#### Fig. 1 Prefabricated concrete kindergarten building constructed in 1980's in Slovenia

The purpose of the current research therefore is to assess indoor air quality and thermal comfort in two classrooms of the selected kindergarten, built in 1980, located in Maribor, Slovenia (Fig. 1). Built in prefabricated concrete construction system, the kindergarten belongs to one of the most commonly used architectural typologies applied to building preschool facilities in the territory of the former SFRY republics in the 70s.15 Partial energy-efficient renovation of the building included window replacement in half of the classrooms, i.e. installation of the new double glazed windows with PVC (polyvinyl chloride) frames, while the other half of the classrooms kept the original timber-framed windows. The analysis comprises typological, architectural and historical analytical aspects of the building along with assessment of individual thermal comfort and indoor air quality parameters based on results obtained from in-situ measurements in two of the kindergarten's classrooms. Hence, the goal of the research is to analyse the parameters of thermal comfort and indoor air quality in one of the classrooms with new windows installed and in one of the classrooms with original windows, for the purpose of answering the following question: Are children using the classroom that underwent energy-efficient renovation procedure, i.e. window replacement carried out with the view of increasing thermal comfort and energy efficiency, indeed exposed to enhanced thermal comfort and a better indoor air quality?

The kindergarten chosen for the purpose of the current study dates from 1981, with its construction type being concrete prefabricated structure (Fig. 1). The kindergarten was built simultaneously with the housing estate of Nova Vas I in Maribor by the *Konstruktor* construction company.<sup>26</sup> As already mentioned, with the then period of concrete architecture on the rise in the territory of the former SFRY, massive construction of concrete buildings for different purposes was also seen in a great number of prefabricated kindergartens.

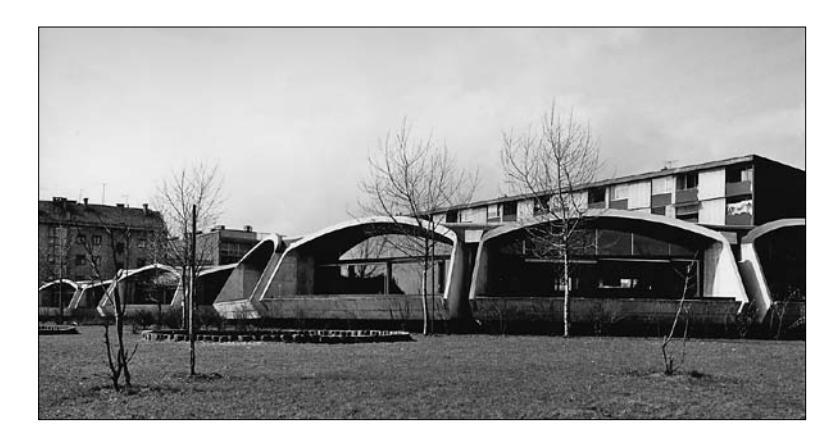
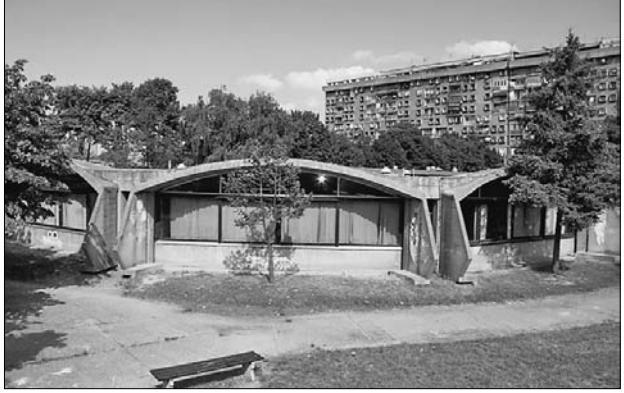
FIG. 3 KINDERGARTEN SLAVUL IN URBAN BLOCK 28. New Belgrade. Behind the kindergarten – in the same URBAN BLOCK – STANDS A BUILDING CALLED "TELEVIZORKA" ("TV SET BUILDING"), DESIGNED IN THE ŽEŽELJ PREFABRICATION SYSTEM. A SLOVENE ARCHITECT, ILIJA ARNAUTOVIC WAS PART OF A LARGER TEAM WHO PARTICIPATED IN DESIGN AND CONSTRUCTION BASED PREPARATORY ACTIVITY PRIOR TO THE BUILDING PROCESS OF URBAN BLOCK 28 IN NEW BELGRADE (1967-71). SL. 3. DJEČJI VRTIĆ SLAVUJ U URBANOM BLOKU 28, Novi Beograd. Iza dječjeg vrtića u istome urbanom BLOKU NALAZI SE ZGRADA NAZVANA "TELEVIZORKA' (TV zgrada), projektirana u prefabriciranom sustavu Žeželj. Slovenski arhitekt Ilija Arnautović bio je član VEĆE SKUPINE KOJA JE SUDJELOVALA U PROJEKTIRANJU I PRIPREMNIM AKTIVNOSTIMA ZA IZGRADNIU URBANOG BLOKA 28 U NOVOM BEOGRADU (1967.-71.).

The post-war period housing policy of former Yugoslavia was oriented towards rapid massive construction of affordable, yet high quality residential units that would satisfy modern lifestyle requirements. The 70s therefore witnessed a situation where numerous construction companies in the territory of former Yugoslavia focused primarily on residential housing and its planning, which was interspersed with experimental attempts at modern construction techniques. The tendencies went towards industrialising the field of civil engineering and enhancing prefabrication which gained ground owing to the need for quick and economical prefabricated construction.<sup>17</sup> Accordingly, a number of light and heavy prefabrication systems were developed within different companies, such as Jugomont in Croatia and Obnova in Slovenia (whose concrete elements production started in 1965 and was based on the system introduced by Jugomont), along with the prefabrication system *Žeželj* originating from Belgrade, Serbia (named after the inventor of the skeletal system – at the Serbian Institute for testing of materials – *IMS Institute*). Apart from residential housing, construction activity encompassed the systems of full or partial prefabrication of other public facilities, with the inclusion of kindergartens. Similar architectural solutions regarding preschool facilities dating from the late 70s can thus be found in many towns and cities of former Yugoslavia (Figs. 2 and 3).

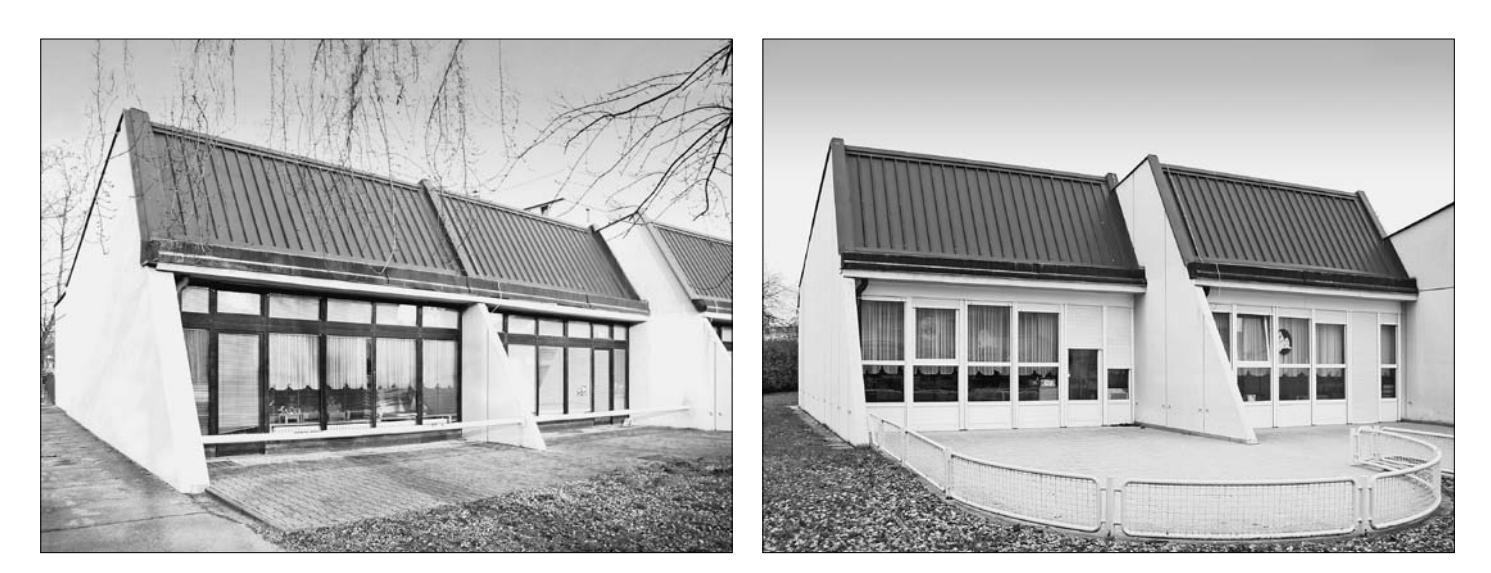
Fig. 4 Classroom with original windows (A) Sl. 4. Učionica s izvornim prozorima (A)

Fig. 5 Classroom with windows replaced (B) Sl. 5. Učionica sa zamijenjenim prozorima (B)

The building chosen for the study case analysis is a specific example as it includes two of the most common cases of kindergarten classrooms today: an end-of-the-70s classroom with its original windows (classroom A), and an end-of-the-70s classroom having undergone a partial renovation procedure of window replacement (classroom B). Such a specific case allows for *in-situ* measurements in a single building with indoor air quality and thermal comfort comparison relative to two classrooms, of which one has been partially renovated (Figs. 4 and 5). The building has district heating with radiators installed directly below the windows. The temperature of water in the heating system decreases at night-time and on days when the facility is closed (Saturday, Sunday), while the heating remains in use during the heating season. The classrooms have no air-conditioning or ventilation systems, i.e. they utilise natural ventilation by means of window opening.

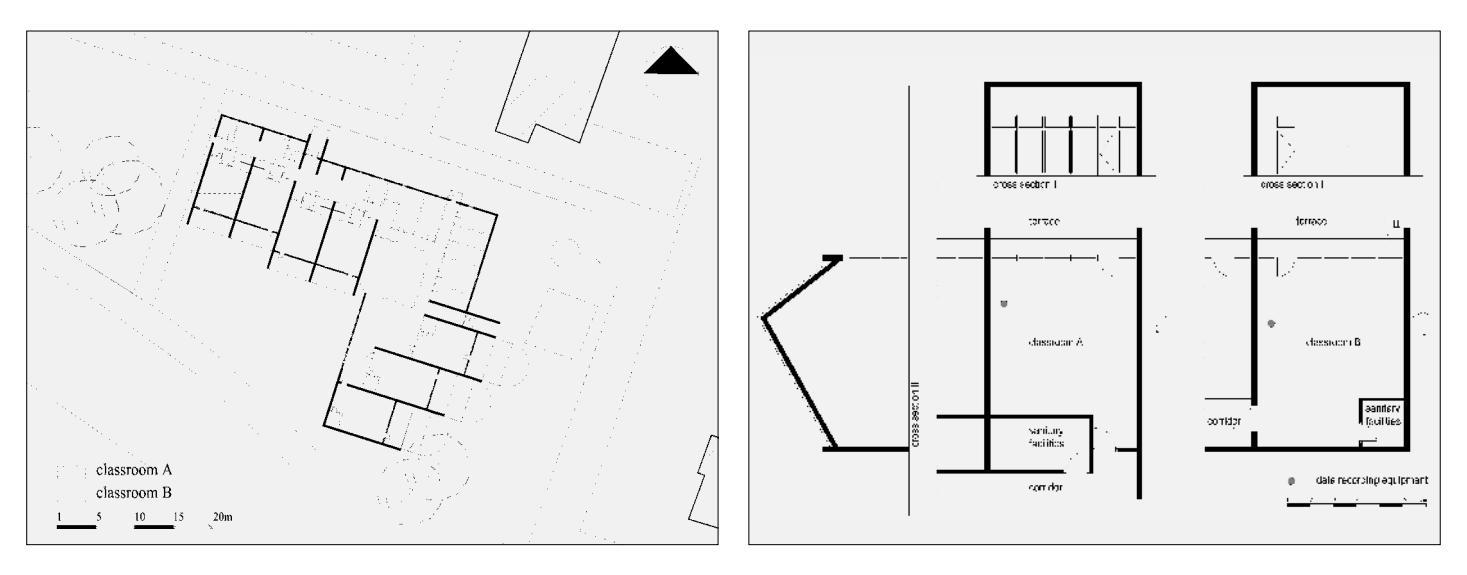
# Fig. 7 Floor plan of the classroom with original timber windows (A) and of the classroom with windows replaced (B), cross section

hidden in order not to be tampered with during the measurement process. Furthermore, the position of measuring devices had to be out of the direct heat source exposure (radiators) or sun radiation and out of the zone of the children's breathing (which is set at an approximate height of approximately 0.5 to 0.7), i.e. at a height of h = 1.5 m. The sensor was placed away from the window, at about 0.6 m from the wall, almost in the centre of the room. The position of the data recording equipment is seen in Fig. 7.

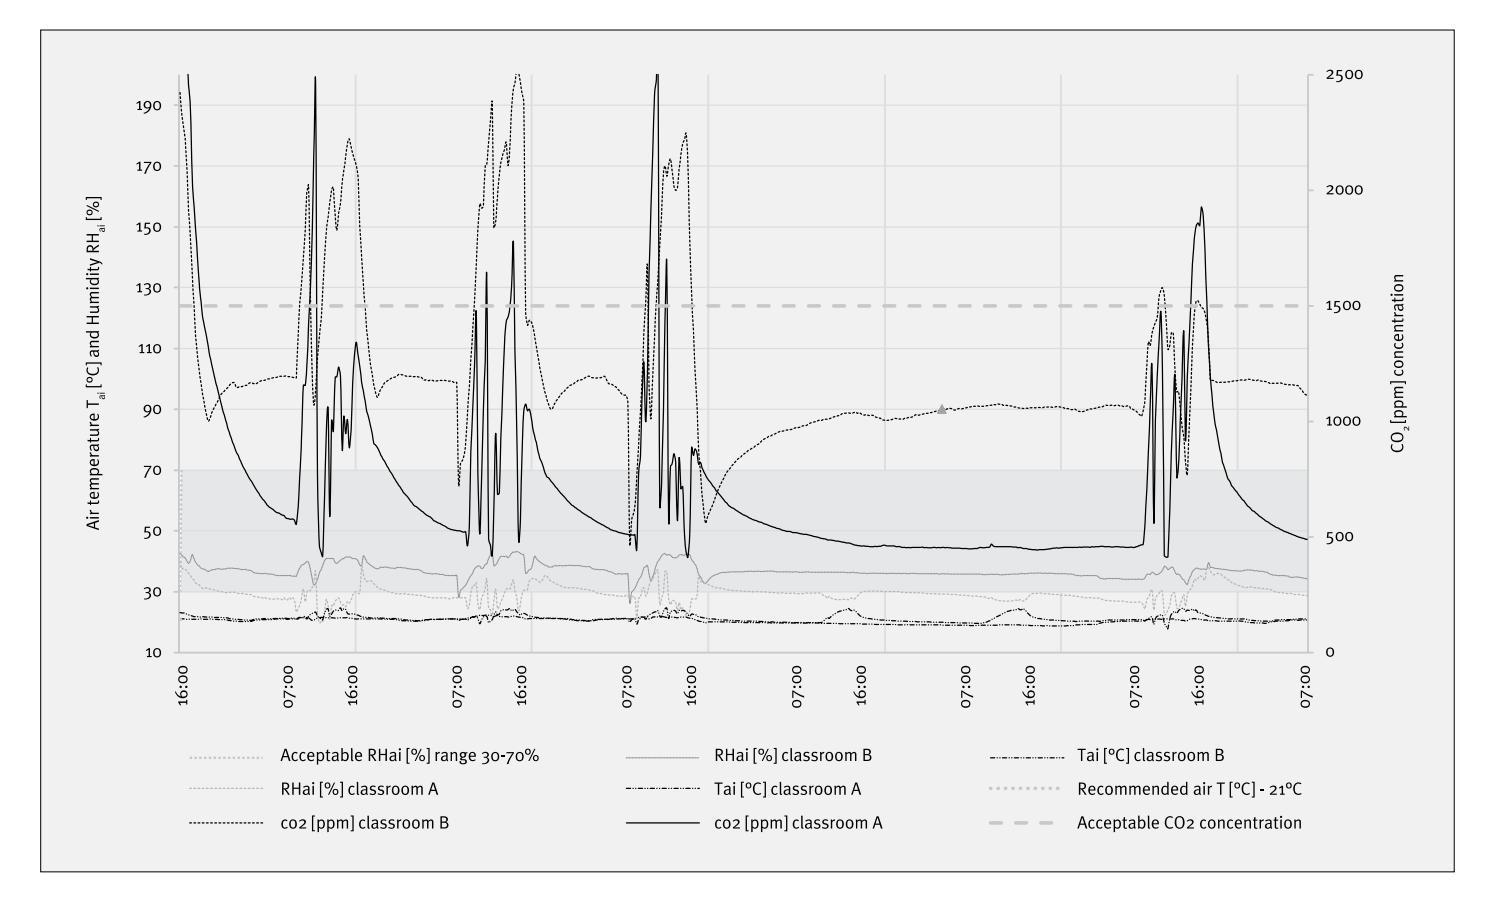
## Graph I Parameters for the entire measurement period, $RH_{\rm Ai}$ [%], $T_{\rm Ai}$ [°C], $CO_2$ [Ppm]

The rooms are usually ventilated for 30 minutes while the children go for a walk, however in the case of bad weather the teachers do not take younger children out, which means lack of conditions for a thorough ventilation. Ten-minute ventilation intervals proved to be ineffective as the room  $CO_2$  concentration hardly showed any decrease, similarly to indoor air temperature and humidity. On the other hand, 30-minute room ventilation significantly decreases  $CO_2$  concentration, while it also lowers indoor air temperature by up to 1°C (Graph I).

Indoor air temperature and  $CO_2$  concentration start rising on a daily basis upon the arrival of children as the windows remain closed while the number of occupants increases. With kindergarten children in the classrooms,  $CO_2$  concentration increases in proportion to the period of time passed since the last ventilation interval. At the end of the workday at 16h, the average  $CO_2$  concentration in the classroom with the original windows (A) amounts to 1,080 ppm, with the value recorded in the classroom with the windows replaced (B) being considerably higher, 2,252 ppm. The time span from the departure of children and their arrival the following day at 7h equals 15 hours. During that time the (A) classroom concentration of  $CO_2$  decreases on average by 62 %, while that of the classroom with new windows (B) shows a reduction by only 39 %, on account of better airtightness. Hence, each new workday in classroom B begins with a strongly elevated  $CO_2$  concentration which gradually increases towards the end of the workday.<sup>30</sup>

Kindergarten children in the classroom with the windows replaced (B) are clearly almost constantly exposed to  $CO_2$  concentration higher than 1,000 ppm. On certain days, the concentration of  $CO_2$  does not fall below 1,000 ppm; what is more, children are frequently exposed to a concentration beyond 1,500 ppm which is present over long time intervals (several hours). Such time intervals, relative to the classroom with original windows (A) lasted for a maximum period of an hour, i.e. until the next ventilation interval and were not observed on a daily basis.
